SAN FRANCISQUITO WATERSHED COUNCIL

# Adult Steelhead Passage in the Bear Creek Watershed

*Jerry J. Smith, Dept. of Biological Sciences,  
and Deborah R. Harden, Dept. of Geology,  
San Jose State University, San Jose, CA 95192*

*Pat Showalter, Watershed Council Director July 2001*

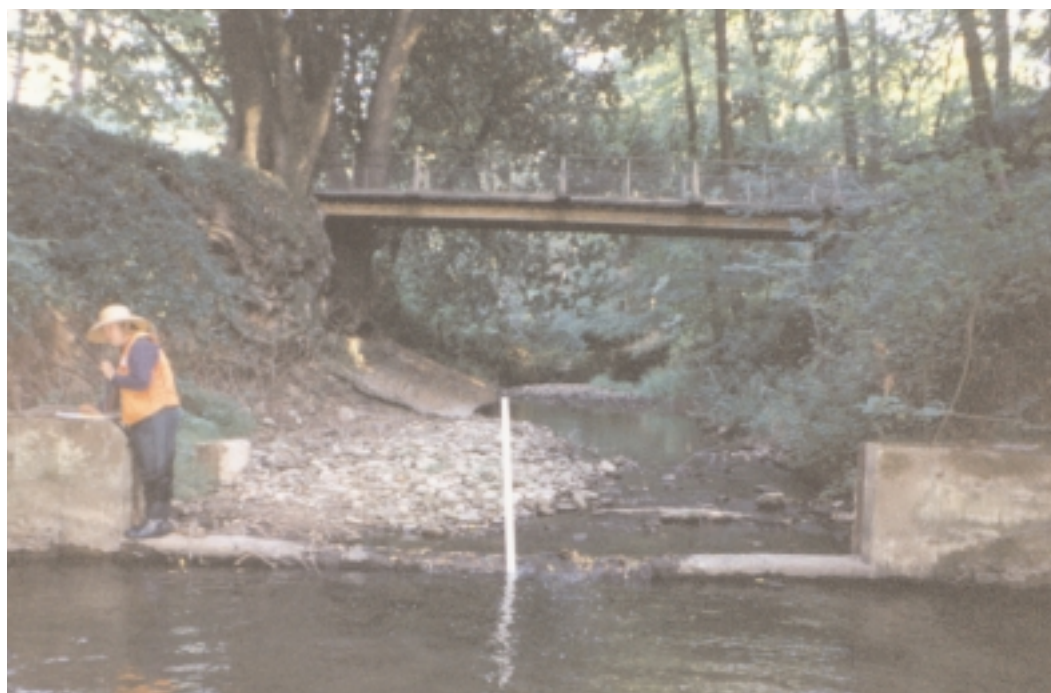
<b>Stream</b>	<b>Bear Creek</b>
<b>Barrier Number</b>	<b>10</b>
<b>Location</b>	Bridge Crossing at Fox Hollow Road, 0.2 miles downstream of Highway 84
<b>Ownership</b>	City of Woodside
<b>Type of Barrier</b>	Bridge box culverts/aprons

**Diagnosis** Pool downstream is sufficiently deep to provide for moderately difficult jump to the culverts at winter flows. However, shallow depth in the culverts makes passage difficult at low flows, and velocity in the culverts is a potential problem at high flows. No California roach or Sacramento suckers were observed upstream of this substantial barrier. The bars serve no purpose and might injure jumping fish.

**Recommended Action** A low curb (6-inch) should be installed at the upstream entrance to one of the culverts to concentrate low flows down the other culvert. In the second culvert the flow should be concentrated down half of the culvert with curbing. In addition, Washington baffles (alternating baffles perpendicular to the side with baffles pointing upstream) should be installed in the culvert without the curb; these baffles will increase the depth and reduce the velocity to provide for relatively easy low flow passage. The bars should be removed. This barrier and barrier #3 represent the most significant passable barriers in the watershed.

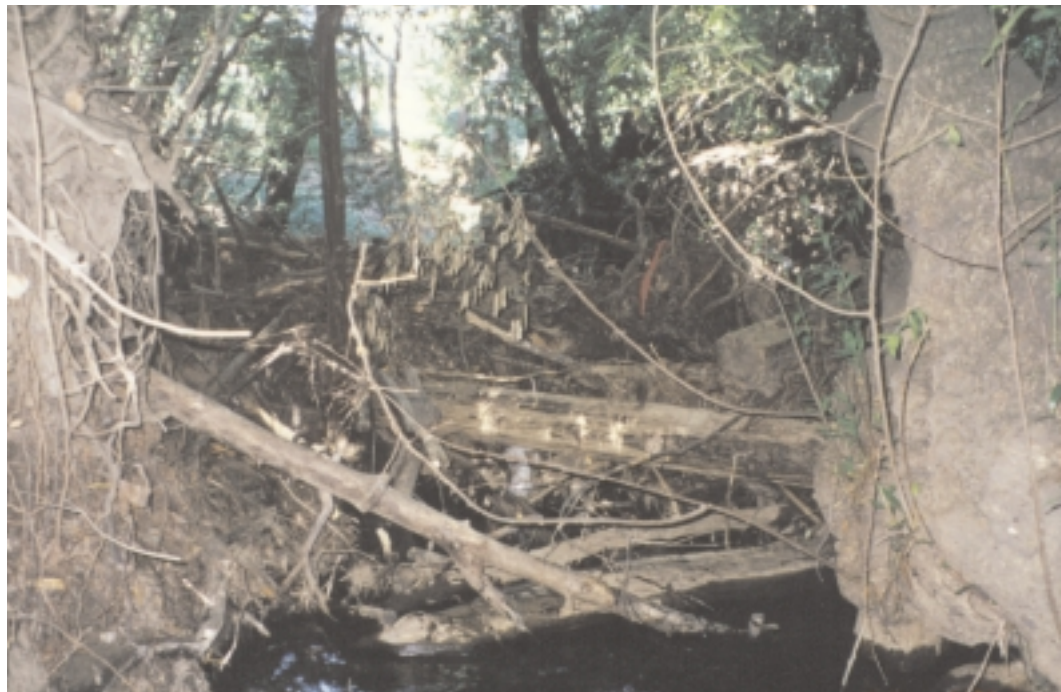
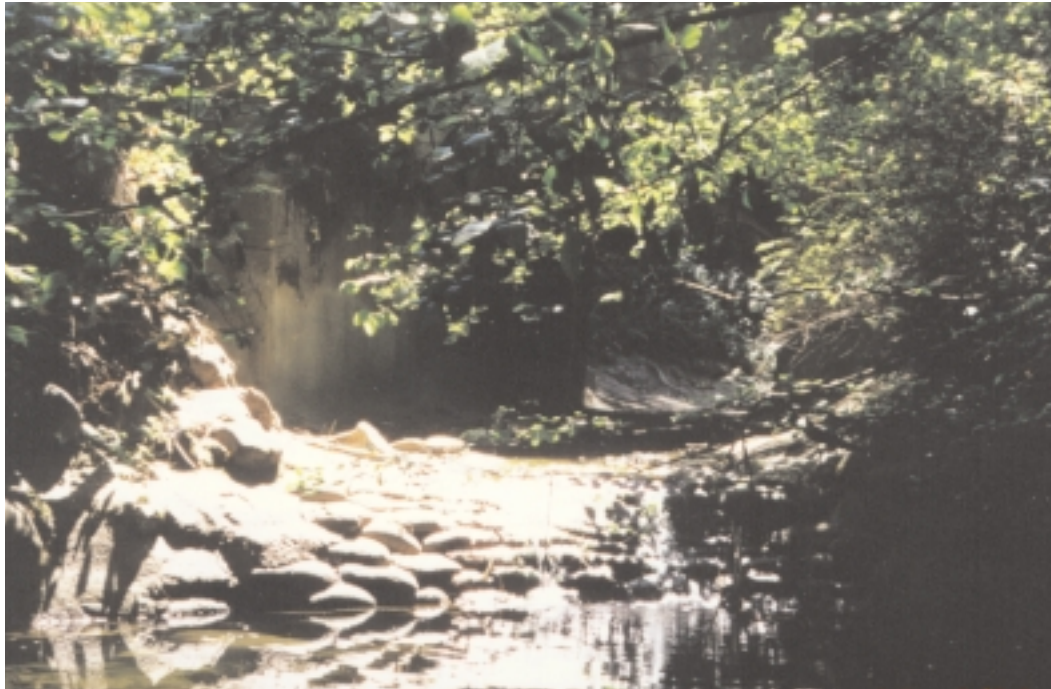
<b>Stream</b>	<b>Bear Gulch</b>
<b>Barrier Number</b>	<b>14</b>
<b>Location</b>	La Honda Road/Highway 84
<b>Ownership</b>	CALTRANS
<b>Type of Barrier</b>	Bridge apron and concrete-lined channel

Five bridge aprons or culverts present significant passage problems in the Bear Creek watershed. The Highway 84 crossing of Bear Gulch (barrier # 14) requires fish to make a relatively easy 2.3-foot jump from a 3.5-foot deep pool, but then to negotiate almost 75 feet of culvert and concrete-bottomed channel. Access under present conditions is possible under moderate flow conditions (30-100 cfs), but is probably very difficult at lower flows because of shallow depth. At higher flows high velocities are probably a problem. Baffles would improve passage, especially at low flows, but less than 0.1 mile of accessible habitat is present between the culvert and the impassable California Water Service dam. The Fox Hollow bridge over Bear Creek (barrier # 10) requires a 2.3-foot jump from a pool 2.9-feet deep. However, again the biggest challenge is negotiating the twin box culverts that are each 10-feet wide and 30-feet long. Installing an upstream curb on one culvert and baffling the other would concentrate low flows down a deeper and slower pathway, and greatly improve dry year access to most of the watershed. At the Highway 84 crossing of West Union Creek (barrier # 17) the apron is beveled, with low flows concentrated down the center; baffles here would also improve low flow passage. In addition, the apron is 1.3 feet above the pool surface downstream, and riprap boulders at the base restrict the pool depth to 0.8-foot deep below the apron; movement of several boulders would improve the jump. A 4-foot diameter culvert on lower McGarvey Gulch (barrier # 28) is perched 0.7 feet above the flow dissipation apron downstream, and the apron is 0.8 feet

**Recommended Action** Washington baffles would reduce the velocity and depth problems in the culvert and lined channel. However, passage is not too difficult at moderate flows. In addition, only about 0.1 miles of habitat exist between the barrier and the impassable dam upstream (barrier #15). Unless that dam is modified to provide for passage, no action is probably justified at this partial fish passage barrier.

If the California Water Service Diversion Dam is modified, improvements at this site will become much higher priority. In addition to the measures mentioned above, the long-term solution of replacing the crossing with a bridge and natural channel should be considered with any future plans for modification or repair of this public structure.

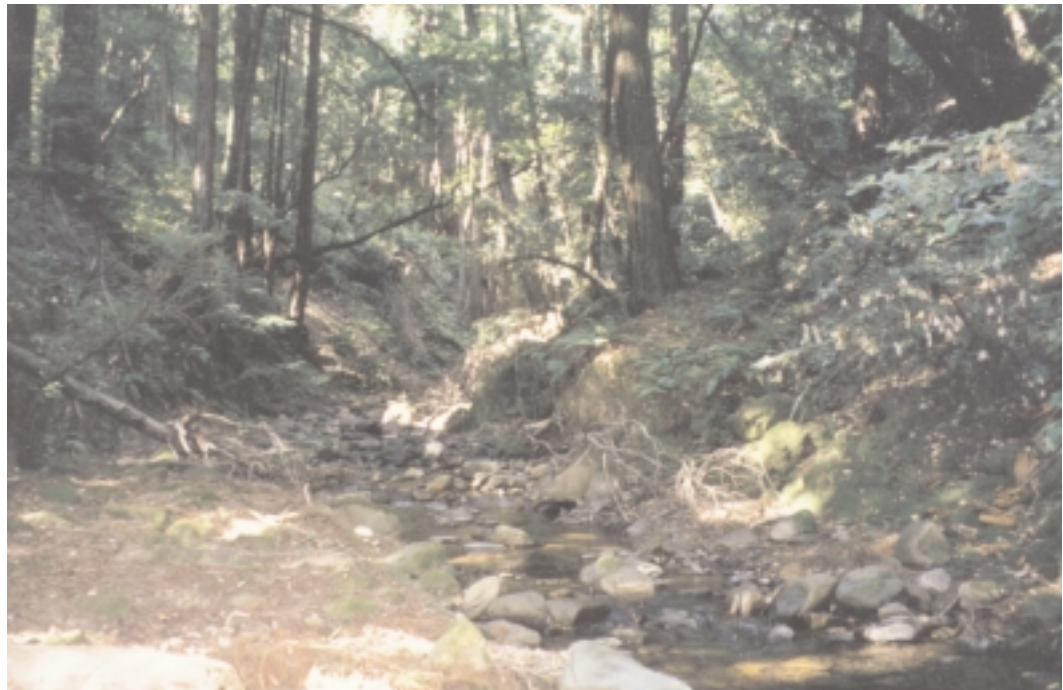
<b>Stream</b>	<b>Bear Gulch</b>
<b>Barrier Number</b>	<b>16</b>
<b>Location</b>	About 0.7 miles upstream of Highway 84
<b>Ownership</b>	California Water Service
<b>Type of Barrier</b>	Series of boulder falls

Sandstone outcrops produce a steep series of boulder falls on Bear Gulch (Barrier # 16), Squealer Gulch (upstream of barrier # 25), and McGarvey Gulch (barrier # 31). Such extended boulder channels are velocity barriers during high flows and lack adequate jump pools to surmount some steps during lower flows. The boulder configurations are likely to periodically change due to severe storms and upslope landslides. On Bear Gulch the stream drops 47 feet through 4 major steps with 3 individual drops greater than 5 feet. Under ideal flow conditions an occasional fish might be able to negotiate the barrier, and trout are present above the barrier. However, significant steelhead access would not be possible with the present boulder configuration, and continuous modification efforts are not practical. The falls on Squealer Gulch are less severe, but those on McGarvey Gulch are completely impassable. Additionally, McGarvey Gulch has logjams at steep, narrow, downstream locations.
