**Fish Passage Assessment
at the State Park Bridge on San Julian Road
Gaviota Creek, California**

Michael Love & Associates

October 8, 2007

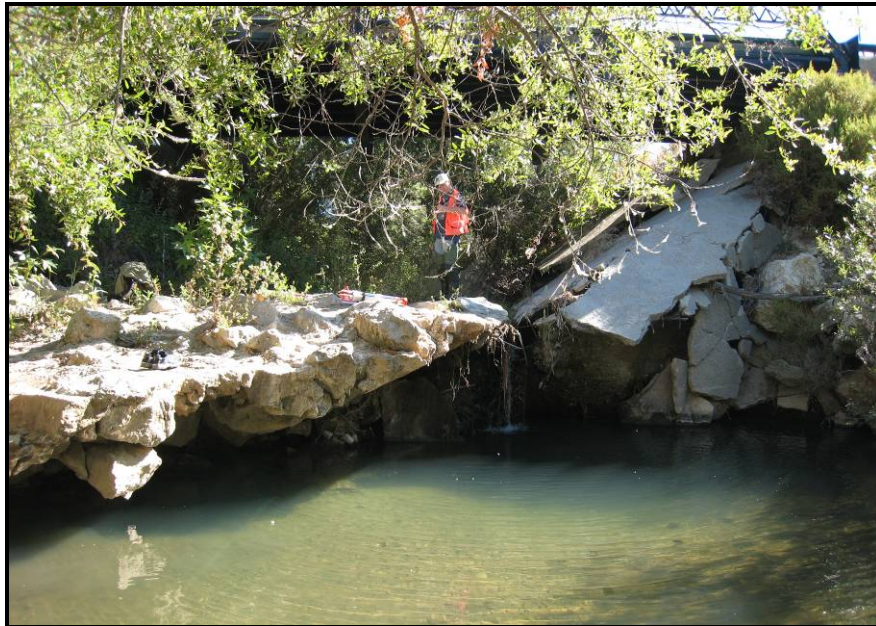
Figure 2 – Looking upstream at the State Park Bridge at San Julian Road. Note undercut broken concrete and grouted riprap within the active channel. The concrete spans the channel and ponds water upstream of the crossing.

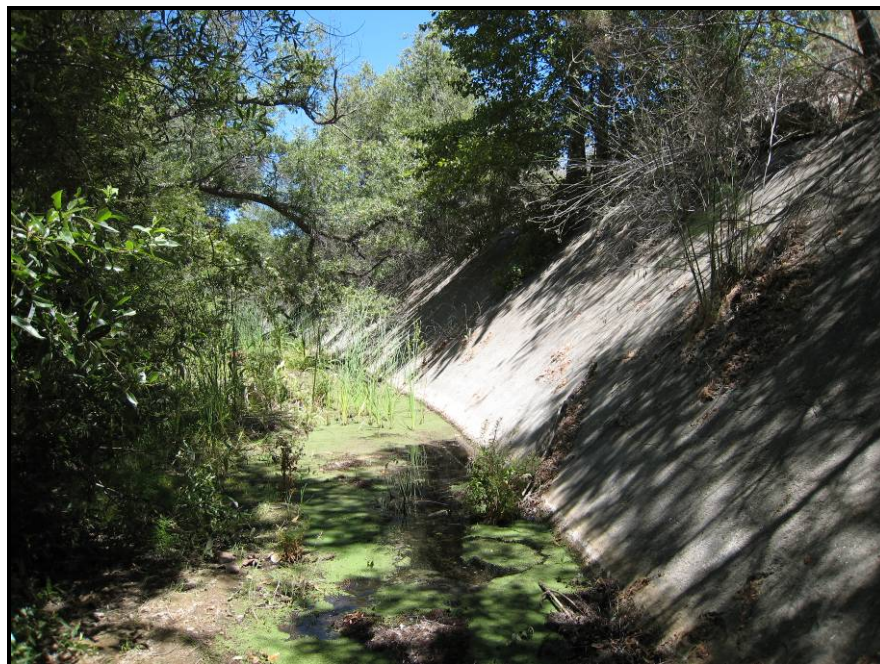
Upstream of the bridge crossing (Figure 3), the left channel bank (looking downstream) is constructed of a sloping concrete revetment wall, which extends over 1,000 feet upstream to the Highway 1 bridge crossing. The concrete wall is part of the channel realignment and Highway 1 to 101 interchange project. Running along the top of the wall is a ranch road and an on-ramp to Highway 101. The sloping concrete wall is 10 to 15 feet tall and is at roughly a 1H:1V slope. The right bank is unarmored. The concrete that spans the channel bottom at the bridge crossing is higher in elevation than the upstream channel bed, creating a backwater condition during low flows. During the time of the survey the resulting still water within the active channel was dense in herbaceous vegetation and algae.

Figure 3 – Looking upstream from the crossing. Note concrete revetment wall on right bank. The left bank is natural and vegetated with dense riparian plants.

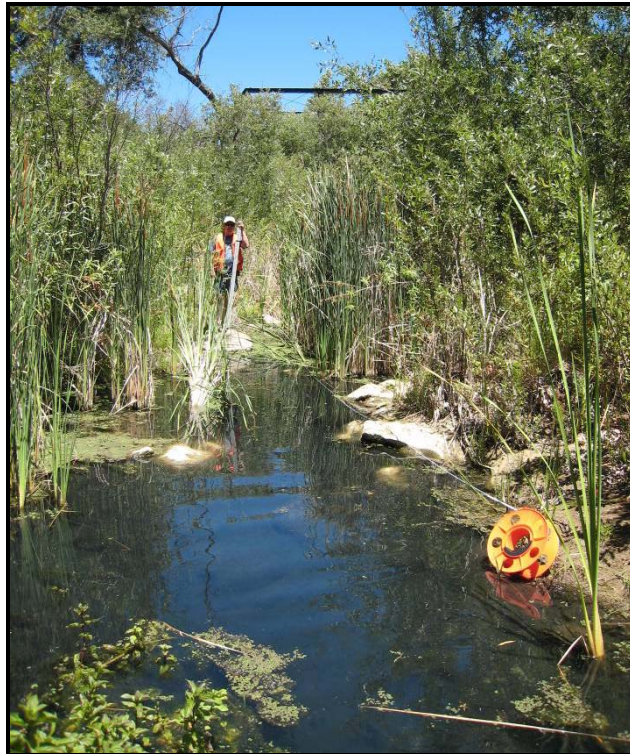
Downstream of the bridge crossing and scour pool (Figure 4) is a 60 foot long natural reach consisting of unarmored channel banks and an extensive cobble bar along the left side of the channel. A sacrete wall begins on the right channel bank approximately 60 feet downstream of the crossing. During the time of the survey dense herbaceous vegetation and algae choked the active channel downstream of the scour pool in the vicinity of the tailwater cross section.

Figure 4 – Looking upstream towards the tailwater cross section and the crossing.

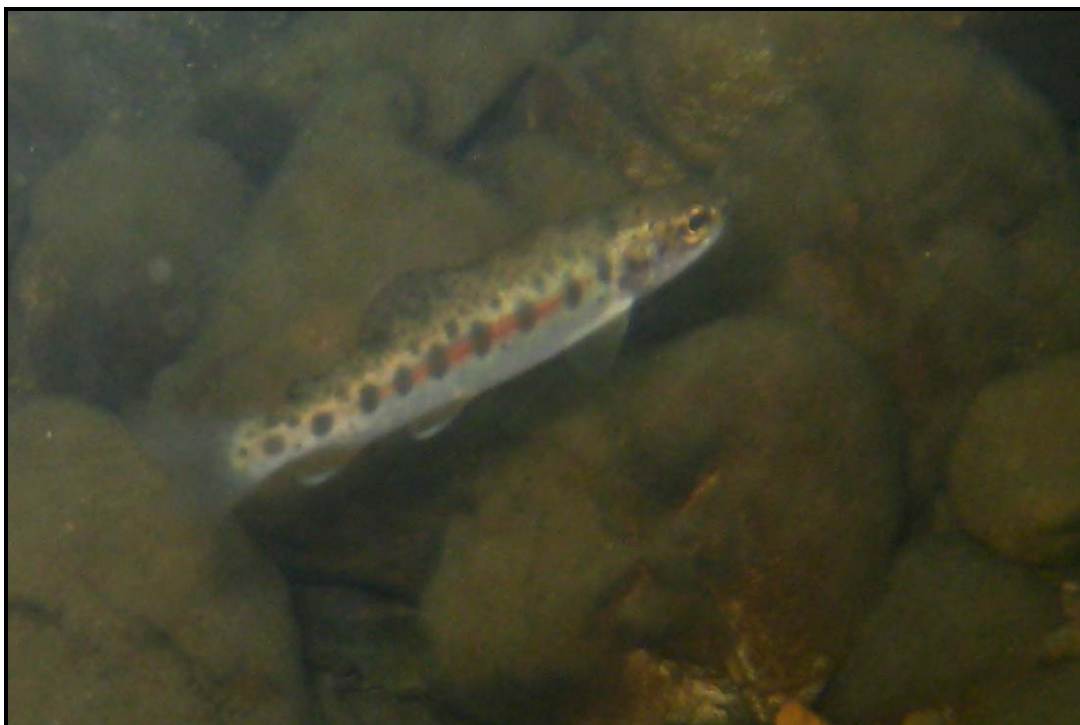
As with downstream reaches previously surveyed on Gaviota Creek, juvenile steelhead trout (*Oncorhynchus mykiss*) were observed adjacent to this fish passage barrier. Prior to surveying the structure Matt Stoecker snorkeled the downstream pool and found two juvenile steelhead parr ranging from 4-5 inches in length (Figure 5). In addition, over forty Arroyo chub (*Gila orcutti*), one Southwestern pond turtle (*Actinemys marmorata pallida*), and 15 non-native crawfish were observed in the downstream pool. No fish or other aquatic species were observed upstream of the barrier to the confluence of the West Fork Gaviota Creek. While the downstream scour pool provides good rearing habitat for steelhead and other aquatic species, the bridge apron that creates it is an obvious barrier, hindering or blocking upstream migration of these native fish and other aquatic organisms.

Figure 5 – One of two juvenile steelhead trout observed in the plunge pool downstream of the bridge apron.

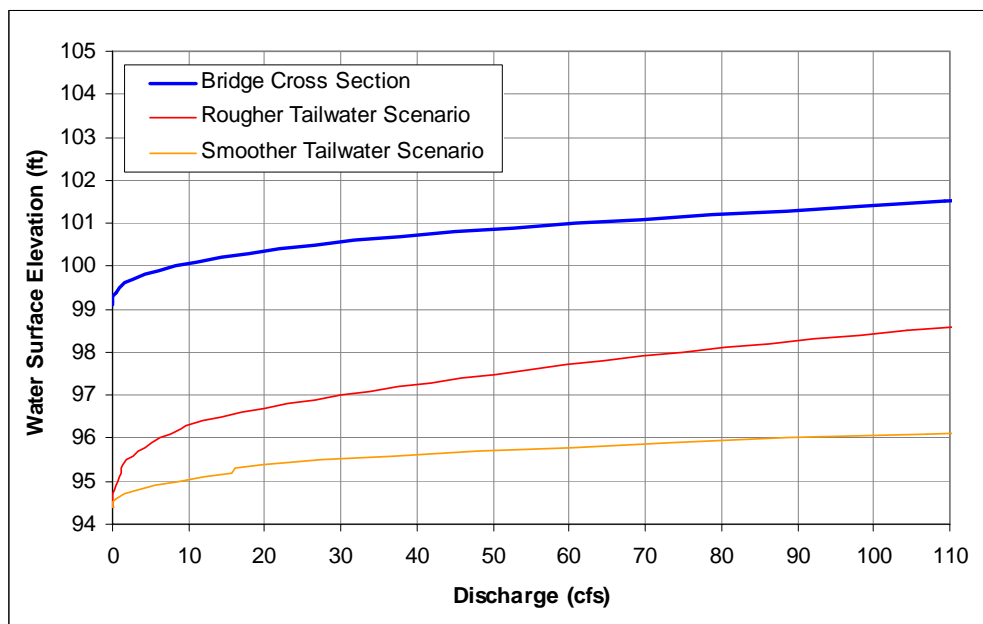
Figure 7 and Table 4 present water surface elevations and total water surface drop between the bridge cross section and two tailwater control cross section for each scenario. Figure 8 illustrates the minimum computed drop height for the San Julian Road Bridge crossing. At all fish passage flows the drop exceeds the maximum recommended by CDFG and NOAA Fisheries. The smallest water surface drop occurs at the upper adult steelhead passage flow, and at least 3.0 feet. The drop heights shown in Figure 8 would likely function as a complete barrier to upstream migrating juvenile and resident trout, and a substantial impediment to most upstream migrating adult steelhead.

Figure 7 – Results of modeled water surface elevations for the crossing and two tailwater scenarios across the range of fish passage flows.

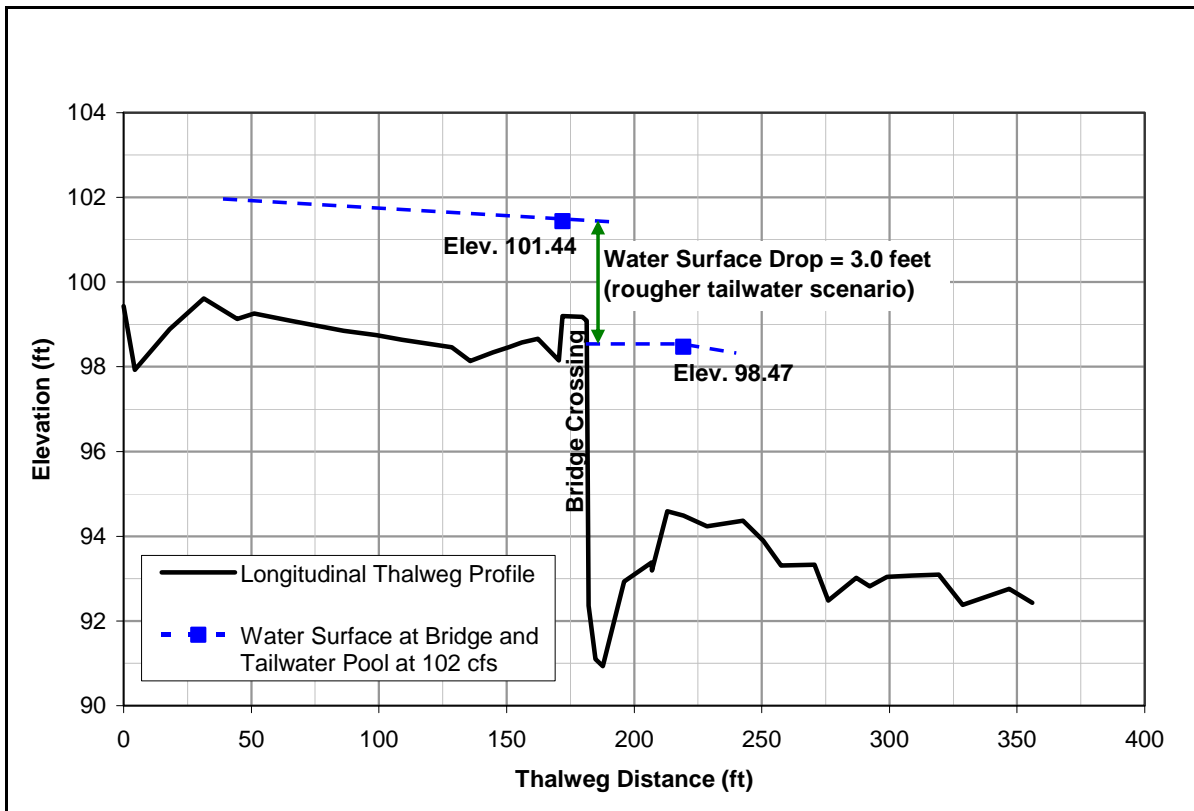
Figure 8 – Predicted water surface elevations at the bridge and tailwater pool at the Upper Adult Steelhead Passage Flow of 102 cfs. Shown water surface elevations are for the rougher tailwater scenario.

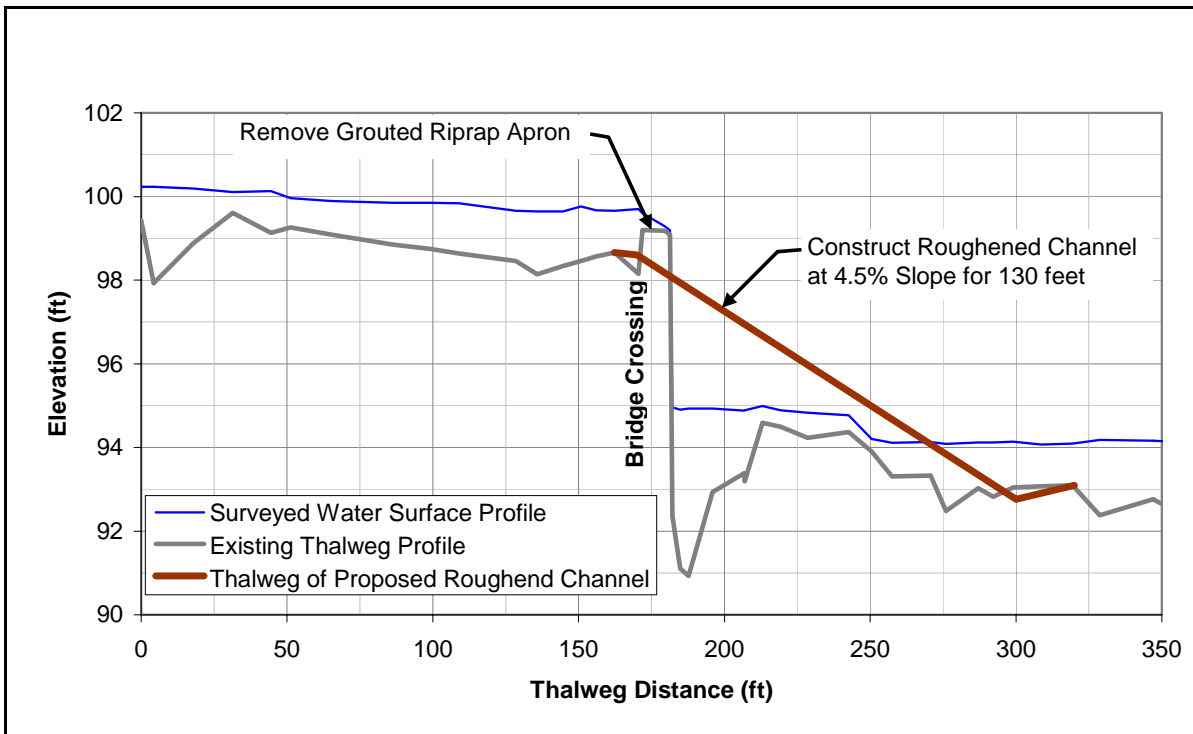
Figure 9 –Potential feasible fish passage retrofit includes construction of a roughened channel that runs from the downstream end of the bridge down to the upstream end of the sacrete revetment. The roughened channel would be approximately 130 long and have an overall slope of 4.5%.

A viable alternative may be to construct either a roughened channel or step pool channel starting at the downstream limit of the concrete apron under the bridge. A roughened channel approach consists of a uniformly sloped natural channel reach constructed of a gradation of larger boulders, cobbles and smaller sediments that creates roughness and flow diversity to facilitate passage for fish of varying species and size (Bates 2003). Roughened channels have been successfully used in a wide variety of settings and is the most stable type of grade control for this site.

Initial calculations indicated that a roughened channel could be designed to eliminate the drop over the existing bridge apron, provide adequate fish passage, and remain stable up to a relatively high design flow (i.e. 50 or 100 year peak flow). Figure 9 shows a schematic profile of a possible roughened channel alternative starting at the downstream limit of the concrete apron under the bridge and running 130 foot downstream at a 4.5% slope. The roughened channel would end near the upstream limits of the sacrete wall. The existing grouted riprap apron would be removed as part of this alternative. This would allow the top end of the roughened channel to be roughly 0.5 feet lower than the existing apron, which would increase the capacity of the channel under the bridge.
