Steelhead Migration Barrier Inventory and Recovery Opportunities for the Santa Ynez River, Ca.

Prepared by:
Matt W. Stoecker
Stoecker Ecological Consulting

Prepared for:
Community Environmental Council
Santa Barbara, Ca.

January 29, 2004

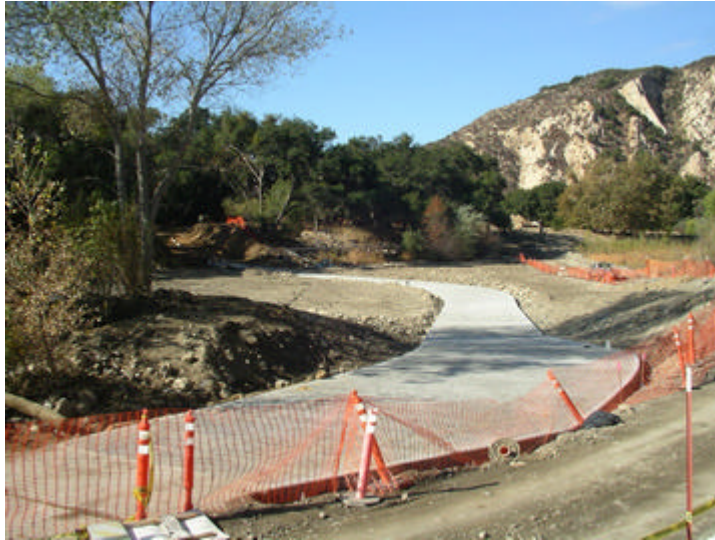
Barrier Status: Partial

Description: This new (fall 2003) road crossing measured 400 feet long by 14 feet wide and 6 inches thick. The crossing was still under construction when observed. The crossing surface was at streambed grade with a mild to flat sloping surface. The substrate had not yet been backfilled around the concrete pour.

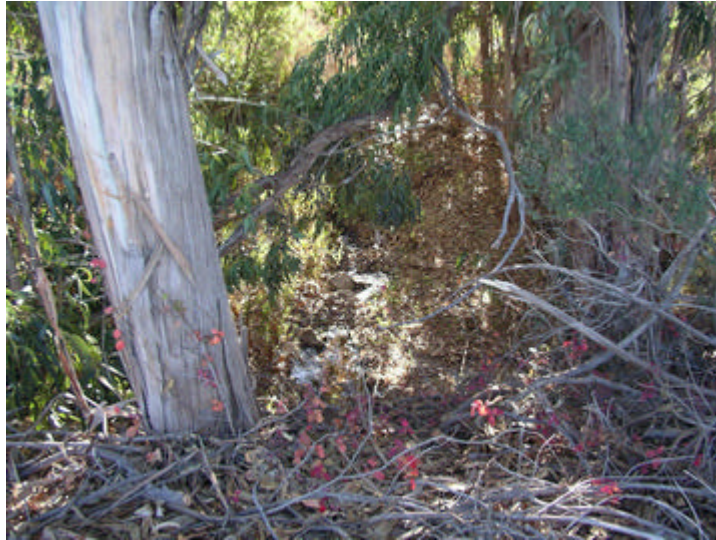
Barrier Status: Unknown

Description: Permission to survey adjacent private land was not obtained and limited observations were made from adjacent public roads. The culvert appears to be approximately 100 feet long, based on the road width and fill.

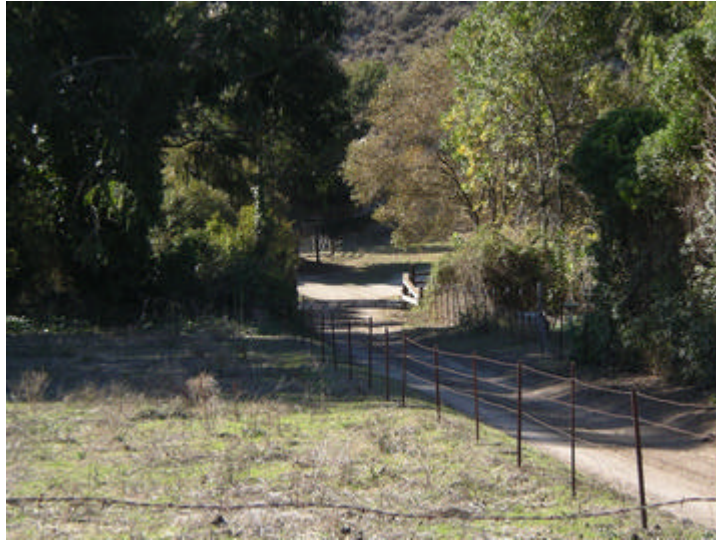
Description: Permission to access and ground survey this crossing and adjacent channel was not obtained and limited observations were made from the Miguelito Road.

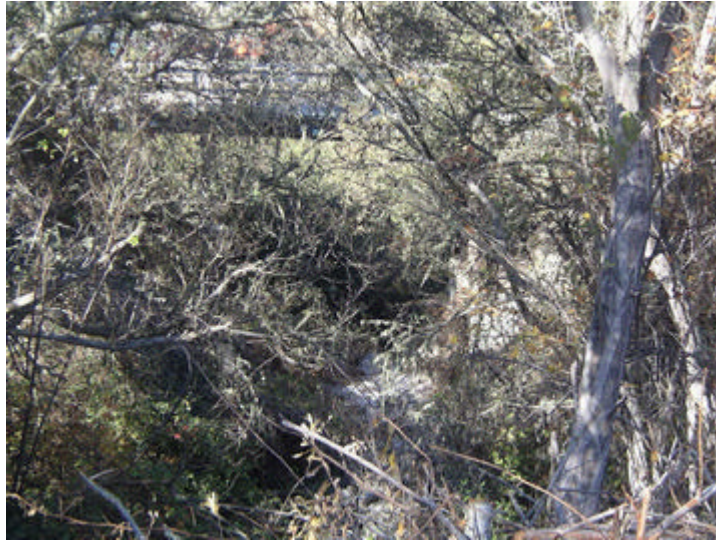
Description: Permission to access and ground survey this crossing and the adjacent channel was not obtained and limited observations were made from Miguelito Road. The stream channel below this bridge appears to be natural, but riparian vegetation impaired observations.

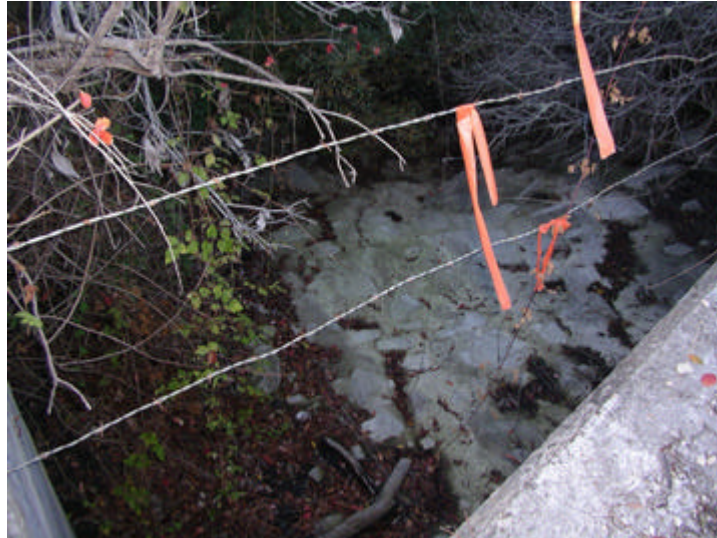
Description: Permission to ground survey the adjacent channel was not obtained and limited observations were made from the public road. This box culvert measured approximately 10 feet wide by 9 feet tall and approximately 130 feet long. There is a riprap apron that extends downstream at a steep gradient for approximately 25 feet.

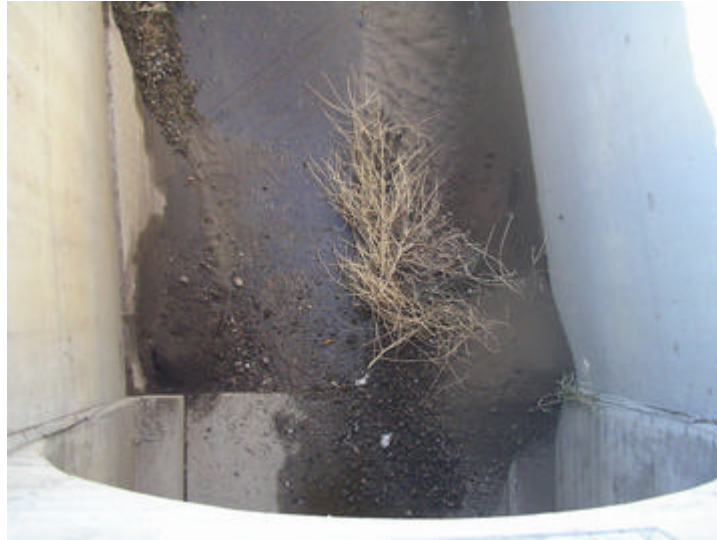
Description: Permission to ground survey all of this structure and adjacent private land was not obtained and limited observations were made from public roads. This concrete arch culvert measured 10 feet tall by 6 feet wide and is approximately 100 feet long.

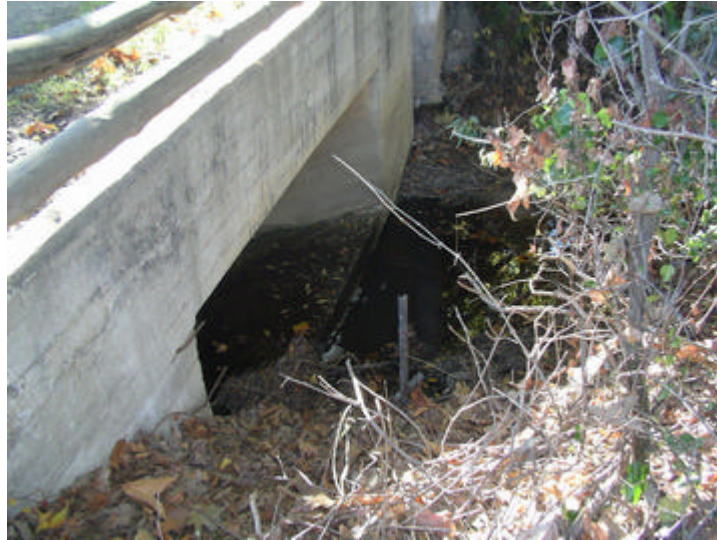
Description: This concrete box culvert measured 4 feet tall by 6 feet wide and is approximately 30 feet long. The height from the downstream pool surface to the downstream lip of the culvert measured 10 inches. The maximum pool depth observed was 12 inches.

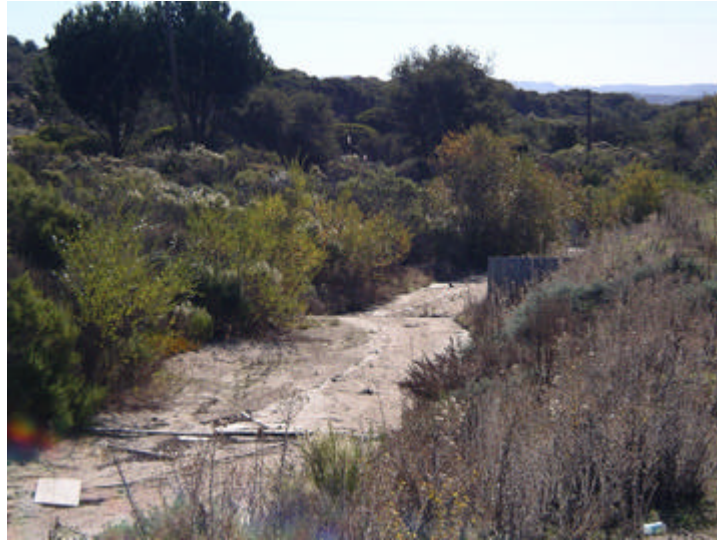
Description: Permission to ground survey this structure was not obtained and limited observations were made from Via Lato Road. This grade control structure appears to be constructed with sheets of corrugated steel. The height from the downstream riverbed to the upstream substrate is approximately 3 feet. Substrate is filled to the top of the steel grade control structure. Corrugated steel wingwalls appear to angle towards the center of the channel and extend downstream for approximately 10 feet.

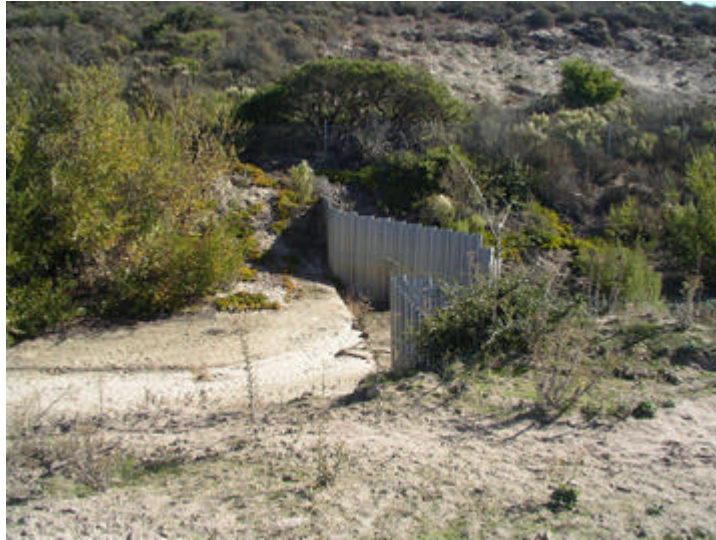
Description: Access to ground survey this structure was not obtained. Observations were made from Via Lato Road and are limited in detail. This concrete and corrugated steel grade control structure contains metal wingwalls that angle toward the center of the stream channel and extend downstream for approximately 10 feet. A drop of approximately 2 feet 6 inches occurs downstream from the concrete lined bottom to the natural substrate. The concrete bottom has a flat to mild slope.

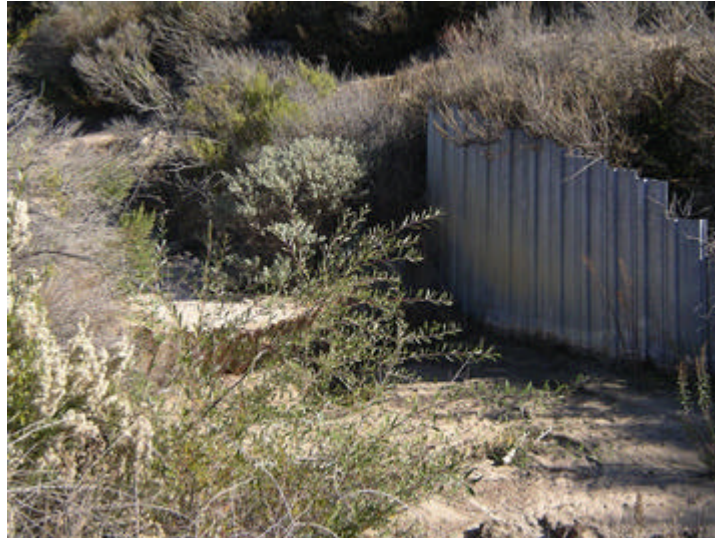
Description: Access to ground survey this structure was not obtained. Observations were made from Via Lato Road and are limited in detail. This concrete and corrugated steel grade control structure contains metal wingwalls that angle toward the center of the stream channel and extend downstream for approximately 10 feet. A drop of approximately 2 feet 6 inches occurs downstream from the concrete lined bottom to the natural substrate.

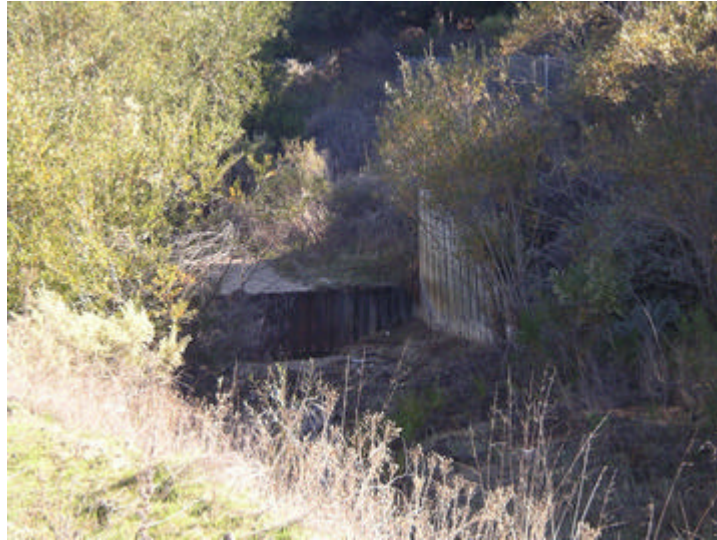
Description: Access to ground survey this structure was not obtained. Observations were made from Via Lato Road and are limited in detail. This concrete and corrugated steel grade control structure contains metal wingwalls that angle toward the center of the stream channel and extend downstream for approximately 10 feet. A drop of approximately 3 feet occurs downstream from the concrete lined bottom to the natural substrate. The concrete bottom has a flat to mild slope.

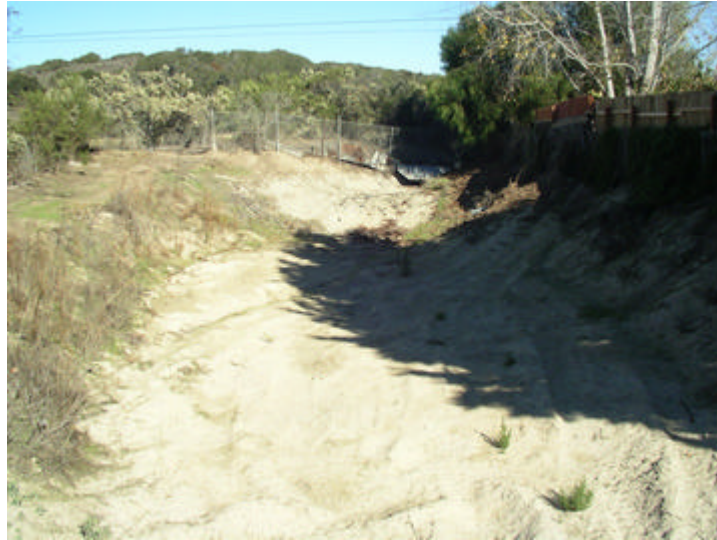
Description: Permission to ground survey this structure was not obtained and limited observations were made from Calle Lindero Road. This concrete grade control structure covers the bottom of the stream channel and extends upstream over 25 feet with an irregular surface and moderately steep slope.

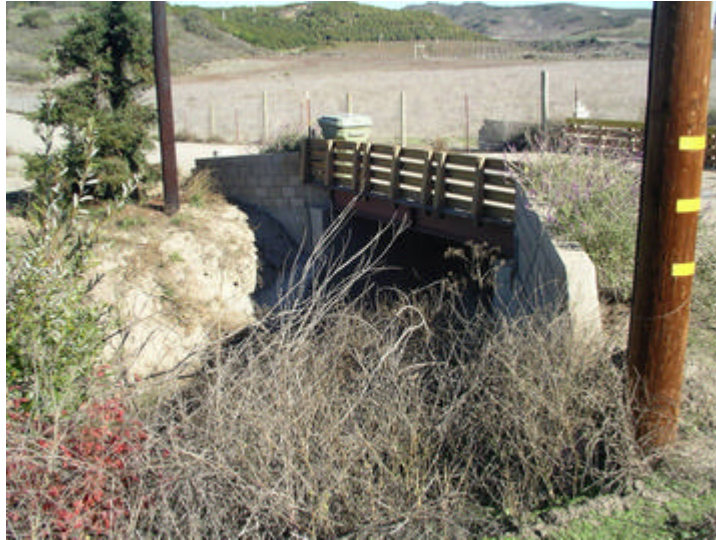
Description: Permission to ground survey this structure and adjacent land was not obtained and limited observations were made from Cebada Canyon Road. This concrete channel is approximately 25 feet long and has a 20-foot long concrete apron attached to the downstream end.

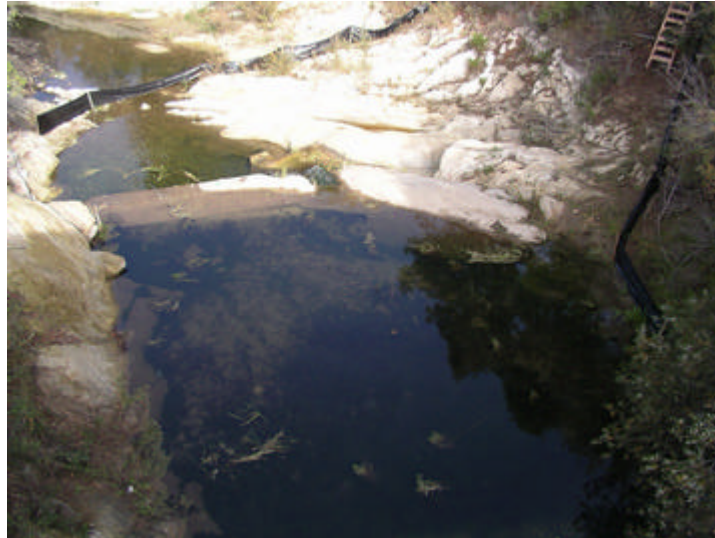
Description: This concrete grade control structure crosses the creek for a width of approximately 35 feet and is 3 feet 6 inches thick. The height from the top of the structure to the surface of the downstream pool is approximately 4 feet. The maximum downstream pool depth measured 4 feet. Low stream flows are concentrate over a low point in the structure from the middle of the structure to the bedrock on river-left. The upstream portion of the structure is submerged by the tailout of the large upstream pool.

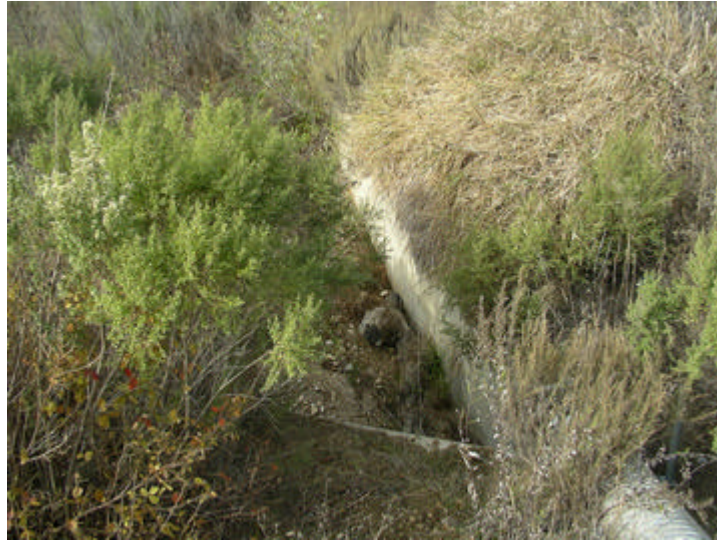
Description: Permission to access and ground survey the private land adjacent to the culvert was not obtained and limited observations were made from Jalama Road. This concrete box culvert conveys flows approximately 75 feet under the road.

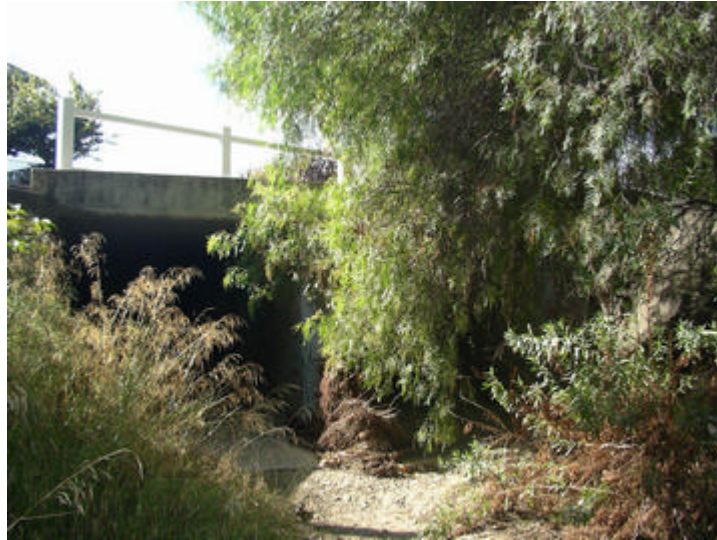
Description: This double box culvert consists of two identical culverts that each measure 10 feet wide by 7 feet tall. The length of the culvert is approximately 700 feet. The height from the downstream lip of the culvert bottom to the downstream substrate measured 6 inches. In addition to the road crossings on top, this culvert also has developments like a parking lot built on top of it.

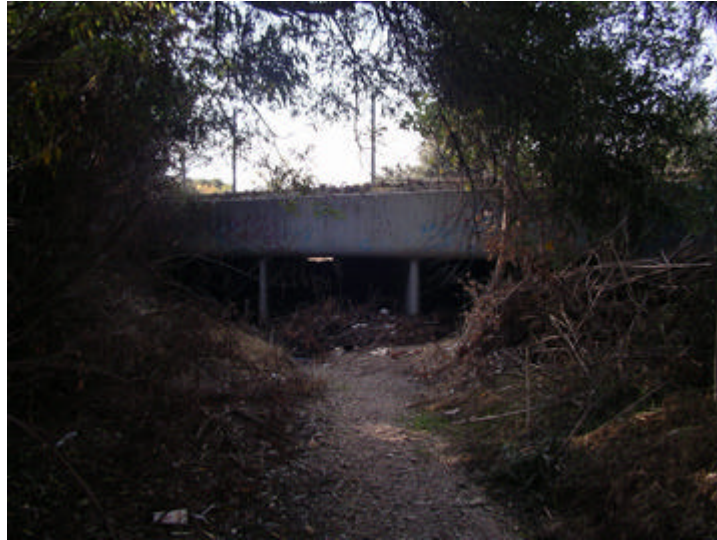
Description: This crossing consists of three box culverts that each measure 8 feet wide by 57 inches tall. The approximate length of the culvert is 300 feet. Immediately upstream from the culvert there is a pipe discharging a milky white liquid into the stream channel. The bottom of the culvert occurs at streambed level and has a mild gradient.

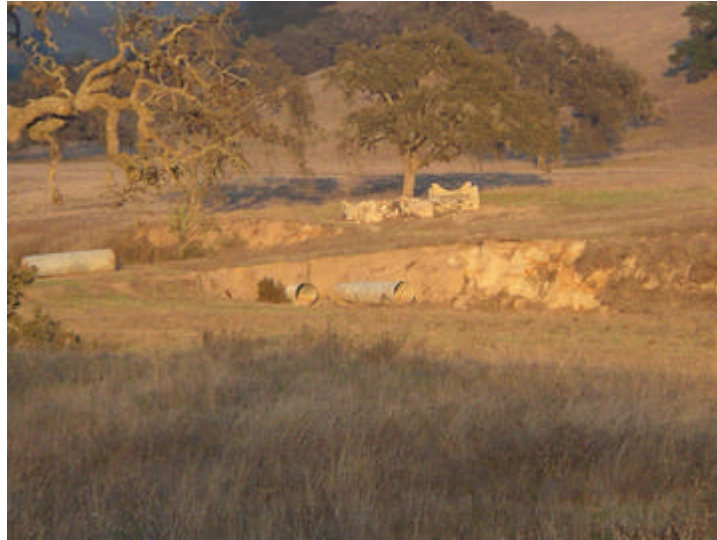
Description: Permission to ground survey the culvert was not obtained and limited observations were made from Zaca Station Road. Two corrugated metal pipes with approximately 3-foot diameters convey flows through an earthen fill crossing. The height from the downstream lip of these perched culverts to the downstream substrate appears to be approximately 2 feet.

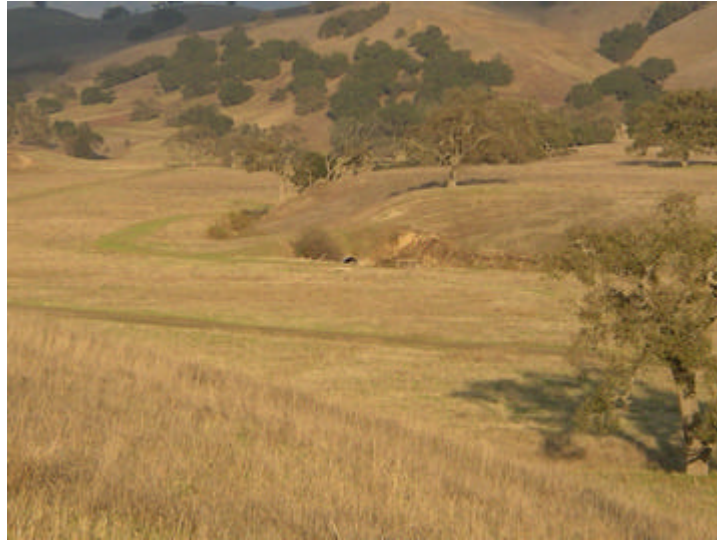
Description: Permission to ground survey the culvert was not obtained and limited observations were made from Zaca Station Road. One corrugated metal pipe with an approximate diameter of 4 feet conveys flows through an earthen fill crossing. The height from the downstream lip of this perched culvert to the downstream substrate appears to be approximately 2 feet. Some concrete appears to encase part of the downstream end of the culvert.

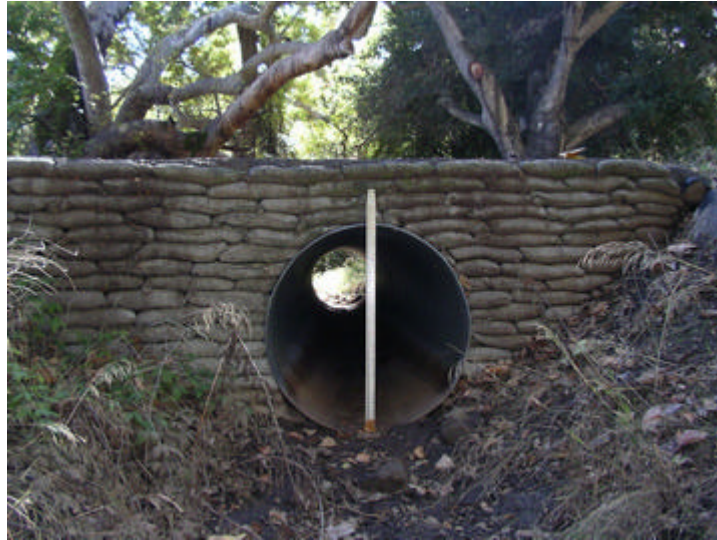
Description: This 4-foot diameter corrugated metal culvert pipe is 38 feet long and encased in sacrete walls at both the upstream and downstream ends. Water marks on the inside walls of the culvert pipe indicate that a 1-foot water depth occurs inside the culvert during certain migration flows.

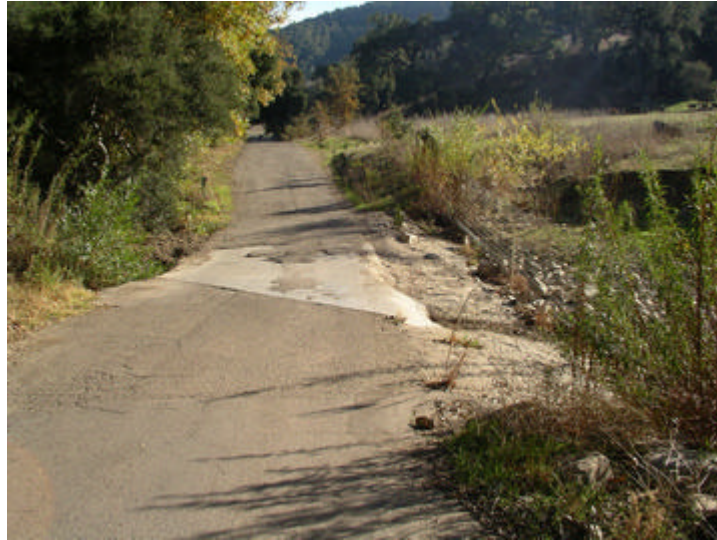
Description: This low-flow road crossing measured 18 feet wide from the upstream lip of the road to the downstream lip of the concrete apron. The asphalt road and concrete crossing spans the active stream channel for 68 feet. A 1-foot diameter corrugated metal pipe passes through the center of the low-flow crossing. The concrete and boulder riprap apron has been added to the crossing and extends downstream for 8 feet, spanning the width of the stream channel for 68 feet. The apron has a moderate slope down to the natural streambed.

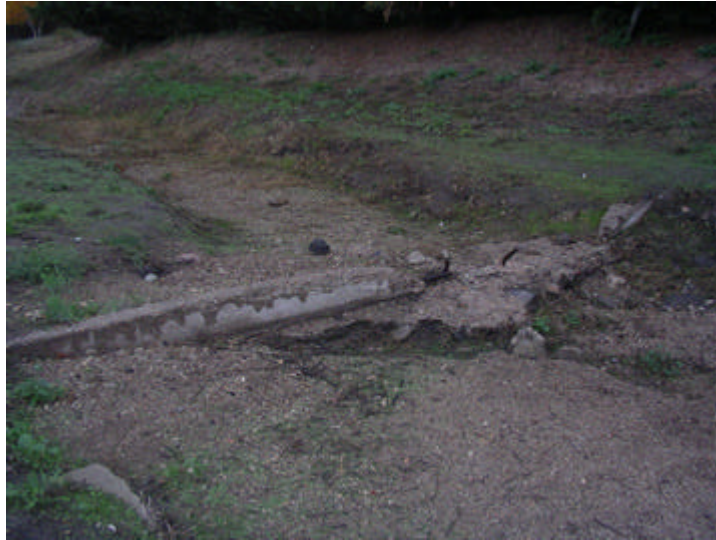
Description: This old broken grade control structure has a maximum measured height of 12 inches from the downstream substrate to the top of the concrete. The grade control crosses the creek channel for 15 feet and occurs at the upstream end of the Santa Ynez County Park.

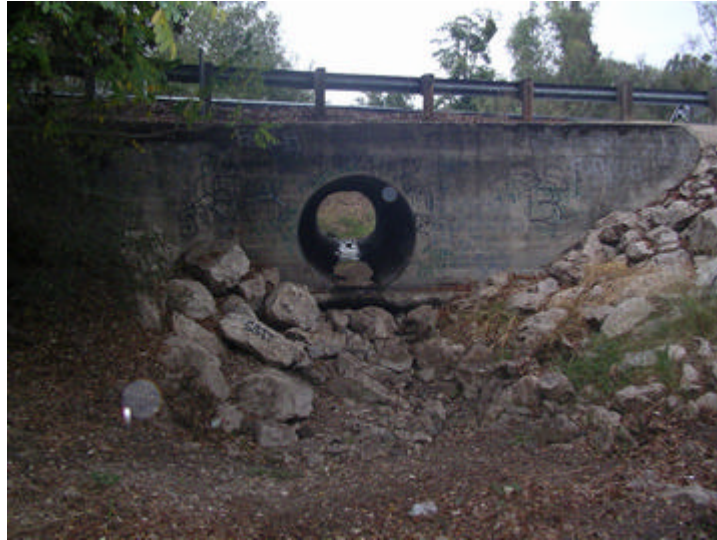
Description: This 6-foot diameter corrugated metal pipe is encased in concrete walls and measured 35 feet long. Boulders and rocks extend up to 10 feet downstream to stabilize adjacent banks and limit scour. The height from the streambed downstream to the lip of the culvert measured 4 feet 6 inches.

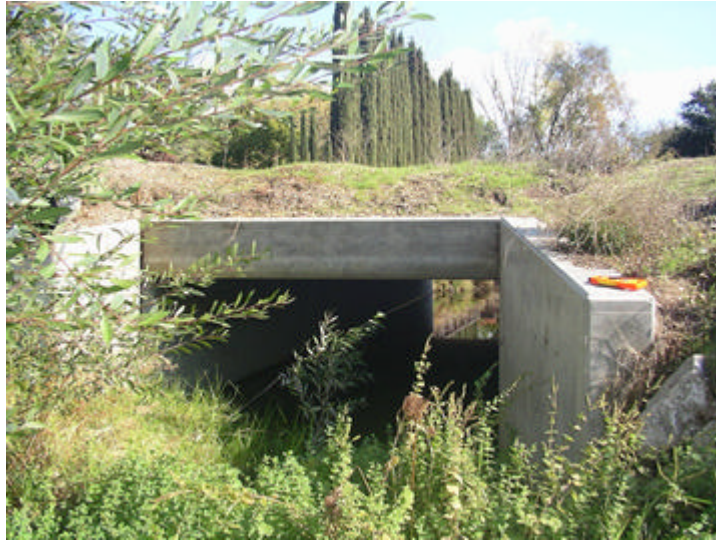
Description: This concrete box culvert is 10 feet wide by 5 feet, 6 inches tall and is 75 feet long. There is 6 inches of water inside the culvert. A 7-foot long concrete apron with angled wingwalls occurs on both the upstream and downstream ends of this culvert.

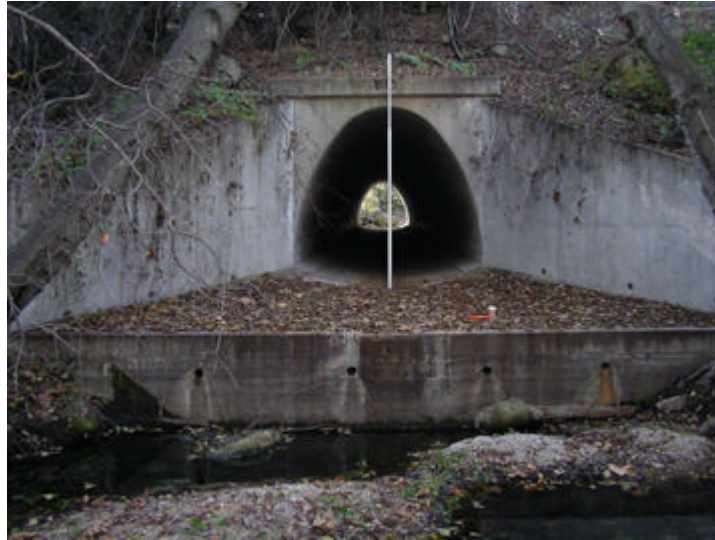
Description: This arch culvert measured 9 feet 6 inches tall by 10 feet wide at the base and the combined culvert and aprons measured 154 feet long. Each upstream and downstream apron measured 14 feet 6 inches. Angled wingwalls extend to the ends of both aprons. The height from the lip of the downstream apron to the surface of the downstream pool measured 3 feet 3 inches. The maximum pool depth measured 1-foot.

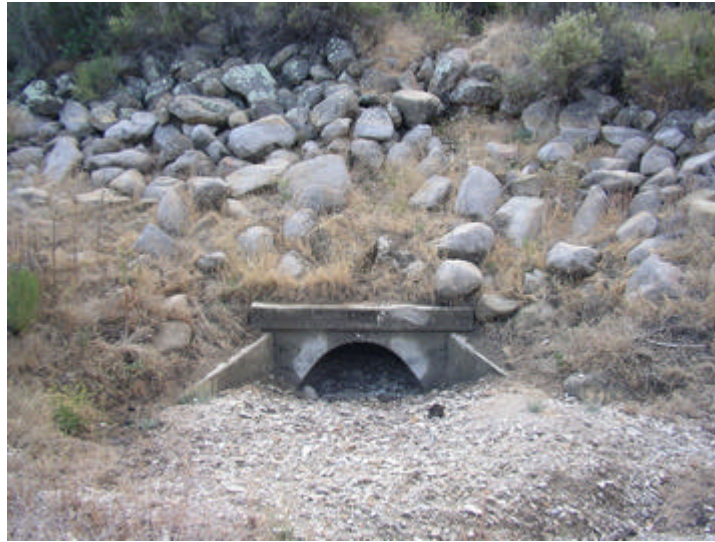
Description: As a result of sediment deposition in Cachuma Reservoir, this concrete arch culvert is almost filled-in with substrate. The culvert measured 4 feet wide on the sediment surface and 2 feet 6 inches tall. The original capacity and culvert dimensions are larger, but mainly buried. Based on the road width and fill the culvert measures approximately 175 feet long. When Cachuma Reservoir is at maximum storage capacity this structure may be completely submerged.

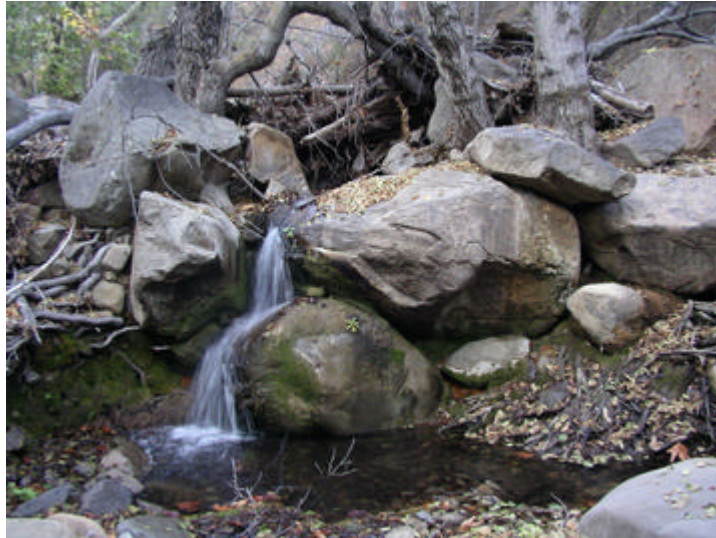
Description: This boulder cascade and steep gradient stream reach have a maximum height of 9 feet tall with a downstream pool only 6 inches deep. Several steep gradient features occur downstream near this location.

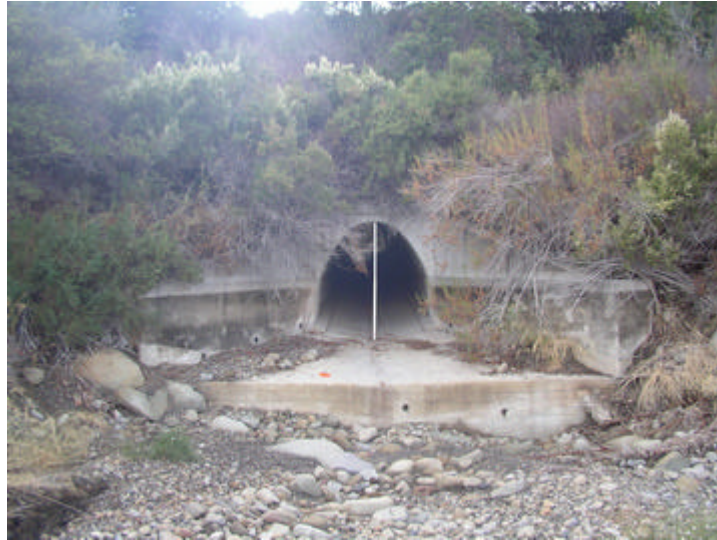
Description: This concrete arch culvert measured 9 feet wide at the base, 8 feet 6 inches tall, and 190 feet long. The height from the downstream substrate to the lip at the downstream end of the concrete apron varied from 18 inches to 3 feet. The culvert and apron have a moderately steep gradient.

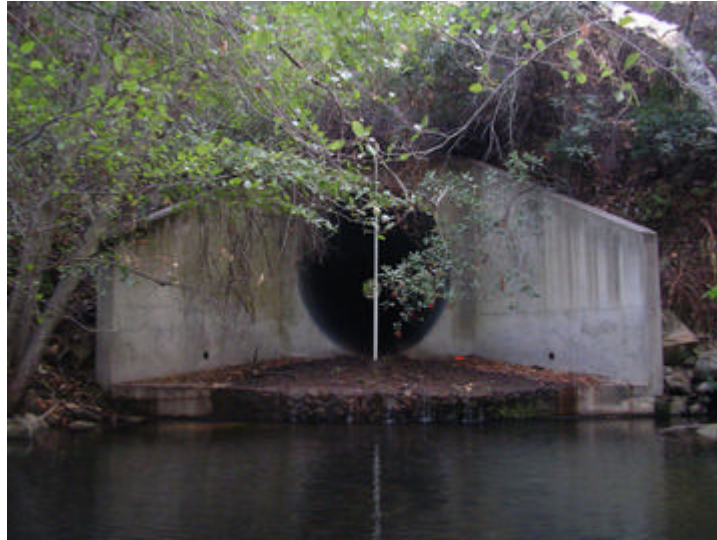
Description: This metal culvert measured 9 feet wide by 10 feet tall and 348 feet long. The moderately steep concrete apron extends downstream for an additional 12 feet 6 inches. The height from the downstream pool surface to the lip at the downstream end of the concrete apron measured 18 inches. The downstream pool's maximum depth measured 2 feet.

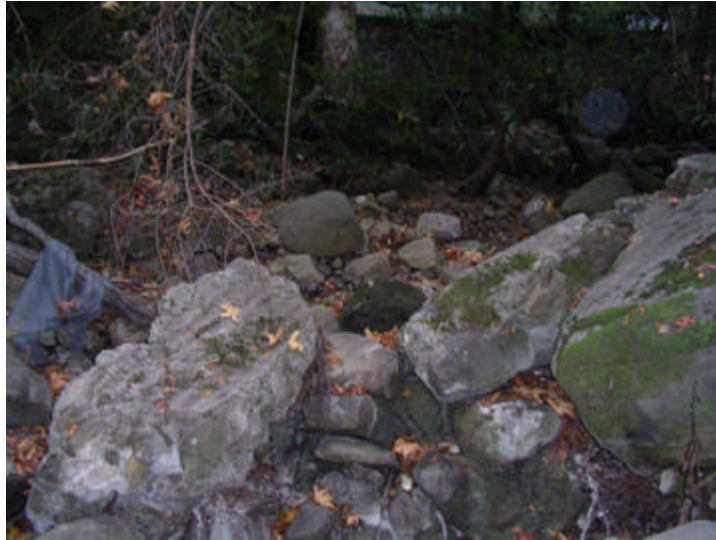
Description: Remnants of this old, broken dam measured 3 feet tall and around 18 inches thick. The dam was constructed with native rock and concrete.

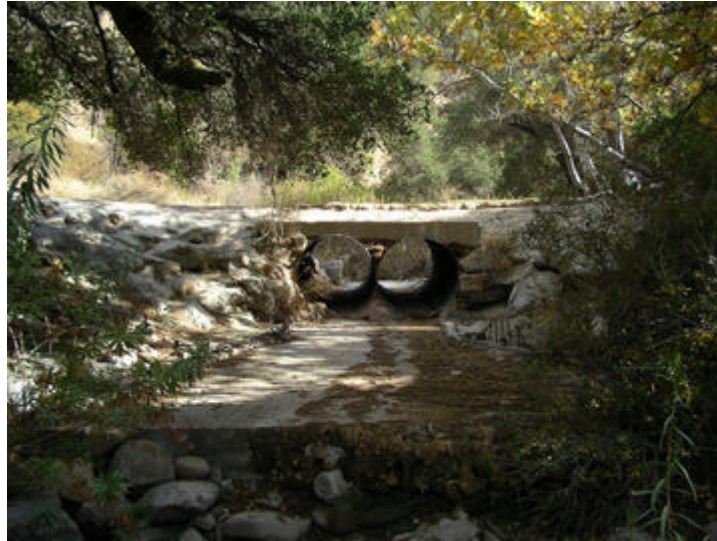
Description: Two 5-foot diameter corrugated metal culvert pipes measured 18 feet long. A concrete apron extends downstream 30 feet below the culvert outlets and a concrete apron extending upstream of the inlets for 12 feet. Concrete and boulder revetment lines the banks downstream for the length of the apron. A 4-foot drop occurs from the lip of the apron to the downstream substrate.
