Barrier ID: SC_TT_21, SC_TT_22
Stream: Tepusquet Creek
Barrier Type: Culvert Crossings
Physical Location: Approximately 1.3 miles upstream of Colson Creek
GPS Location: N/A
Ownership/Interest: Unknown
Surveyor(s) and Date: Matt Stoecker and Jim Stoecker 12/16/02

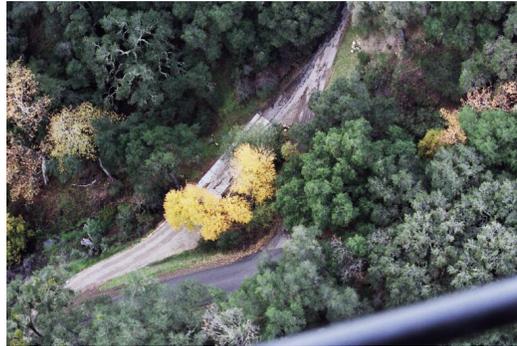
SC_TT_21 and SC_TT_22

Description: Access to ground survey these two culvert crossings was not obtained. Observations of these culvert crossings were made from the air and adjacent Tepusquet Road, and are limited in detail. These two private road crossings occur only 25 feet apart from each other. The overall lengths of the culverts are approximately 12-15 feet. From the road, the downstream culvert crossing (SC_TT_21) appears to have one 3-foot diameter corrugated metal culvert and the upstream crossing culvert (SC_TT_22) appears to have one 5-6 foot diameter corrugated metal culvert.

Diagnosis: The severity of these culverts crossings to fish passage could not be accurately determined from the road, but their impact appears significant. Water velocities were observed to be high through the culverts. Outlet configurations could not be accurately determined. It appears likely that both crossings would negatively impact fish passage, and possibly prevent upstream migration, by producing shallow water conditions during low flows and excessive water velocities during higher flows. There does not seem to be any practical reason for having two crossings at this location.

Recommended Action: Work with the owner to assess the possibility of removing both crossings and replacing them with one bridge that does not impact the stream channel and allows unimpeded passage for salmonids.

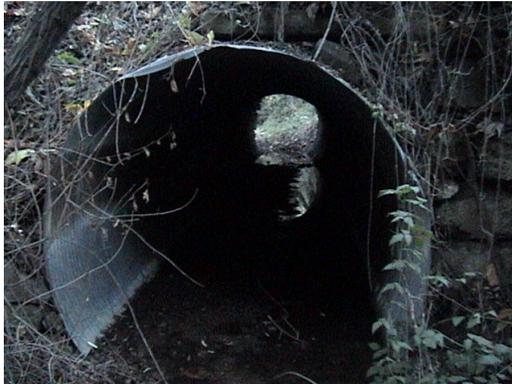
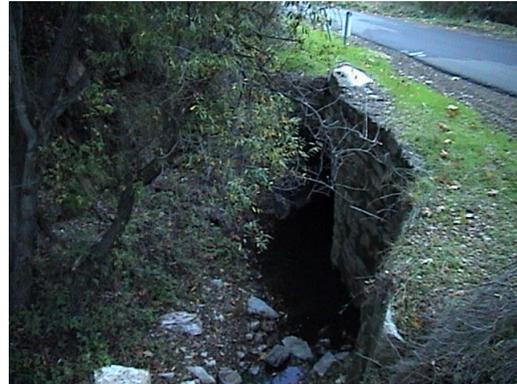
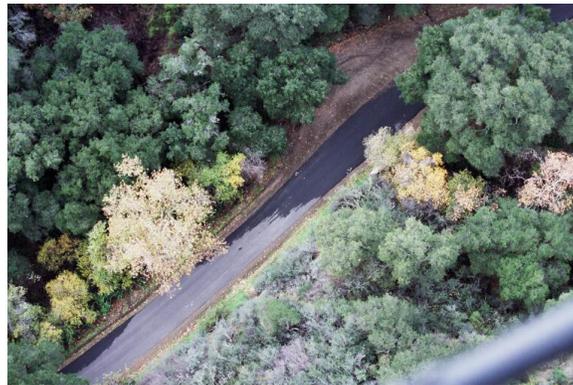
SC_TT_24 (Looking upstream); 12/16/02

Description: This county road crossing on Tepusquet Road consists of one 6-foot diameter corrugated metal culvert that conveys stream flows underneath. The overall length of the culvert is approximately 60 feet. The inlet and outlet of the culvert are set at streambed level and an average of 12 inches of substrate was deposited along the bottom of this large culvert.

Recommended Action: Work with the county to assess the possibility of removing the culvert crossing in coordination with future road improvement projects and replacing it with a bridge that does not impact the stream channel and allows unimpeded passage for salmonids and restoration of this stream reach.

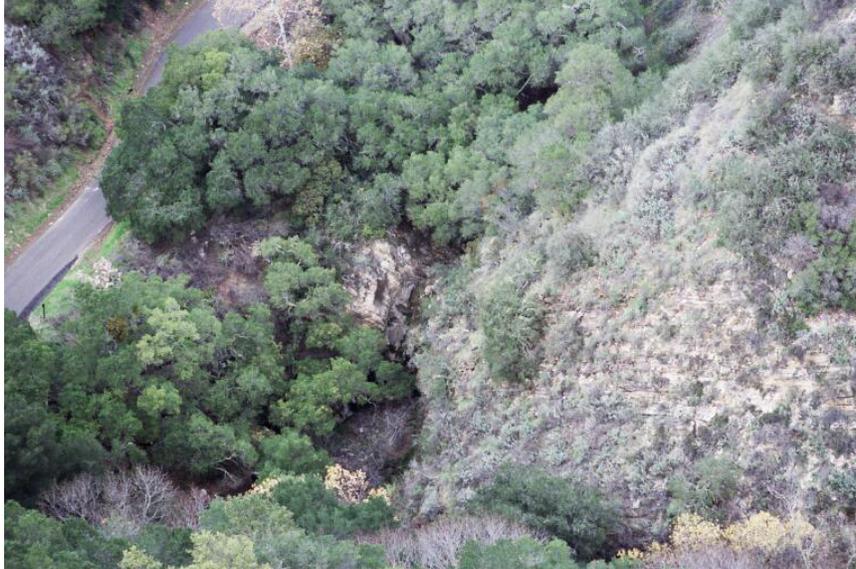
Description: Access to ground survey this structure was not obtained. Observations of this waterfall were made from the air and Tepusquet Road, and are limited in detail. This impressive bedrock waterfall drops approximately 25-30 feet and has carved a large pool at the base.

Condition: Stable bedrock feature.

Recommended Action: No recommended action for this natural feature.

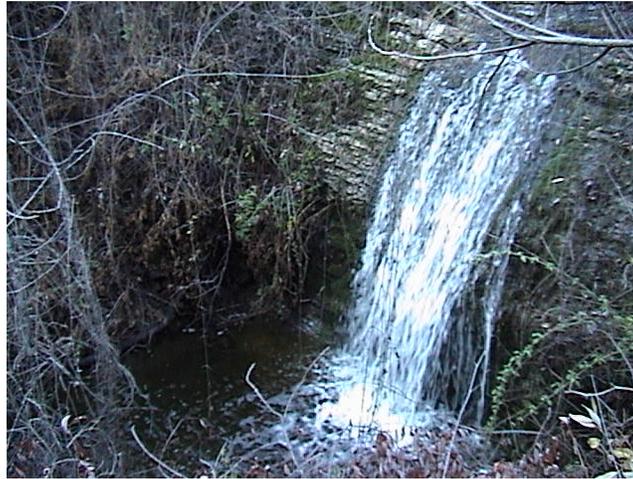
Description: This bedrock waterfall measured 11 feet 6 inches tall from the surface of the downstream pool, which has a depth of approximately 3 feet.

Condition: Stable bedrock feature.

Recommended Action: No recommended action for this natural feature.

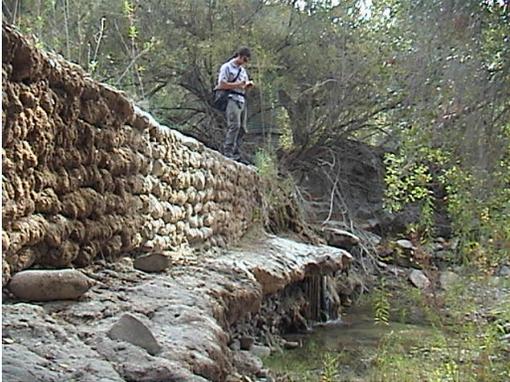
Severe undercutting

Condition: The dam is extremely undercut up to 6 feet horizontally underneath the footing and 6 feet 6 inches vertically from the downstream substrate to the bottom of the exposed footing.

Recommended Action: This obsolete dam will eventually fail as it continues to deteriorate. Removal of the dam would open up the entire Horse Creek tributary to upstream steelhead migration, providing perennial rearing habitat. This is one of the largest tributaries of the Sisquoc River within the LPNF and adequate spawning and rearing conditions exist for many miles upstream. This dam occurs on public land, and is within the San Rafael Wilderness and Wild and Scenic River Corridor. Removal of the dam is highly recommended. A unique study of this process should be conducted in coordination with relevant agencies and possibly a local university such as UCSB or Cal Poly. This dam removal study could aid agencies in assessing the long-term impacts of this type of small dam removal on potential steelhead recovery response. Such a study is desperately needed in southern California, and elsewhere, as small debris dams blocking steelhead are being looked at throughout the state for possible removal.

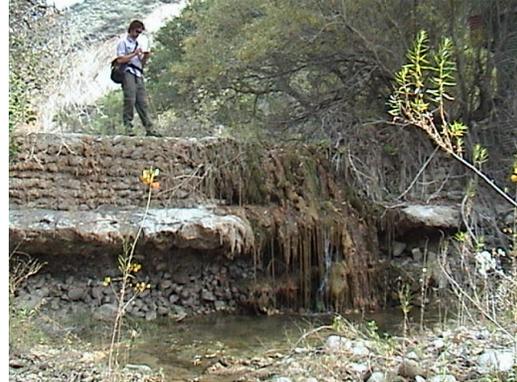
Sacrete berm on top of concrete footing

Description: This obsolete dam consists of a concrete footing that has a sacrete berm built on top. The dam height measured 10 feet 6 inches from the top of the dam to the surface of the downstream pool, which had a maximum depth of 18 inches. The dam's small, upstream reservoir is completely filled in with sediment. Kevin Cooper, Wildlife Biologist with the LPNF, thought the dam might be an old Santa Barbara County debris dam that was built after a local fire to catch sediment and/or act as a possible gaging station. The dam is not thought to serve any current purpose and does not appear to have been used to divert water.

Diagnosis: Watermarks and scours on adjacent downstream banks indicate that the downstream pool may fill up 2 feet during high stream flows; reducing the jump height to 8 feet 6 inches and increasing the jump depth to 3 feet 6 inches. This excessive jump height and limited jump depth would prevent all upstream steelhead passage, unless a much deeper downstream pool was to scour out with high flows. Even then it is likely that this structure would remain impassable to steelhead during all flows conditions.

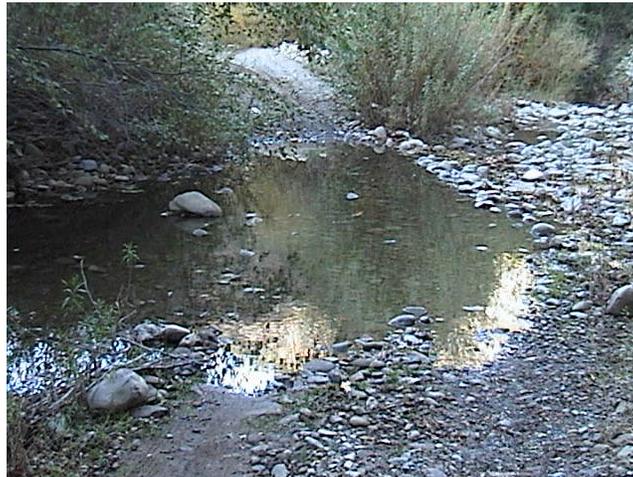
Typical In-stream Road Crossing on Manzana Creek

Description: Private landowners and LPNF personnel along lower Manzana Creek utilize a total of 19 in-stream road crossings. All crossings consist of natural streambed bottoms and have no observable anthropogenic structures. It appears that they are maintained and likely cleared of debris and large boulders following higher stream flows. The crossings do not significantly impede stream flow and during higher flows they are likely washed out and must be reformed with a tractor and/or truck.

Condition: Natural streambed conditions with occasional clearing of large substrate.

Diagnosis: During migration flows these stream crossings do not cause significant impediments to salmonid passage in their observed configurations. During low flow conditions these crossings could impede salmonid migration if their configuration produced any significant drops, shallow water depths, or accelerated water velocities.

Recommended Action: Work with landowner and LPNF to ensure that clearing activities and debris piling does not impede upstream or downstream fish passage. Ideally, clearing activities can be manipulated to create a natural streambed channel through the crossing that allows sufficient stream depth for low flow migration. Continue to monitor these sites to ensure unimpeded fish passage and natural streambed conditions.

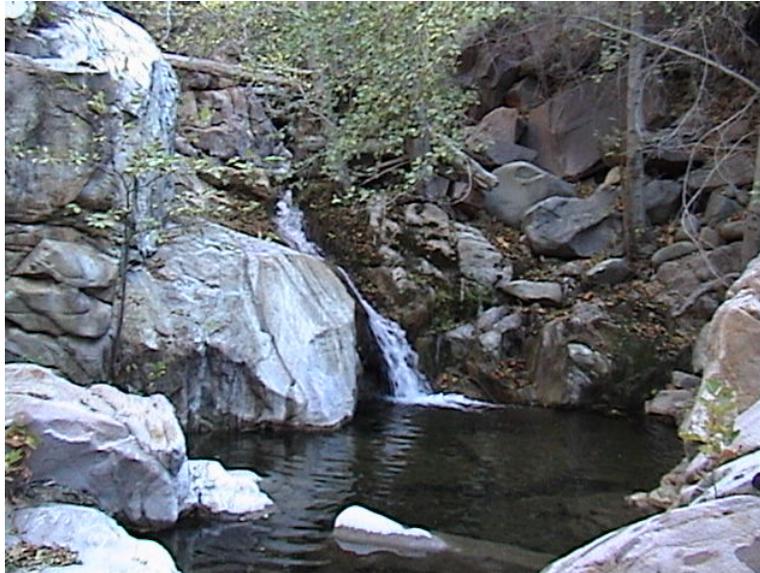
10' tall bedrock waterfall

Description: This bedrock waterfall drops a total of 10 feet from the top of the waterfall to the surface of the downstream pool. This waterfall drops 2 feet vertically at the top and then slants downward at a 60% slope for 5 feet before dropping another 3 vertical feet. The downstream pool has a jump depth of 2 feet 6 inches. This downstream pool has a confined bedrock tailwater control that will cause the pool to increase up to 4 feet during high stream flows.

Diagnosis: During low and moderate flows, this feature is impassable due to the excessive jump height. During high stream flows, the downstream pool may attain depths of over 6 feet and a jump height of 6 feet. Under these high flow conditions, adult steelhead may be able to make a difficult jump over this partial migration barrier. Observations of this waterfall on 12/15/02, with flow estimated at approximately 100 c.f.s., indicate that limited upstream adult steelhead migration during high flows may be possible.

Recommended Action: No recommended action for this natural feature.

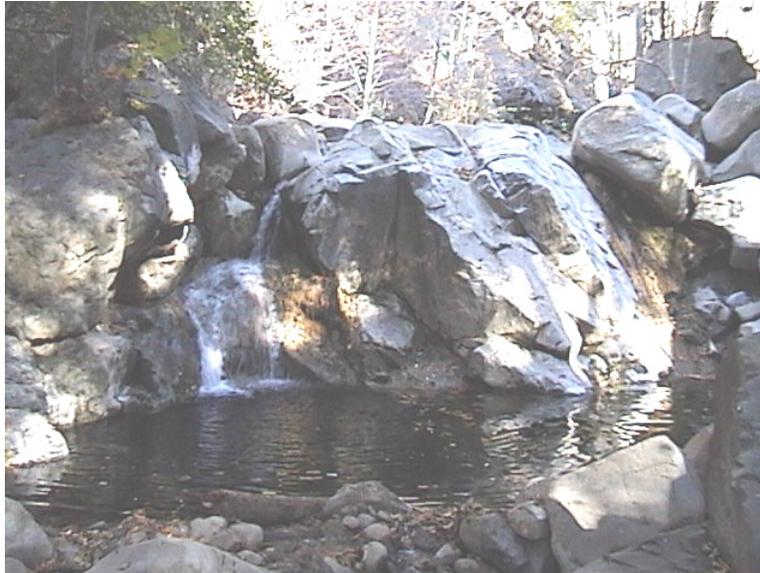
Description: This bedrock waterfall drops a total of 9 feet 6 inches from the top of the falls to the surface of the downstream pool. The downstream pool had a maximum measured depth of 7 feet. While the majority of this feature is composed of exposed bedrock, large boulders are also present at the top of the falls.

Diagnosis: During low and moderate flows, this feature is impassable due to the excessive jump height. During high stream flows, the downstream pool will increase at least 2 feet in depth and the jump height will decrease. Under these high flow conditions, adult steelhead can make a jump with a moderate to high degree of difficulty over this partial migration barrier.

Recommended Action: No recommended action for this natural feature.

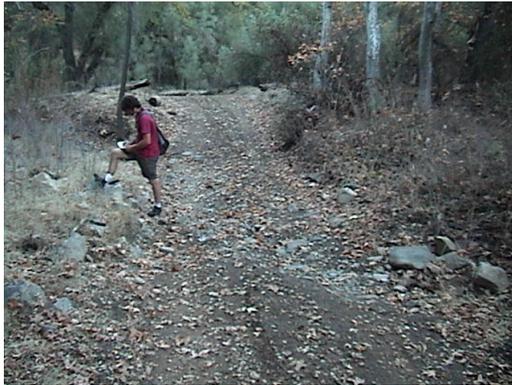
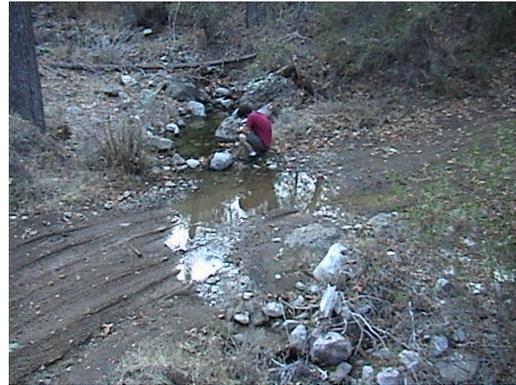
SC_MA_DY_1

Description: Both private landowners along Manzana Creek and LPNF personnel utilize these two in-stream road crossings. Both consist of natural streambed bottoms and neither includes any observable anthropogenic feature. It appears they are maintained by clearing debris following high stream flows. The crossings do not cause significant alteration of the streambed and do not impede stream flow. No elevation drops are caused by these crossings.

Condition: Natural streambed conditions with occasional clearing.

Diagnosis: These stream crossings do not cause any significant impediment to salmonid passage.

Recommended Action: No action is recommended at these crossings. Continue to monitor these sites to ensure unimpeded fish passage and natural streambed conditions.

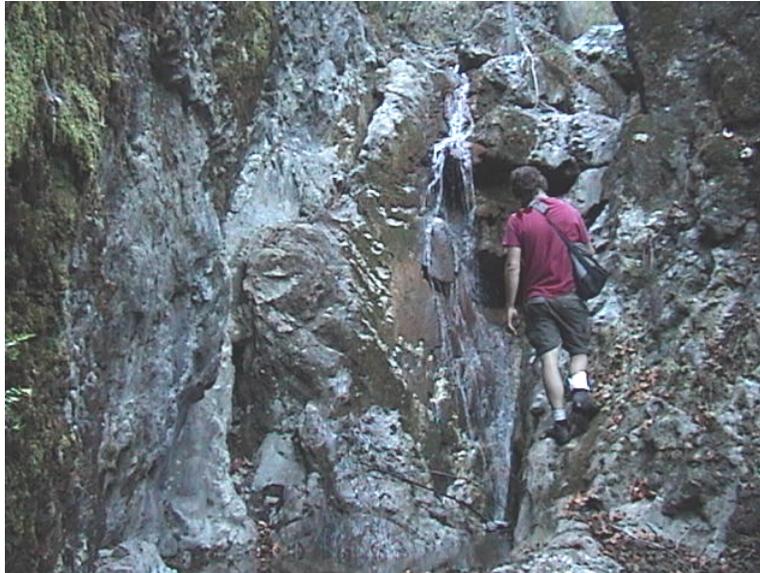
Description: The stream passes over a large waterfall and through a narrow canyon just upstream from this bedrock waterfall. The waterfall measured 8 feet 6 inches tall with a maximum downstream pool depth of 1 foot 6 inches.

Condition: Stable, natural feature.

Recommended Action: No action is recommended for this natural feature.

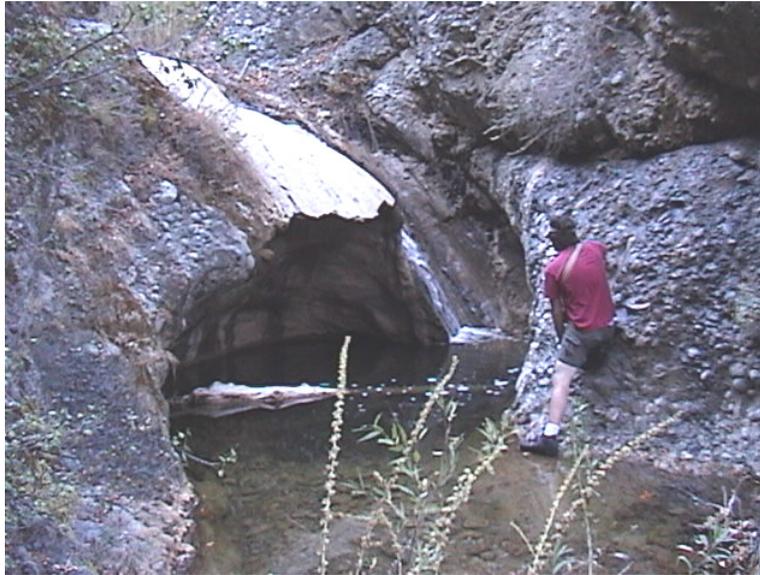
Waterfall at Turtle Bowl Creek

Description: This waterfall has carved an impressive pool into the surrounding bedrock with a maximum depth of 5 feet. The jump height, from the pool surface to the top of the waterfall, measured 12 feet 6 inches tall. This tributary drains into the south side of Manzana Creek approximately 0.5 miles upstream from Coldwater Camp.

Condition: Natural, stable bedrock condition.

Recommended Action: No action is recommended for this natural feature.

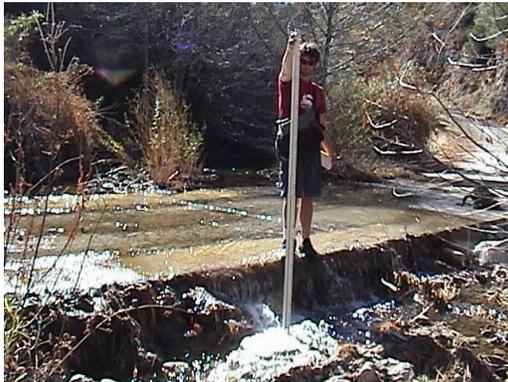
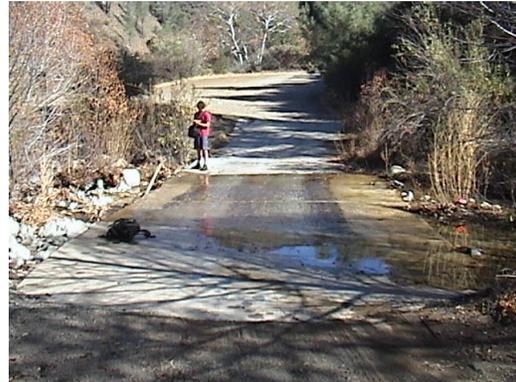
Description: This concrete low-flow crossing is approximately 105 feet upstream from the Manzana Creek confluence and spans 130 feet across the stream channel. The upstream to downstream width of the crossing measures 18 feet. At a stream flow of approximately 0.8 c.f.s., water is conveyed over the crossing at a depth of 1 inch or less and was spread across much of the crossing. The maximum downstream pool depth and identified jump depth are the same, measuring 13 inches. A jump height of 18 inches was measured from the downstream pool surface to the top of the downstream edge of the crossing. The crossing has a smooth surface that is slippery due to aquatic algae growth. The surface slope was calculated at 2.3% with a rise of 5 inches over 18 feet.

Condition: The concrete appears to be in good condition with minimal downstream undercutting. The crossing is a potential pedestrian and vehicular hazard due to its extremely slippery surface. A sign is posted warning recreational users of this hazard on the north side of the crossing.

Diagnosis: The shallow water depth across the concrete crossing likely impedes upstream passage of juvenile and adult salmonids during low, base flow conditions. As water depth increases during moderate to high stream flows, upstream adult steelhead passage is possible with a moderate degree of difficulty. Excessive water velocities across the smooth concrete crossing may impede upstream passage of salmonids during exceptionally high flows. The window of opportunity for upstream steelhead and rainbow trout migration is limited due to these factors, especially during exceptionally dry years and low stream flow conditions. Davy Brown Creek is an important perennial tributary for rainbow trout and potentially steelhead, especially during drier years, and upstream passage to refugia pools is critical during lower flows and/or when Manzana Creek dries up near the creek mouth.

Recommended Action: Determine the structural requirements necessary for a bridge at this site and assess the feasibility of installing one. The most effective long-term fish passage solution at this site is complete removal of the structure and replacement with a wide-span bridge that does

not impact the stream channel. A bridge may also be highly desirable to the LPNF. Recreational users must travel over the slippery crossing in order to access the trailhead to the lower Manzana area. In addition to eliminating potential aquatic animal fatalities caused by vehicles crossing in the stream, a bridge would provide safe vehicular access and recreational pedestrian user access across the creek during all stream flows.

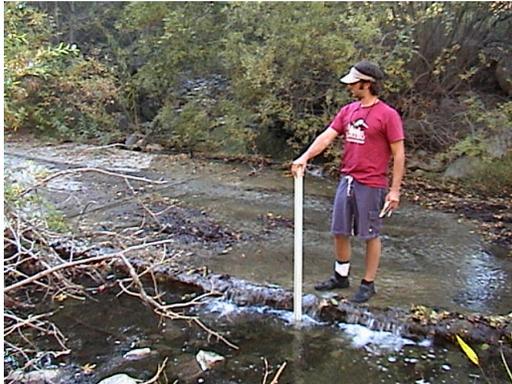
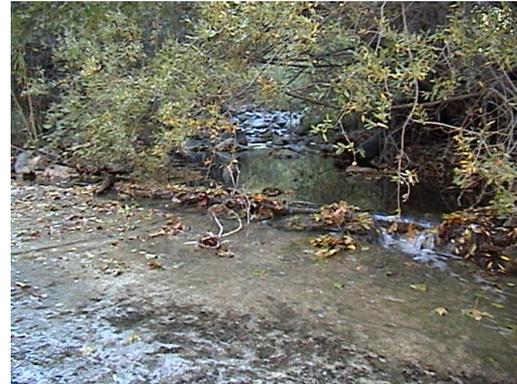
Description: This concrete low-flow crossing spans 127 feet across the stream channel connecting the paved road at either end. The upstream to downstream width of the crossing measures 20 feet. With a stream flow of approximately 0.8 c.f.s., spreads out over the crossing at a depth of 1 inch or less. The maximum downstream pool depth measured 16 inches. The jump pool depth measured 10 inches. A jump height of 4 inches was measured from the downstream pool surface to the top of the downstream edge of the crossing. The crossing has a smooth surface lacking any potential resting spots. The surface slope measured 2.1% with a rise of 5 inches over 20 feet. A metal pipe spans across the creek at the upstream end of the structure rising 6 inches above the surface of the crossing.

Condition: The concrete appears to be in good condition with minimal downstream undercutting.

Diagnosis: The shallow water depth across the concrete crossing may impede upstream passage of juvenile and adult salmonids during low, base flow conditions. As water depth increases during moderate to high stream flows, upstream adult steelhead passage would be possible with a moderate degree of difficulty. Excessive water velocities across the smooth concrete crossing may impede upstream passage of salmonid during exceptionally high flows. The window of opportunity for upstream steelhead and rainbow trout migration may be limited due to these factors, especially during exceptionally dry years and low stream flow conditions. Davy Brown Creek is an important perennial tributary for rainbow trout and potentially steelhead, especially during drier years. Upstream passage to refugia pools is critical during lower flows and/or when Manzana Creek dries up near the creek mouth. The lack of jump depth on the crossing below the metal pipe at the upstream end adds an additional element of difficulty for fish passage.

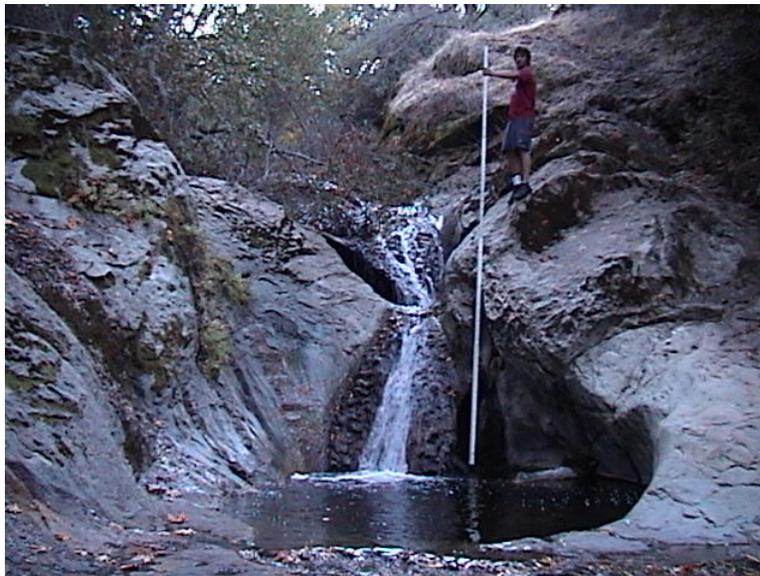
Description: This impressive three-stage waterfall drops a total of 16 feet 8 inches and has carved three pools and several steep chutes into the exposed bedrock. The lowest pool measured 7 feet deep with a jump height of 7 feet to the next pool. The depth of the second pool measured 3 feet deep with a jump height of 6 feet to the third pool, which measured 11 inches deep. A final jump height of 3 feet 8 inches occurs upstream to reach an adequate landing zone. A long, steep bedrock chute with no resting pools and a slope exceeding 20% occurs just upstream of this bedrock waterfall.

Condition: Stable bedrock feature.

Recommended Action: No recommended action for this natural feature.

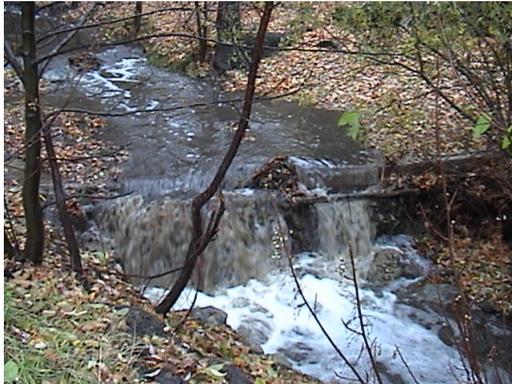
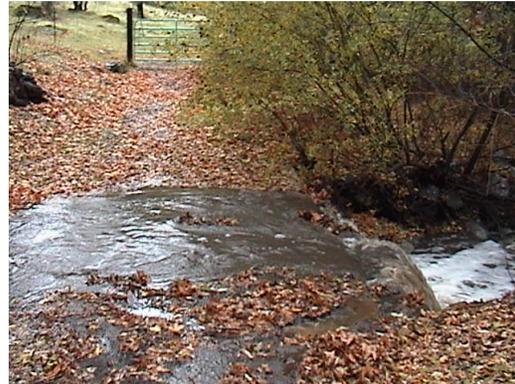
Description: This concrete low-flow crossing spans the stream channel at the lower end of the Davy Brown Campsite to a locked gate and old jeep track. The crossing does not appear to be used often, if at all, and may not be necessary.

Condition: This structure is in poor condition with visible cracking and moderate downstream undercutting.

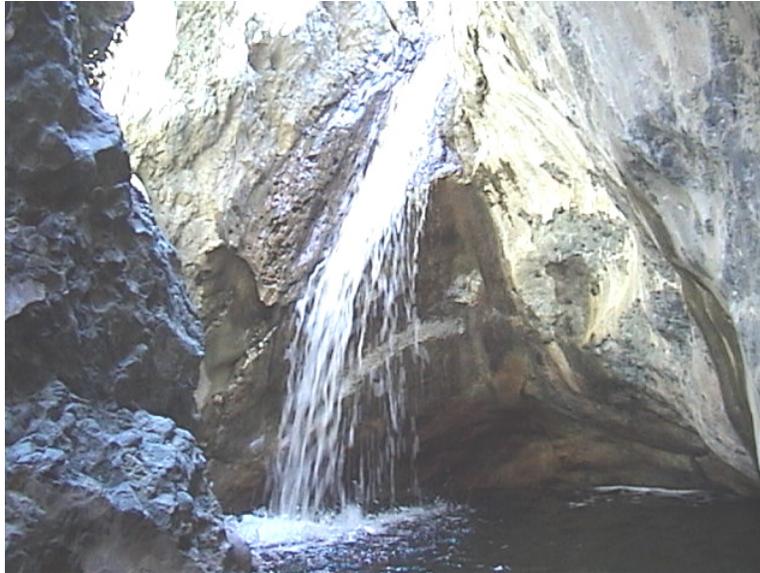
Description: This waterfall has carved an impressive 6 ft. deep pool into the surrounding confined bedrock gorge. The jump height, from the pool surface to the top of the waterfall, measured 18 feet.

Condition: Natural, stable bedrock condition.

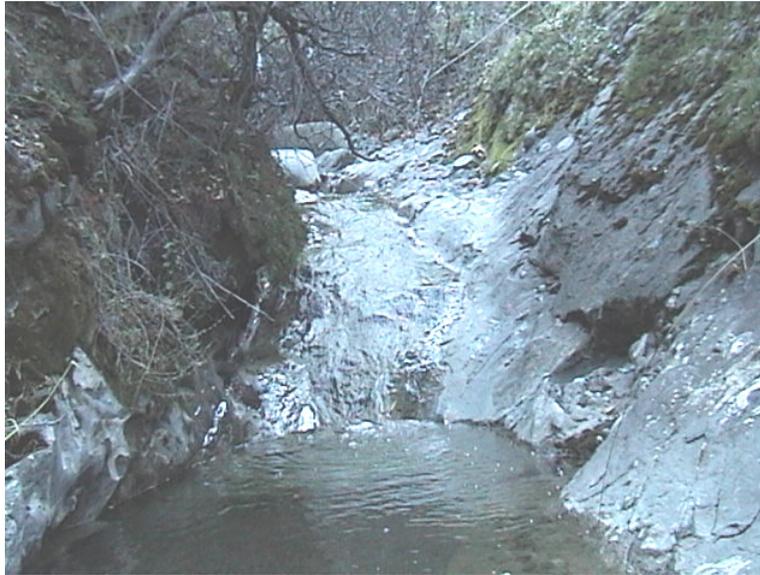
Description: This 16-foot long bedrock chute has carved into the surrounding bedrock producing a slope of approximately 20%. The small, downstream pool has a maximum depth of 6 inches.

Condition: Natural, stable bedrock.

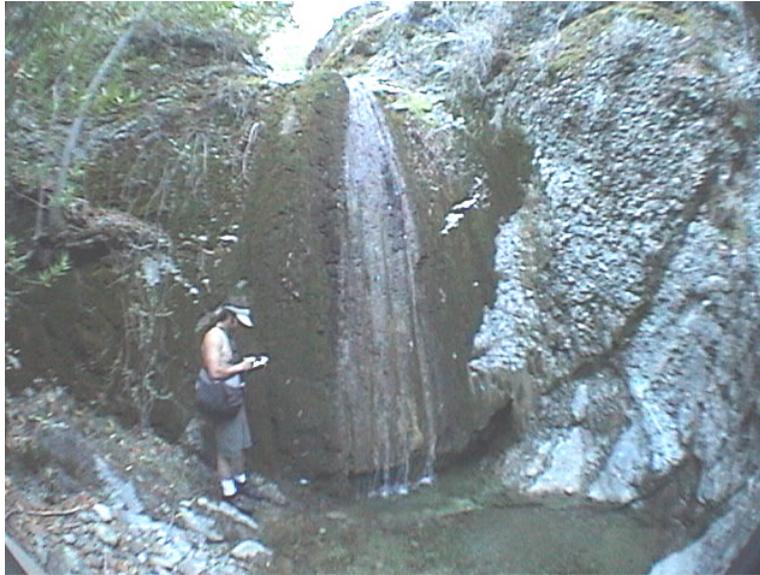
Description: This impressive, vertical bedrock waterfall measured over 18 feet tall from a small downstream pool that measured 12 inches in depth to the top.

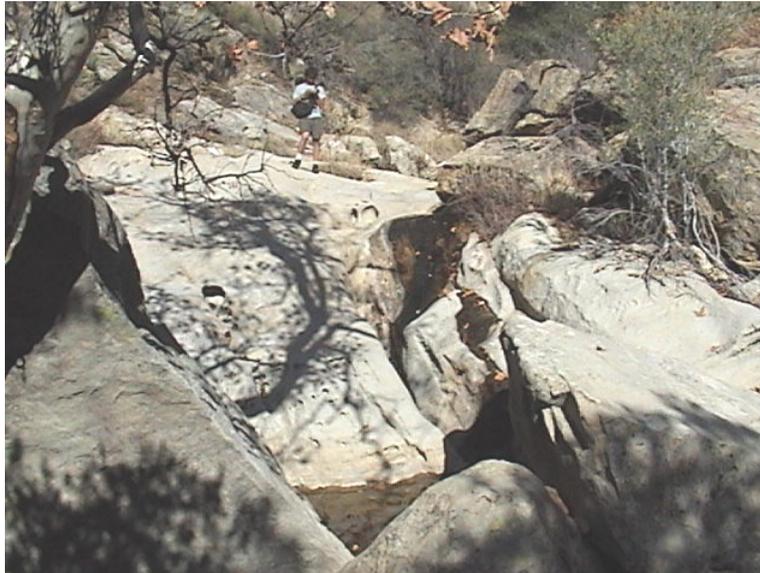
Description: This steep bedrock chute drops 12 vertical feet over a distance of 30 feet. Downstream of this chute a large boulder jam has accumulated and drops flows vertically 10 feet into a shallow pool with 12 inches of depth.

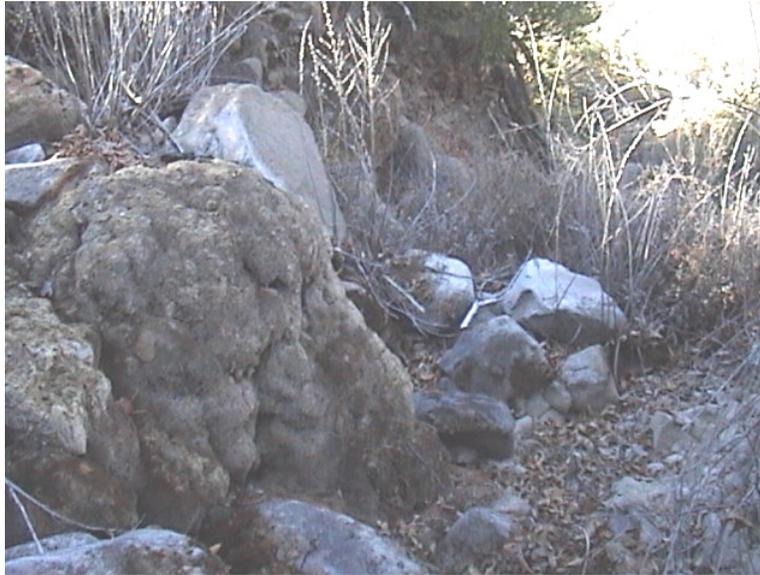
Description: This boulder cascade has a slope exceeding 15% with a drop of 6 feet and no downstream pool depth. This unnamed tributary flows into the south side of Manzana Creek approximately 0.6 miles downstream from the Manzana Campsite.

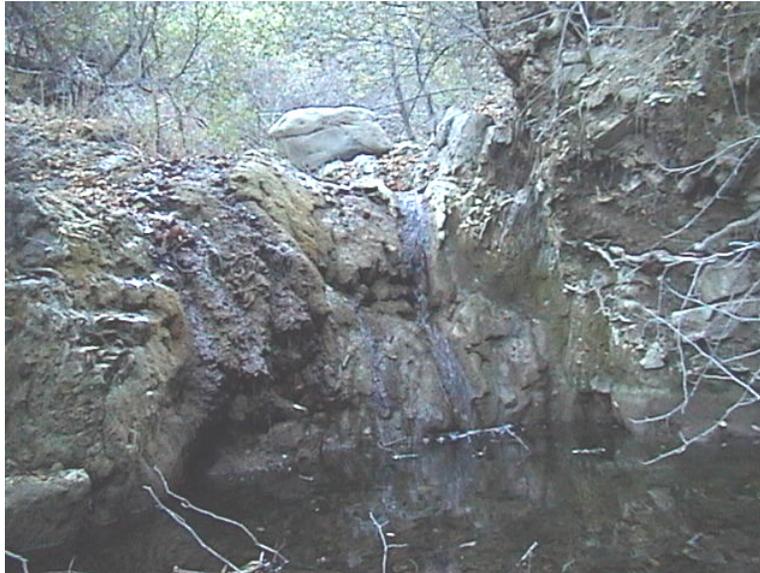
Description: This bedrock waterfall has a total height of 8 feet 6 inches from the top of the feature to the surface of the downstream pool, which has a maximum pool depth of 2 feet. Stream flows sheet across 12 feet of smooth bedrock dropping 3 feet before freefalling 5 feet 6 inches to the downstream pool. This unnamed tributary flows into the south side of Manzana Creek approximately 0.5 mile downstream from the Manzana Campsite.

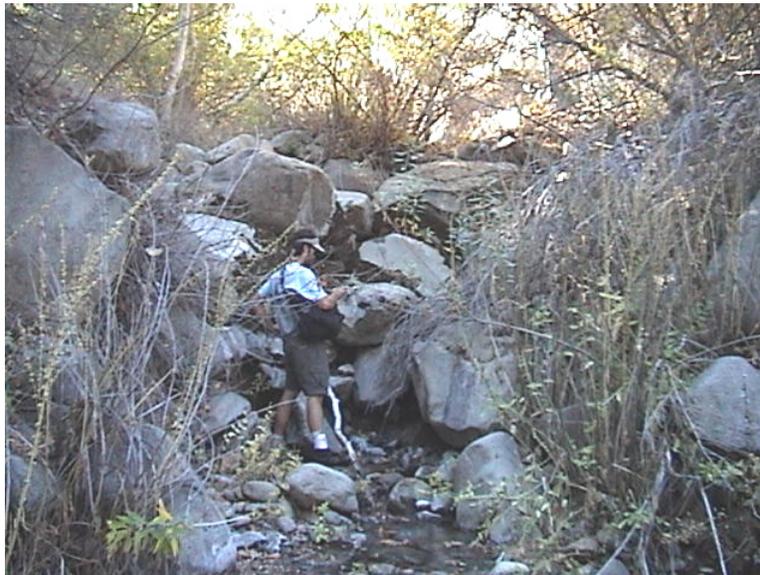
Description: This boulder jam produces a cascade 11 feet tall with no downstream pool developed. This unnamed tributary flows into the south side of Manzana Creek immediately downstream from the Manzana Campsite.

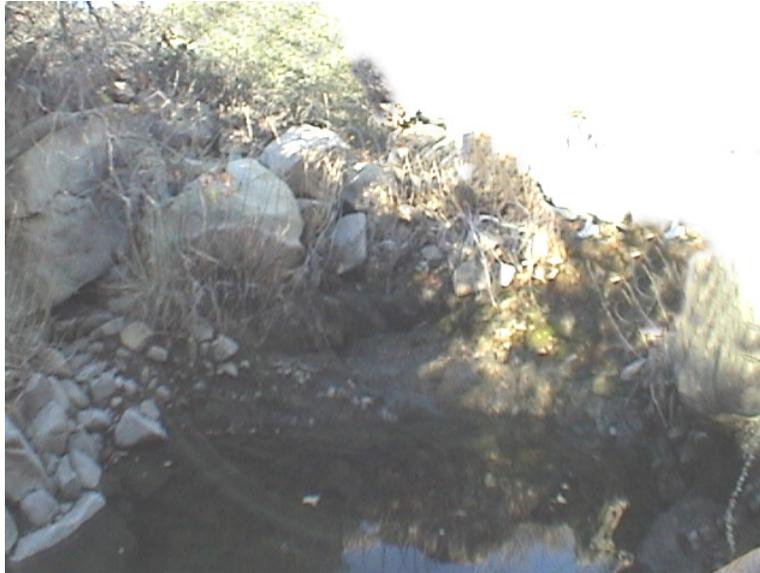
Description: This boulder and bedrock waterfall has a jump height of 8 feet and downstream pool depth of 12 inches. Immediately upstream from this waterfall the stream slope exceeds 10%.

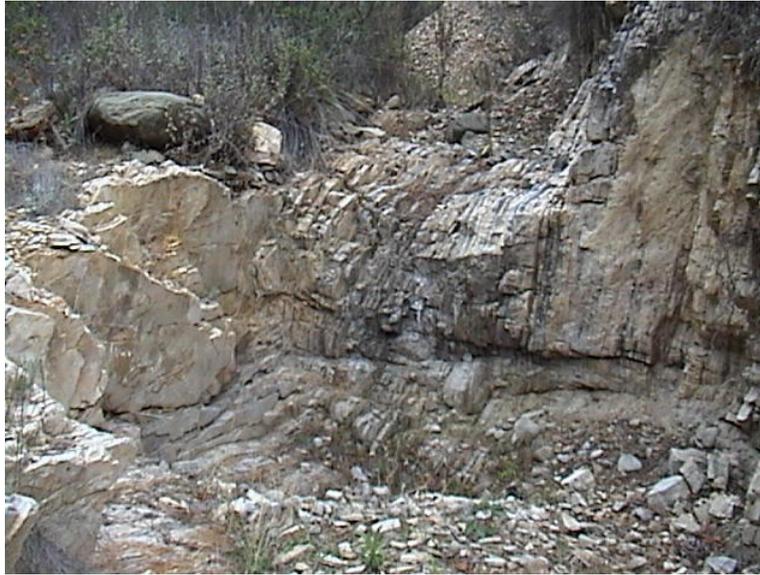
Description: This bedrock waterfall measured 7 feet tall from the top to the dry streambed downstream.

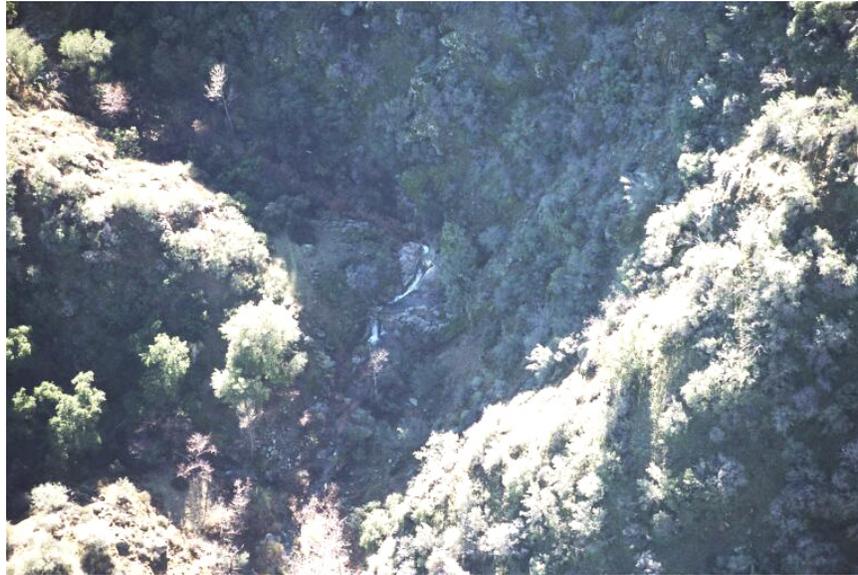
Description: Observations of this waterfall were made from the air and are limited in detail. This waterfall and chute have carved through a confined section of exposed bedrock and drop flows over 40 feet into a pool below. A vertical waterfall at the downstream end is at least 15 feet tall and a long, steep bedrock chute extends immediately upstream over 25 feet.

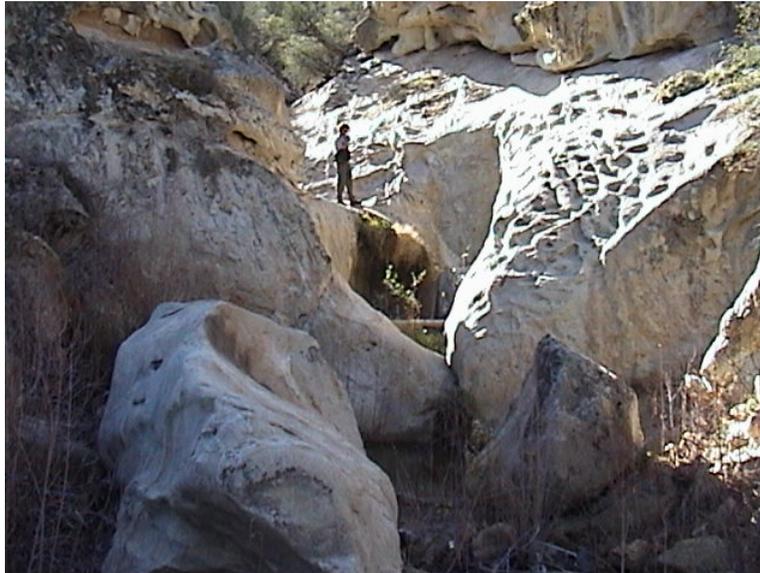
Description: This 9-foot tall waterfall occurs at the downstream end of an extensive bedrock gorge. Flows have carved interesting “pockets” of water into the gorge walls. The waterfall drops water flows vertically into a dugout pool only 6 inches deep. This tributary enters the Sisquoc River approximately 1.0 mile upstream of Foresters Leap Creek. The tributary enters the Sisquoc on the river-left, or west, side of the river.

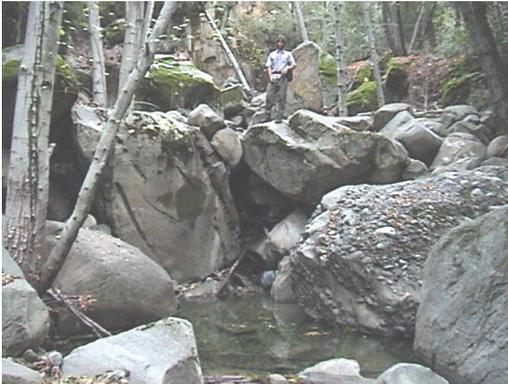
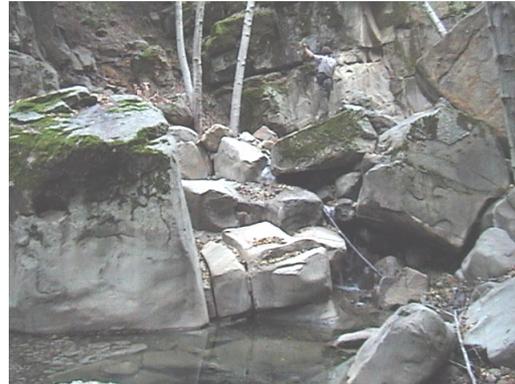
Description: Beginning 300 feet downstream from the White Ledge Creek confluence, large boulders and moderate to steep stream gradients begin to appear on the South Fork Sisquoc. These steep boulder gradient sections appear sporadically, along with milder sloped reaches and continue upstream to what was determined to be the natural upstream limit for steelhead, described here. It should be noted that several natural features downstream from this identified upstream limit may limit or prevent upstream salmonid passage during certain flow situations and are subject to seasonal changes in configuration and passage severity. Rainbow trout/steelhead are present throughout this reach to within 200 feet of this identified upstream limit. This natural upstream limit to steelhead migration occurs approximately 1.15 miles upstream from the South Fork Sisquoc River/ White Ledge Creek confluence. This upstream limit is actually a series of three massive bedrock and boulder cascades that occur within a 100-foot long stretch of stream over an elevation change of 45 feet. The most downstream cascade drops stream flow 12 feet onto bedrock with no downstream jump pool depth.

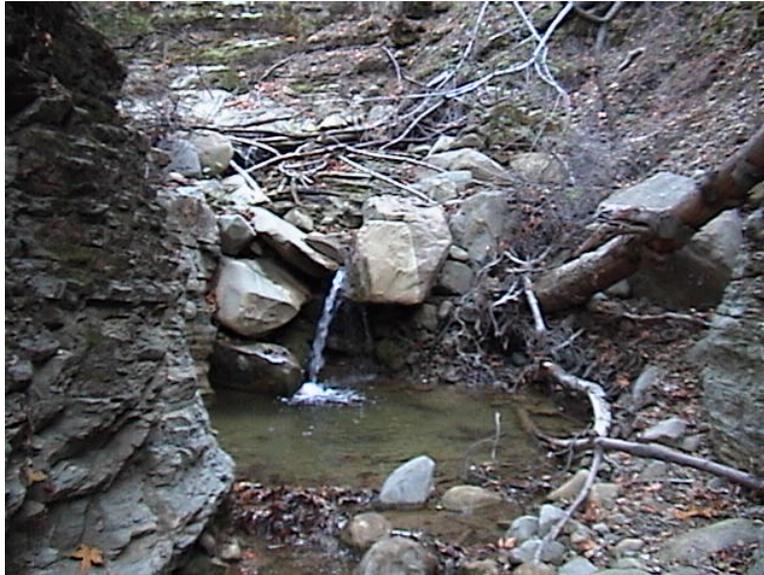
Description: This large boulder jam rises 10 feet above the downstream substrate. A small pool 12 inches deep occurs downstream from this steep boulder jam. The adjacent steep-walled stream banks have an impressive array of Maiden Hair ferns. This previously unnamed tributary enters the south side of the Sisquoc River approximately 0.9 miles upstream from the South Fork Sisquoc River.

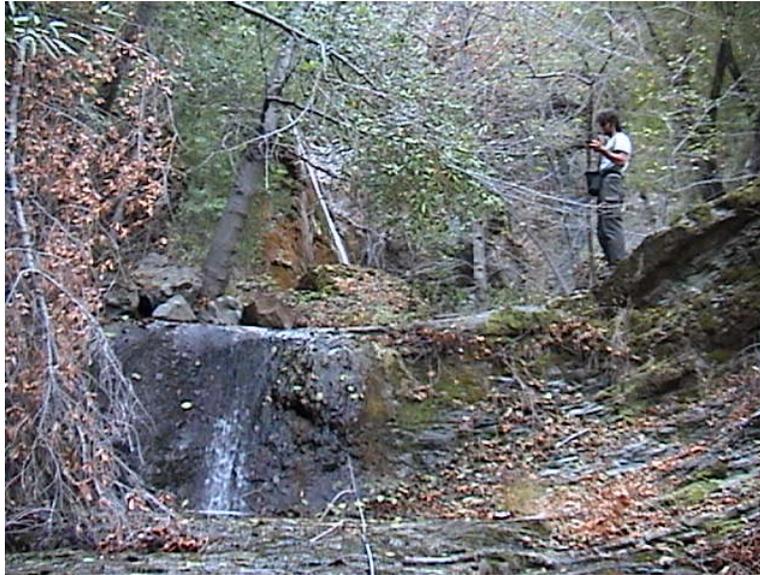
Description: This bedrock waterfall drops water vertically 6 feet 6 inches to the surface of a small downstream pool, which had a maximum measured depth of 2 feet. The massive Rattlesnake Falls occurs just upstream and rises over 100 feet tall.

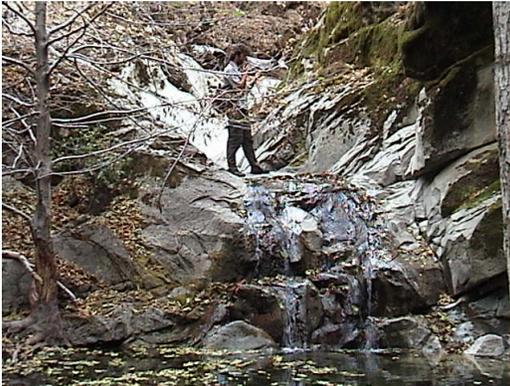
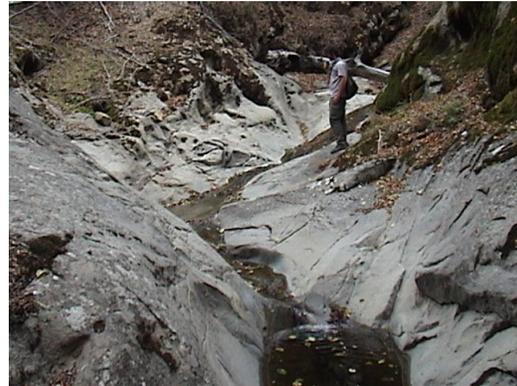
Description: This series of bedrock chutes carves into exposed bedrock where the river channel becomes confined. At the downstream end, a 4-foot deep pool occurs below the first nearly vertical chute that has a height of 6 feet 6 inches. A small 2-foot deep pool exists at the top of this chute. From this small pool, flows sheet over 10 feet of bedrock and up a 10-foot long section of moderately sloped bedrock and then a 10-foot long chute that exceeds a 25% slope.
