# Upper Carpinteria Creek *Arundo donax* Survey

October 11, 2004

Prepared for:

Prepared by:

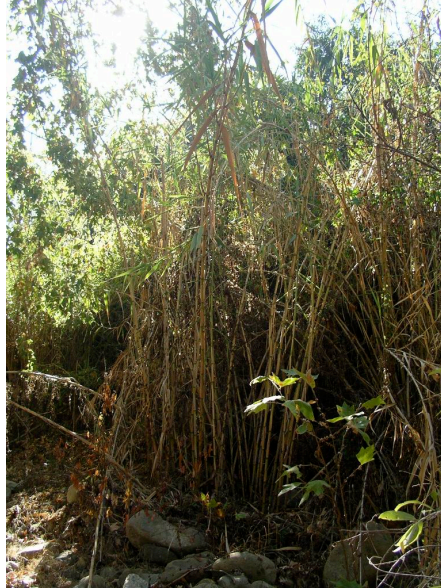
Gobernador Creek- Only one patch of *Arundo donax* was observed on Gobernador Creek and throughout the entire project survey area. This patch occurs on the “river-left” or east side of Gobernador Creek adjacent to a private residence with a mailbox address of 654 Gobernador Road, which occurs across the road from the residence. This *Arundo* location can be seen from Gobernador Road, where the road first makes a sharp bend on the creek bank. The *Arundo* patch occurs approximately 100 feet downstream from this bend and the above residential driveway. The GPS coordinate obtained in the stream channel adjacent to the *Arundo* patch was (34-24-00.9, 119-28-57.1). The patch contains 3 clumps of *Arundo*. The height of these clumps exceeds 20 feet and encompasses approximately 100 feet of the creek bank. The landowner appears to be dumping yard clippings in the creek at this location and this practice may have led to the establishment of the *Arundo*. Images of the *Arundo* patch are shown below and on the cover page of this report.

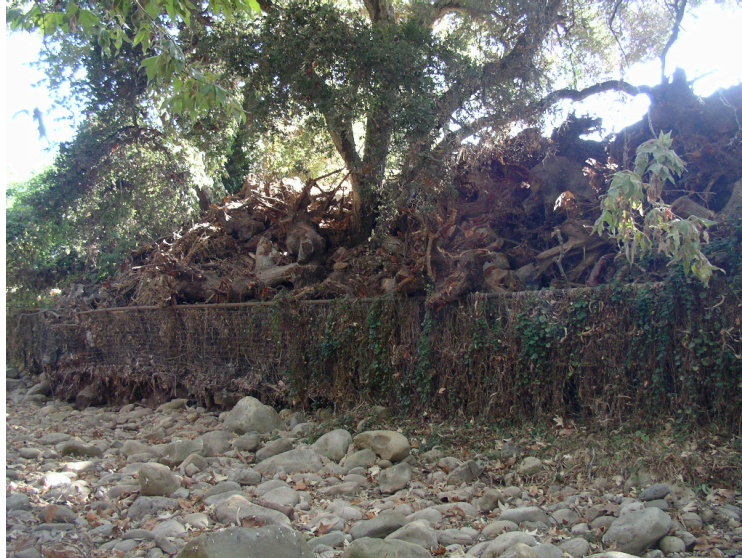
Immediately upstream of the *Arundo* site, at the sharp Gobernador Road bend, additional clippings and large avocado stumps have been stacked against a failing Pipe/Wire revetment in apparent attempts to slow down bank erosion at this site. Moving the road further away from the creek bank and removal of these stumps and Pipe/Wire revetment combined with biotechnical bank stabilization and native planting is recommended.

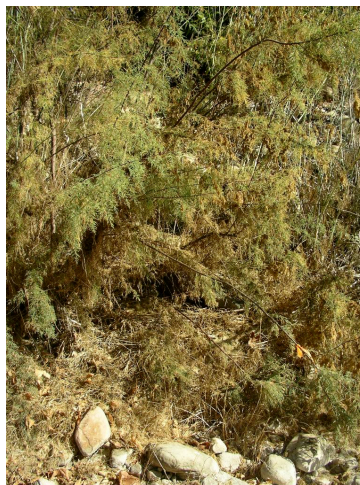
Several other exotic plant species were observed in this stream reach including, Castor bean, Ivy (sp.), Fennel, and Eucalyptus. A large Eucalyptus grove occurs on the other side of the creek from the *Arundo* site. One clump of Tamarisk was observed on Gobernador Creek adjacent to Gobernador Road at GPS coordinate (34-24-1.8, 119-28-43.7). This Tamarisk clump occurs on the river-right side of the creek within the channel and within site of Gobernador Road between two fenced areas and directly across from the outlet of a culvert draining the road. This lone clump of Tamarisk (pictured below) should be removed to prevent further spread of this exotic species, which was not observed further upstream.
