Horse Creek Dam Removal Project Salmonid Habitat Survey

September 15, 2005

STOECKER ECOLOGICAL™
NATURAL RESOURCE ASSESSMENT AND RESTORATION SERVICES

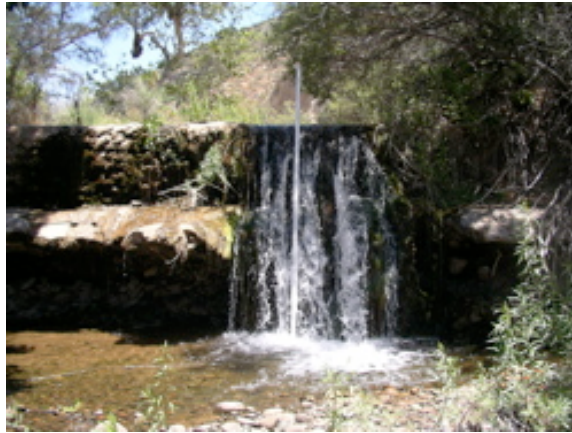
Horse Creek Dam

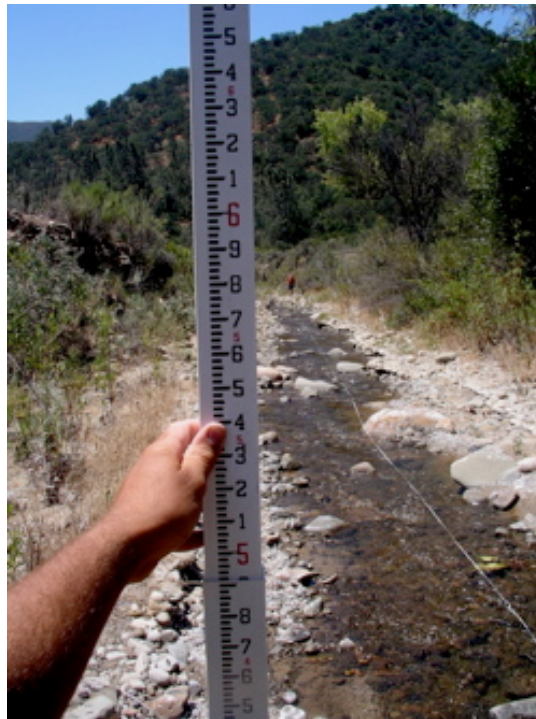
Downstream of the dam, Horse Creek provides limited salmonid rearing habitat of poor to fair quality due to the lack of pools, maximum water depth of less than 2 feet, low riparian canopy cover, and low instream cover. Adequately sized spawning substrate occurs in moderate abundance downstream of the dam with substrate embeddedness averaging 50%.

Looking downstream of the dam

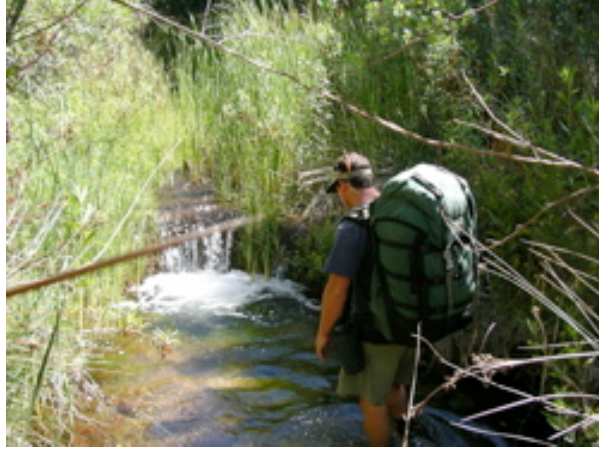
Upstream of the dam, the wetted stream width measured between 5-12 feet and small pools up to 2 feet 6 inches in depth were observed. Shallow runs and riffles are the dominant habitat type with pocket water and small pools occurring to a lesser extent. The substrate consists mainly of cobbles and small boulders. Riparian canopy cover increases upstream of the dam and emergent vegetation also increases the available instream cover. Salmonid rearing habitat conditions are mostly fair upstream of the dam with several smaller pools that would provide good salmonid rearing habitat. Fair spawning substrate conditions occur with moderate substrate embeddedness and a moderate amount of adequately sized substrate.

Scour pool 950 feet upstream of dam

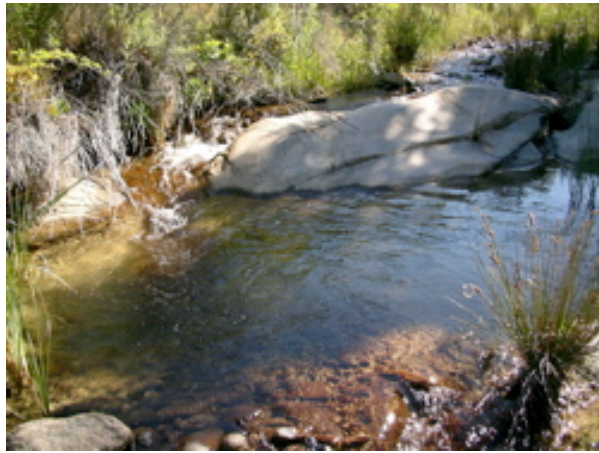
Bedrock scour pool approximately 1 mile upstream of dam

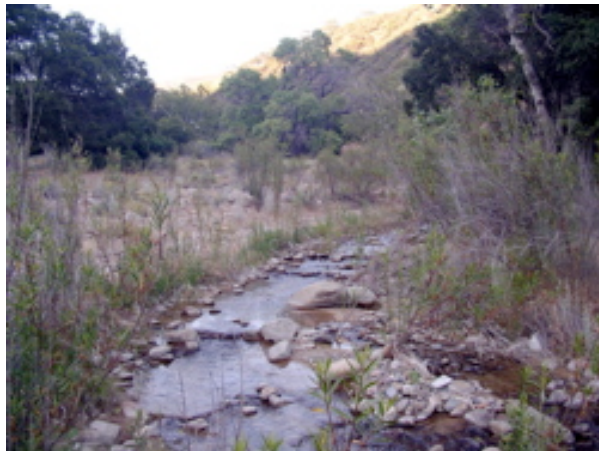
Stream habitat approximately 2.5 miles upstream of dam

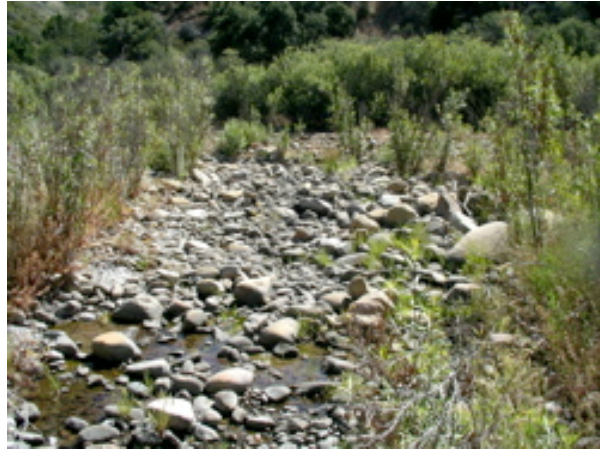
Surface flow of approximately 2.0 c.f.s. was observed to occur continuously from the Sisquoc River confluence upstream for 5.0 miles to near the 1800-foot elevation. At this location a prolific groundwater source occurs and appears to supply all summer surface flows to lower Horse Creek.

Groundwater resurfacing and dry channel upstream

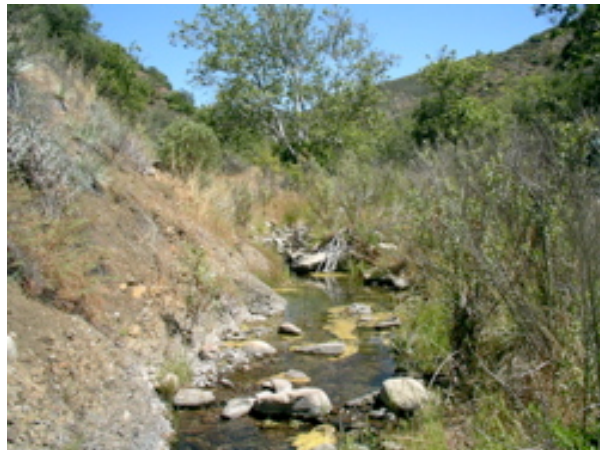
Upstream of the groundwater source, Horse Creek was observed to be dry for 1.1 miles to 100 feet upstream of the East Fork Horse Creek confluence. Approximately 100 feet upstream of the East Fork Horse Creek confluence, a short reach of Horse Creek was observed to have trickling flows mixed with short dry reaches and several small pools. This wetted reach extended for only 0.05 miles and contained one bedrock scour pool measuring 2 feet 6 inches deep. Water temperature measured 67 degrees Fahrenheit. The pool and adjacent wetted reaches would provide adequate, but limited summer rearing habitat for salmonids.

Habitat approximately 250 feet upstream of the East Fork

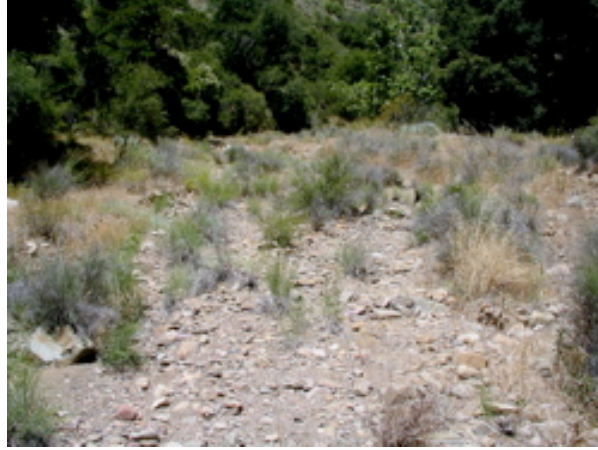
The Horse Creek channel remained dry for 0.9 miles upstream to 250 feet downstream of the Middle Fork where surface flows of 1 c.f.s were observed upstream to the Middle Fork. The Middle Fork supplied all surface flows into this portion of Horse Creek. Water temperature was measured at 65 degrees Fahrenheit and fair spawning and rearing habitat was observed. Beginning immediately upstream of the Middle Fork, the mainstem of Horse Creek was dry for 1.15 miles upstream to near the 2400-foot elevation.

Dry channel upstream of the Middle Fork

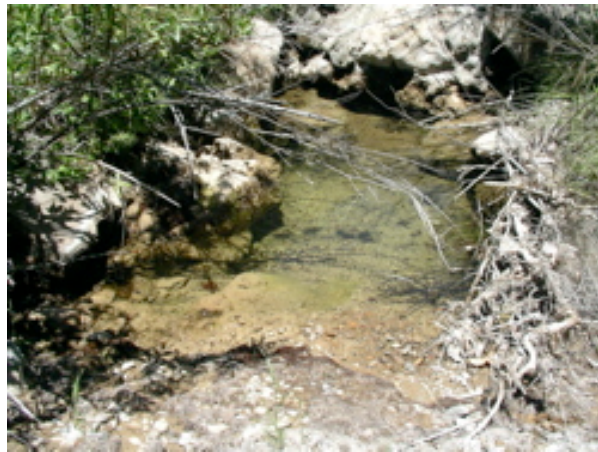
Upstream of the previously mentioned dry stream reach, trickling flow of less than 0.1 c.f.s was observed along with isolated pockets of shallow water and short dry reaches. Salmonid rearing habitat conditions were poor in this upper reach of Horse Creek due to sporadic surface flows, and shallow water depth. These variable surface flow conditions continued upstream to the upper extent of the survey approximately 8.7 miles upstream from the Sisquoc River.

Isolated pool in upper Horse Creek

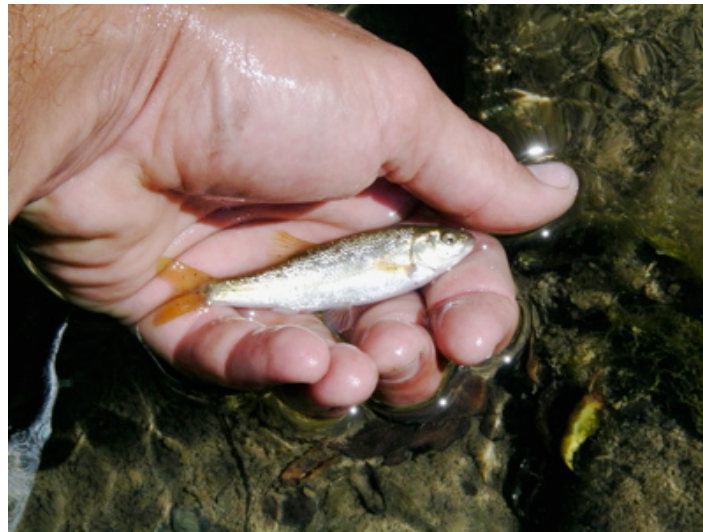
Southern steelhead (*Oncorhynchus mykiss*) were not observed in the Horse Creek drainage. Arroyo Chub (*Gila orcutti*) ranging from 1.5 to 4 inches in total length were observed sporadically in low densities from the Sisquoc River upstream 4.0 miles. One Arroyo Chub was observed downstream of the dam. No fish species were observed upstream of the lower 4 miles of Horse Creek.

Arroyo Chub downstream of Horse Creek Dam

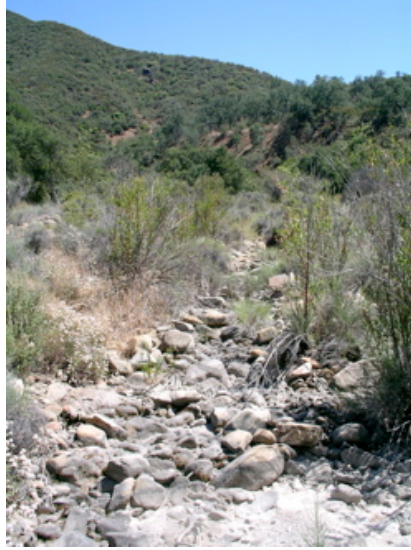
The lower 0.6 miles of the East Fork Horse was dry. Upstream of the dry reach, variable stream flow conditions occurred for 0.1 mile with trickling flow less than 0.1 c.f.s mixed with dry reaches.

Dry channel on East Fork upstream of Horse Creek

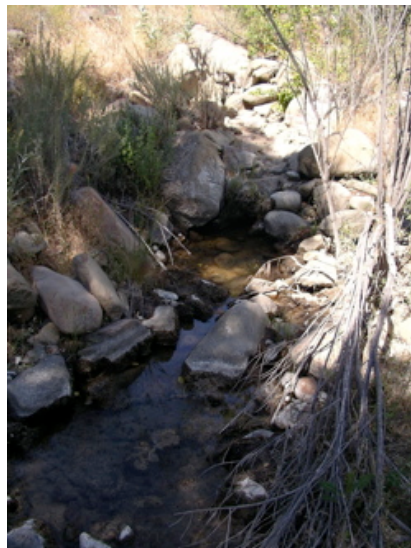
Surface flow of less than 0.2 c.f.s was observed 0.7 miles upstream of the mainstem of Horse Creek and continued past the upstream limit of the survey 1.0 mile upstream of Horse Creek. Water temperature was measured at 64 degrees Fahrenheit. Poor to fair rearing habitat was observed due to the shallow water depth, low instream cover, and highly limited habitat size. Adequate spawning substrate was present in low abundance and substrate embeddedness was moderate. No fish species were observed in the 1.0 mile of stream surveyed on the East Fork.

Near upper survey limit of the East Fork

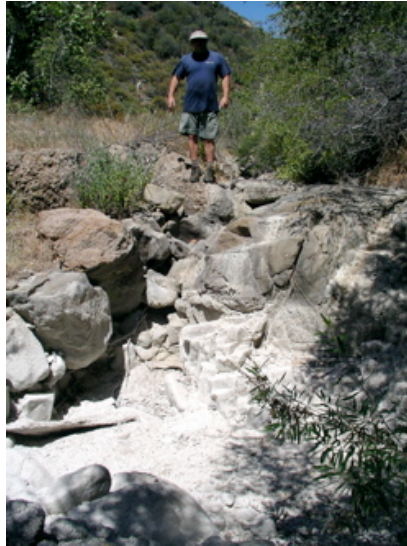
Dry channel conditions along the lower 0.6 miles of the East Fork limit fish passage during most or all of a given year, depending on stream flows. Approximately 0.5 miles upstream from the mainstem of Horse Creek a 6-foot tall bedrock and boulder cascade was observed. This cascade would likely limit upstream fish passage depending on the amount of surface flow encountered during a given flow year. Waterlines suggest the downstream pool may fill 2 to 3 feet in depth leaving a 3 to 4-foot jump for fish. Such a scenario is near the upper limitation of adult steelhead jump capabilities, but may be possible during high stream flows when the downstream pool is at its deepest.

6-Foot bedrock drop 0.5 mile upstream on the East Fork

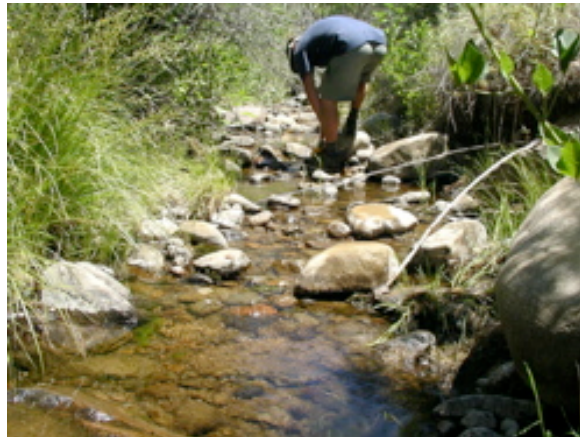
The Middle Fork of Horse Creek was observed to have the greatest surface flow upstream from flows observed on the lower 5 miles of Horse Creek. At the confluence with the mainstem, the Middle Fork was discharging approximately 1.0 c.f.s of stream flow with a temperature of 65 degrees Fahrenheit. The surface flow only continued upstream for 0.15 miles before abruptly ending. Fair to good salmonid rearing habitat was observed in this reach with moderate instream cover, 50-75% riparian canopy cover, and pool depth to 2 feet. Adequately sized spawning substrate was moderately abundant and substrate embeddedness measured 45%.

Middle Fork flow immediately upstream of Horse Creek

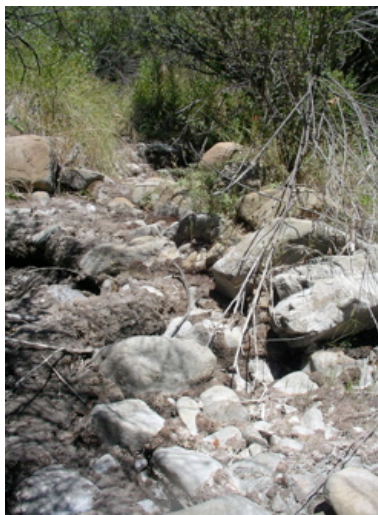
Dry channel conditions were observed upstream of the reach with surface flow for approximately 0.25 miles. Trickling flows of approximately 0.1 c.f.s combined with dry reaches were observed upstream to the upper survey limit. No fish species were observed on the Middle Fork.

Near the upper survey limit on the Middle Fork
