SAN FRANCISQUITO WATERSHED COUNCIL

# Adult Steelhead Passage in the Bear Creek Watershed

*Jerry J. Smith, Dept. of Biological Sciences,  
and Deborah R. Harden, Dept. of Geology,  
San Jose State University, San Jose, CA 95192*

*Pat Showalter, Watershed Council Director July 2001*

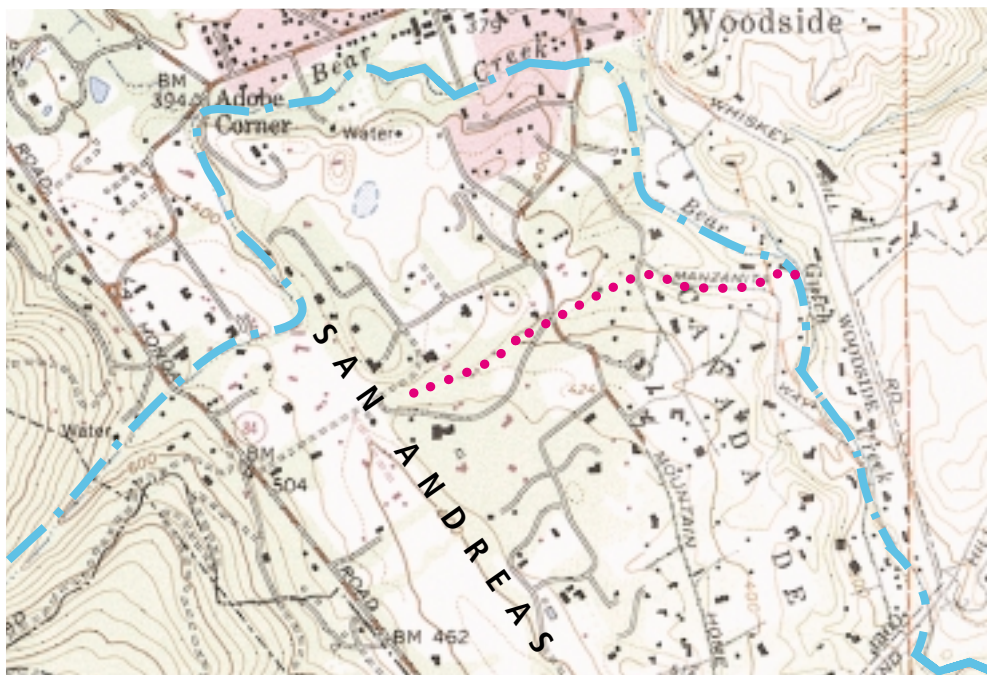
When this occurs, ponds or wetlands, like those at Searsville Marsh, may form. In other areas, stream channels may be abandoned because the stream no longer flows across the fault, but rather flows into a new channel. An excellent example of stream abandonment and capture can be found along Bear Creek near Manzanita Way (Figure A-4).

**Figure A-4.** A portion of the Woodside and Palo Alto 7.5' topographic maps, showing the capture of Bear Gulch along the San Andreas fault. Before capture, Bear Gulch Creek flowed in the depression shown by the dotted line. After blockage along the San Andreas, the creek was captured, and it now flows into Bear Creek at Adobe Corner.
