Steelhead Migration Barrier Inventory and Recovery Opportunities for the Santa Ynez River, Ca.

Prepared by:
Matt W. Stoecker
Stoecker Ecological Consulting

Prepared for:
Community Environmental Council
Santa Barbara, Ca.

January 29, 2004

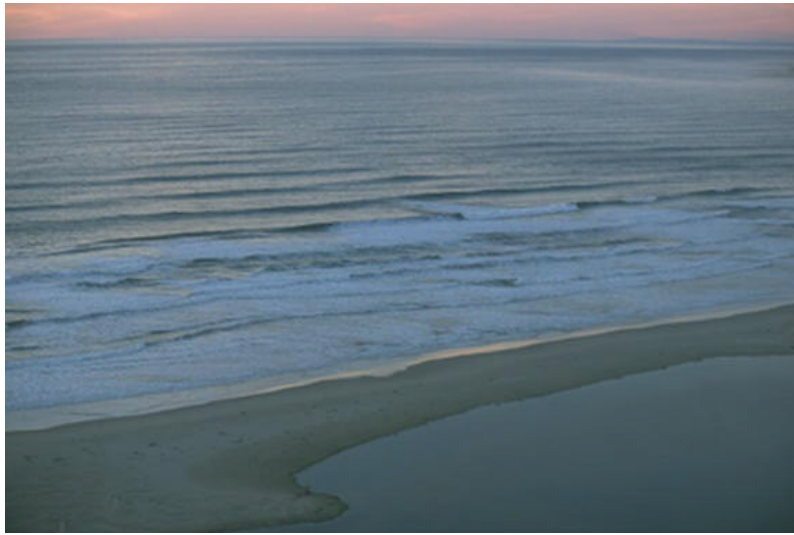
Barrier Status: Partial

Description: For most (or all) of a given year, a sandbar occurs at the mouth of the Santa Ynez River preventing salmonid migration to and from the ocean. This sandbar creates important estuarine habitat for a variety of species, including various life stages of steelhead trout. The configuration and location of the sandbar change from year to year depending on river flows, dam releases, and ocean processes. The permeable sandbar allows both fresh and saline water to move between the estuary and ocean, but typically the absence of surface flows across the sandbar prevents steelhead from migrating across the sandbar. During high stream flows and/or favorable ocean and tidal activity, the sandbar will be breached, creating a channel of surface water through the sandbar that allows steelhead migration between the river and sea. Sandbars typically breach following sizable early-winter rain events that produce sizable stream flows, sometimes in conjunction with large surf and high tides.

Diagnosis: While sandbar formation and occurrence in Southern California streams is a natural process, anthropogenic factors impact the sandbars' breaching frequency and duration. In particular, the amount and duration of water releases from upstream dams and groundwater pumping dramatically impact the sandbar and affect steelhead migration to and from the Santa Ynez River. In particular, large early-winter stream flow events are likely reduced at the mouth due to the timing of water storage at Bradbury Dam/Cachuma

Recommended Action: Adequate fish passage at the sandbar is essential to all steelhead recovery efforts on the Santa Ynez River and significant for southern steelhead recovery as a whole. Understanding the complex interplay between stream flow, dam releases, oceanic processes, and sandbar breaching is beyond the scope of this project and needs to be further studied to identify the most optimal management options. One alternative that should be further studied is the establishment of a water release schedule from Bradbury Dam that provides the optimal amount and duration of stream flow for sandbar breaching and stream connectivity to available tributaries. Utilizing rain and tributary gage information it should be possible to develop operational protocols for optimal water release amounts and timing. It is likely that along with the established (and adaptively managed) water release schedule an early peak-flow release may be needed to initially break the sandbar preceding “steelhead migration flow releases”. It is critical that flow releases provide adequate water depth and connectivity to the base of Bradbury Dam and the furthest accessible upstream tributaries in conjunction with sandbar breaching. Downstream migrating smolts also require stream connectivity to the ocean across the sandbar during their late winter to early summer downstream migration.

Unnatural mechanical breaching of the sandbar is not recommended as a viable option for several reasons. Human breaching of the sandbar may negatively impact estuarine habitat conditions for steelhead and other dependant species. The sandbar should be breached by stream flows only so that upstream migrating adults are ensured to have adequate stream depth and connectivity to upper tributaries and are not stranded in unfavorable conditions. Following sandbar breaching, adequate flows need to be maintained for several days/weeks in order to maintain connectivity to upstream tributaries.

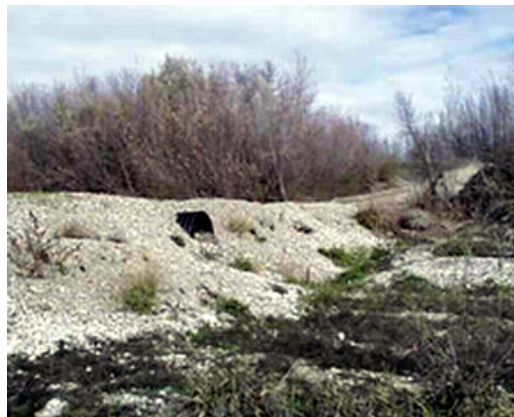
Barrier Status: Unknown

Description: Permission to ground survey this extensive channelization was not obtained and limited observations were made from public roads west of Solvang. Heavy equipment was observed moving large amounts of substrate in the river channel. It appears that extensive gravel extraction is taking place. A long and constricted channelized reach that straightens and confines the Santa Ynez River has been created to allow expansion of development/gravel extraction into the river's flood plain. Due to serious manipulation of this river reach, the stream course has been significantly altered. Downstream of the gravel extraction a private road crossing has been constructed using gravel fill and a large culvert. This crossing was observed by NMFS warden and the owner has been instructed to remove this none permitted structure (pers. comm. Capelli). The crossing is shown below.

Diagnosis: The full extent of channelization could not be observed from public roads and fish passage severity could not be adequately determined. It is likely that significant modifications, check dams, and equipment crossings are impeding or preventing fish passage in this reach. The river's aquatic habitat and riparian vegetation has been significantly altered in this reach. Reportedly, the crossing is currently being removed.

Recommended Action: This channelization/gravel extraction project needs to be assessed by the authorizing agencies and checked for potential fish migration barriers and habitat degradation. In addition, the long-term objectives/operations need to be assessed to determine the impacts to the overall stream channel, impacts to surface flows and migratory connectivity, reduction of the river floodplain and carrying capacity, and associated impacts to aquatic resources. Ensure adequate removal of the crossing.

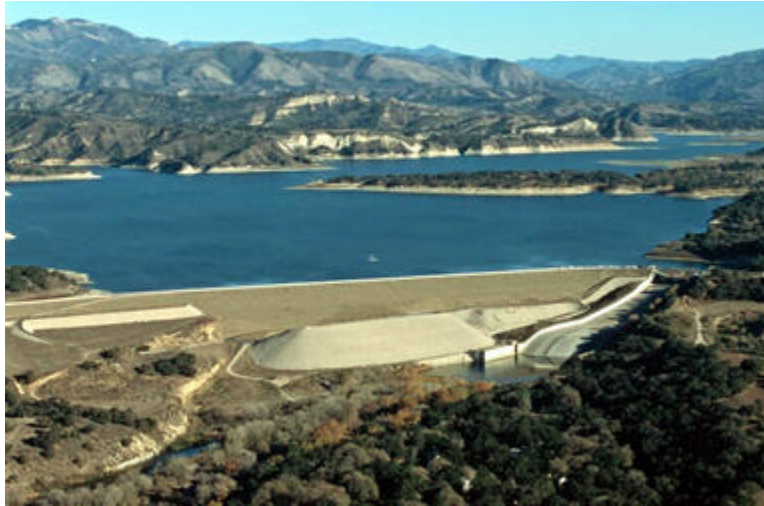
Barrier Status: Complete

Description: Information about this dam was obtained from the Santa Barbara County Public Works Department- Water Resources Division and U.S. Bureau of Reclamation websites. Bradbury Dam was built between 1950 and 1953 at a cost of \$6,722,520 and is owned by the U.S. Bureau of Reclamation. The dam is constructed of earth and rock and has a concrete spillway. The dam's watershed is reportedly 421 square miles. The structural height is listed as 279 feet (and an effective hydraulic height of 160 feet) with a crest length of 3350 feet. The dam is composed of 6,695,273 cubic yards of material. The reservoir capacity in 1956 is listed as 205,000 acre-feet. Sediment deposition has reduced the capacity to less than 190,400 acre-feet (1989 estimate). Using these numbers, the reservoir accumulates approximately 442.4 acre-feet of sediment per year, effectively reducing the water storage capacity by the same amount. In 1997, the 42-mile Santa Ynez Extension of the State Water Project's Coastal Branch brought state water to Cachuma Reservoir thus tapping the watershed into one of the world's most complex water diversion networks.

Diagnosis: This dam is the primary factor for the near elimination of the Santa Ynez River steelhead run. It was not constructed with any fish passage facilities; consequently, it is a physical barrier to upstream migration. Additionally, regulated water releases and storage operations affect stream connectivity and steelhead migration within the lower river. Access to and from the ocean across the sandbar at the mouth of the river is also highly influenced by dam releases and is further discussed as a stream flow connectivity barrier in write-up SY_ 1.

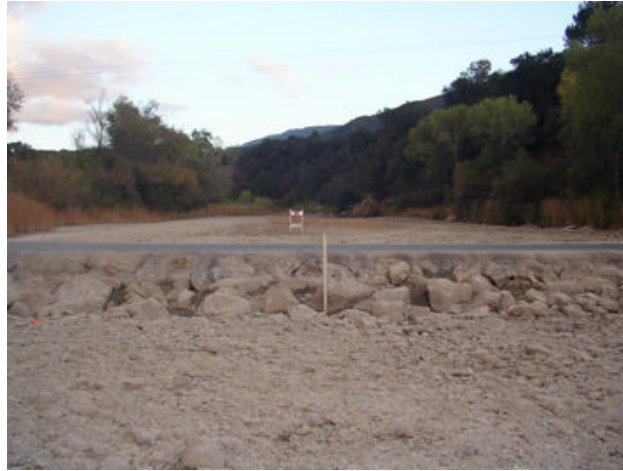
Barrier Status: Partial

Description: This low-flow road crossing measured 170 feet across the channel and 15 feet wide. A moderately steep apron composed of boulders and concrete extends downstream 10 feet. The vertical height from the natural downstream channel bottom to the downstream lip of the road surface measured 3 feet.

Diagnosis: When adequate water depth occurs during moderate and high flows, adult salmonids can jump/swim onto the road surface with a moderate to high degree of difficulty. Due to a lack of roughness, excessive water velocities over the smooth concrete crossing may impede/block upstream migration during higher flows. During these flow conditions, water also becomes turbulent down the sloping apron and may impede or prevent upstream passage for smaller salmonids. All fish passage is prevented during lower flows due to the shallow (or absent) water depth on the crossing and apron. This crossing represents a partial barrier, especially during lower flows, and reduces the window of opportunity for salmonid passage at this site.

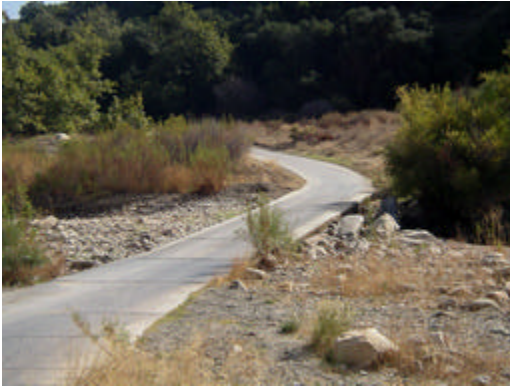
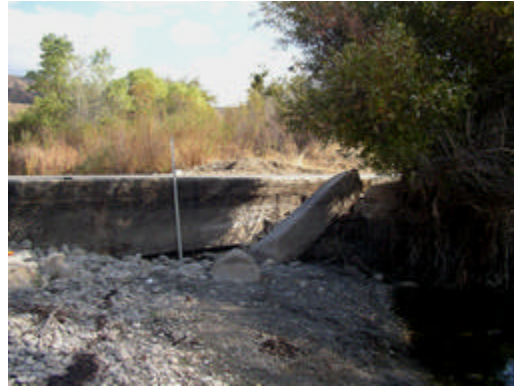
Barrier Status: Partial

Description: This low flow crossing measured 175 feet across the channel and 14 feet wide. The maximum height from the top of the road to the downstream channel measured 6 feet at river-left where significant undercutting has occurred. This is likely the low point in the crossing.

Diagnosis: Moderate to high stream flows are needed at this site to establish a downstream jump-pool and/or sufficient depth for salmonids to migrate up the boulders on river-right. Due to the scour height and required jump to migrate onto the crossing, this structure presents a moderate to high degree of difficulty to salmonid passage during moderate and high flows respectively. Water velocities become accelerated over the smooth concrete crossing during higher flows due to a lack of roughness. During these higher flow conditions, easier fish passage may be obtained on river-right where flows spill over the downstream boulders at road surface grade. All fish passage is prevented during lower flows due to the shallow water depth spread out over the crossing's surface and apron. This crossing represents a partial barrier, especially during low and moderate flows, when insufficient water depth occurs on the crossing or downstream pool depth.

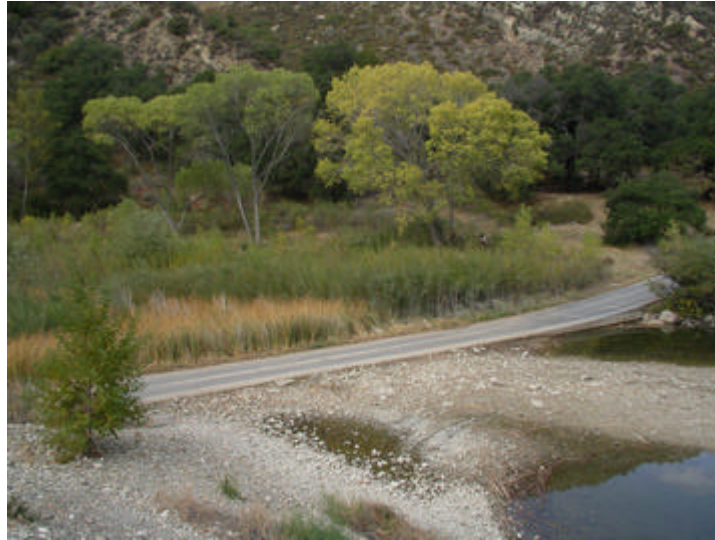
Looking downstream

Barrier Status: Partial

Description: This road crossing measured 240 feet across the stream channel and 13 feet wide. Most of the crossing surface occurs at or near streambed grade and has a mild or flat slope.

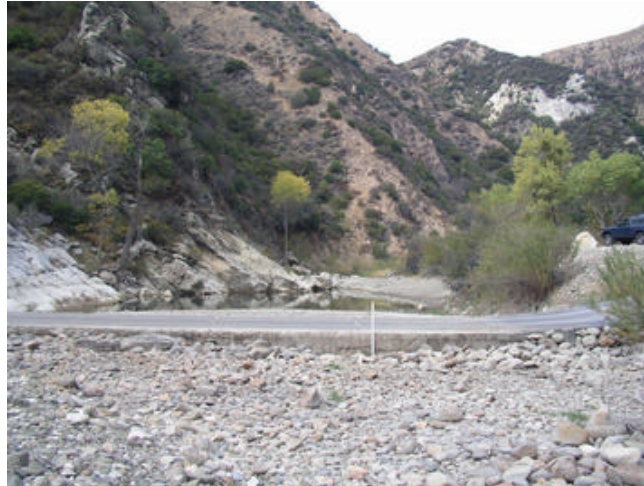
Barrier Status: Partial

Description: This crossing measured 170 feet across the channel and 14 feet wide. A vertical drop from the downstream substrate to the downstream lip of the road measured 2 feet 6 inches. A large pool occurs immediately upstream.

Diagnosis: When adequate water depth occurs during moderate and high stream flows, salmonids can jump and/or swim onto the road surface with a moderate degree of difficulty. Due to a lack of roughness, water velocities become accelerated over the smooth concrete crossing during higher flows and may impede or prevent upstream passage for smaller salmonids. Depending on the velocities encountered during high stream flows and the size/condition of fish, salmonids may have difficulty swimming across the road surface. All fish passage is prevented during lower flows due to shallow water depth spread out over the crossing's surface. While passable during a significant window of flow conditions, this crossing represents a partial barrier, especially during lower flows, and reduces the window of opportunity for migration at this site.

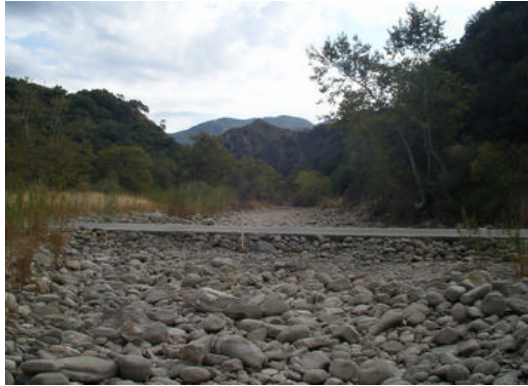
Barrier Status: Partial

Description: This road crossing occurs at a braided section of the river where two road crossings occur on either side of a central island. The road crosses the channel at river-left for 75 feet and is 14 feet wide. Smaller boulders slope downstream for 5 feet at a moderate slope. The drop from the downstream lip of the road crossing to the streambed measured 2 feet 6 inches. The road crosses the second channel at river-right for 60 feet. The height from the road surface to the downstream channel measured 2 feet 6 inches.

Diagnosis: When adequate water depth occurs during moderate and high stream flows, salmonids can jump and/or swim onto the road surface with a moderate degree of difficulty. Due to a lack of roughness, water velocities are accelerated over the smooth concrete crossing during higher flows and may impede or prevent upstream passage for smaller salmonids. All fish passage is prevented during lower flows due to shallow water depth spread out over the crossing's surface. While passable during a significant window of flow conditions, this crossing represents a partial barrier, and reduces the window of opportunity for salmonid passage at this site.

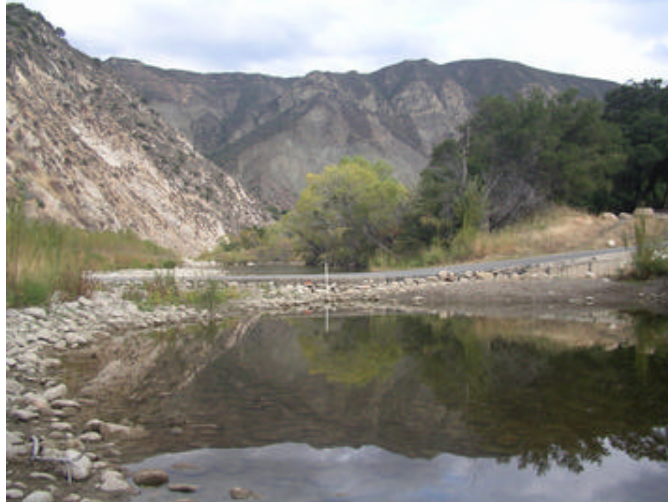
Barrier Status: Partial

Description: This road crossing measured 70 feet across the channel and 14 feet wide. The height from the downstream lip of the road to the downstream substrate measured 2 feet 7 inches. Large pools occur upstream and downstream.

Diagnosis: When adequate water depth occurs during moderate and high stream flows, adult salmonids can jump and/or swim onto the road surface with a moderate degree of difficulty. Due to a lack of roughness, water velocities are accelerated over the smooth concrete crossing during higher flows and may impede or prevent upstream passage for smaller salmonids. All fish passage is prevented during low flows due to shallow water depth spread out over the crossing's surface. This crossing represents a partial barrier, especially during lower flows, and reduces the window of opportunity for salmonid passage at this site.

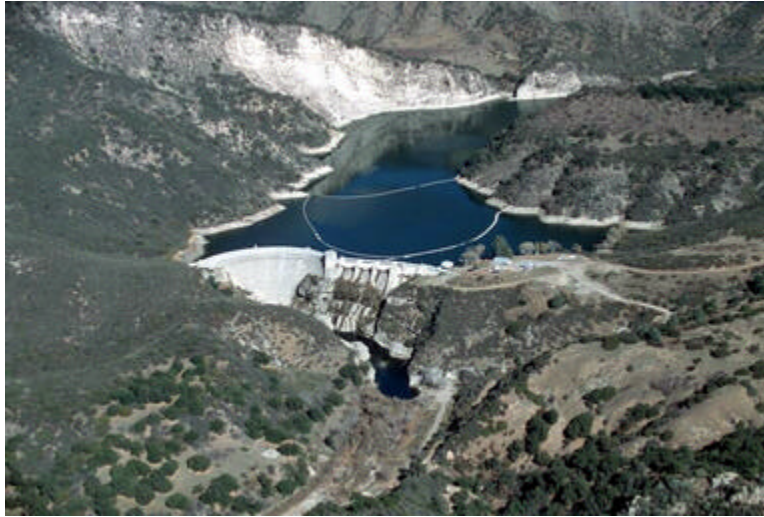
Barrier Status: Complete

Description: Information about this dam was obtained from the Santa Barbara County Public Works Department- Water Resources Division's web site. Gibraltar Dam was built in 1920 by the City of Santa Barbara and accomplished the first diversion of water to the south coast through Mission Tunnel. The dam is a constant radius concrete arch dam that measures 150 feet tall. The reservoir capacity in 1920 was 14,500 acre-feet. The drainage area above the dam is reported to be 214 square miles. Sedimentation had reduced capacity to 7,800 acre-feet by 1945, but the dam was raised 23 feet in 1948 to regain close to the original capacity. However, sedimentation has continued to reduce the capacity of the reservoir by an average of 215 acre-feet each year since 1948. The City of Santa Barbara's website identifies the storage capacity at 7264 acre-feet per a 1998 bathymetric survey. However, the 1-04 water supply report by Steve Mack (as of 9-30-03) lists storage capacity at 7,098 acre-feet (pers. comm. Trautwein).

Diagnosis: This dam was not constructed with any fish passage facilities and was the first major dam to block upstream migration for the Santa Ynez River steelhead. In addition to being a physical barrier to upstream migration, the dam also indirectly limits downstream salmonid migration by reducing flows below Gibraltar.

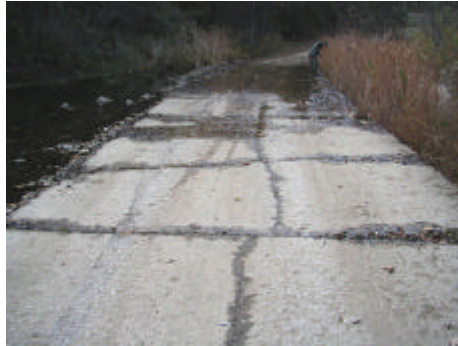
Barrier Status: Partial

Description: This concrete low-flow crossing measured over 300 feet long and extends far onto either side of the stream channel at this wide section of the river. The surface of the concrete crossing measured 16 feet wide and has a flat to mild downstream slope. Observed flows of approximately 0.25 c.f.s. dropped 1-foot 8 inches into a downstream pool that has a maximum measured depth of 16 inches. A large upstream pool extends for several hundred feet and appears to be a location where subsurface flows emerge and provide consistent summer flows in this reach.

Diagnosis: During the observed base-flow conditions, fish passage is impeded due to the shallow water depth spread out over the crossing and the moderate jump height and limited downstream pool depth. During moderate and high flows, adequate water depth will allow salmonids to jump or swim onto the crossing and migrate upstream with a low to moderate degree of difficulty. While passable during a significant window of flow conditions, this crossing represents a partial barrier, especially during lower flows, and reduces the window of opportunity for salmonid passage at this site.

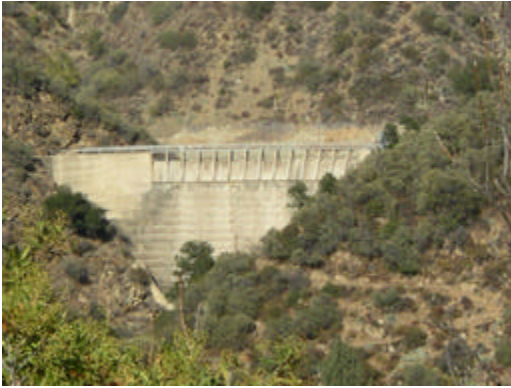
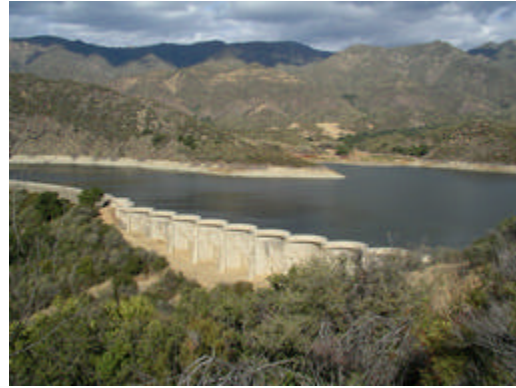
Barrier Status: Complete (see diagnosis)

Description: Information about Juncal Dam was obtained on the Santa Barbara County Public Works Department- Water Resource Division and Montecito Water District websites. The dam was completed in 1930 and serves as the water supply for the Montecito Water District on the south side of the Santa Ynez Mountains. The Montecito Water District website reports that the dam measures 80 feet tall and 240 feet across the top. An impressive series of connected arch dams were also built to the south of the main dam to increase the reservoir capacity of Jameson Reservoir. The storage capacity is reported to be 5,291 acre-feet. Upstream tributaries feed the reservoir as well as stream flows that are conveyed from Alder Creek through an aqueduct (See barrier assessment SY_AR_2 and SY_AR_3). The dam's watershed is approximately 17 square miles. An earthen debris dam was built in the 1990's upstream of the reservoir approximately 0.25 miles on the Santa Ynez River, but this structure was blown out with high stream flows and no longer spans the river channel or impedes fish passage.

Diagnosis: This dam has no fish passage facilities and completely blocks upstream salmonid passage; additionally, the storage and distribution of water in the reservoir reduces flows in the Santa Ynez River between Juncal dam and Gibraltar Reservoir, and ultimately below Bradbury Dam. Note: salmonids downriver may be able to migrate up Alder Creek (a downstream tributary), jump over the Alder Creek diversion dam, get sucked into the diversion, and be transported through the aqueduct into Jameson Reservoir, allowing access upstream of Juncal Dam. See Alder Creek barrier assessments for more detail on this unintended and extremely difficult fishway around Juncal Dam. This Alder Creek diversion could be modified to enhance upstream access.

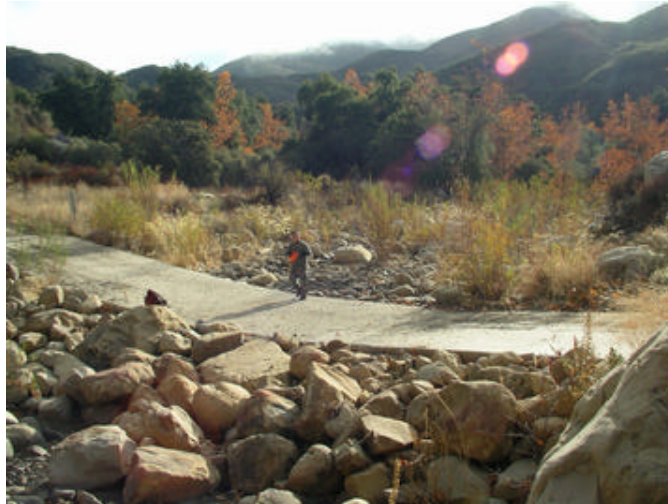
Barrier Status: Partial

Description: This road crossing measured 103 feet long, with approximately 85 feet crossing the active stream channel. The crossing measured 14 feet wide and has a flat to mild slope. A large-boulder apron has been placed downstream of the crossing to prevent downstream scour. This 10 to 20-foot long boulder apron has a moderate downstream slope to natural substrate below. The surface of the crossing has moderate wear and cracking with an irregular surface.

Diagnosis: This structure impedes the upstream spawning migration of Jameson Reservoir rainbow trout, which have been found to be genetically similar to native southern steelhead. All fish passage is prevented during lower flows due to shallow water depth spread out over the crossing's surface and insufficient water depth over the boulder apron. During moderate to high flows, adequate water depth may facilitate upstream migration of trout across the rough apron and onto the crossing. Extremely high flows may produce velocities across the concrete surface that would prevent passage of smaller trout. This crossing represents a partial barrier, especially during lower flows, and reduces the window of opportunity for rainbow trout to migrate upstream of this site.

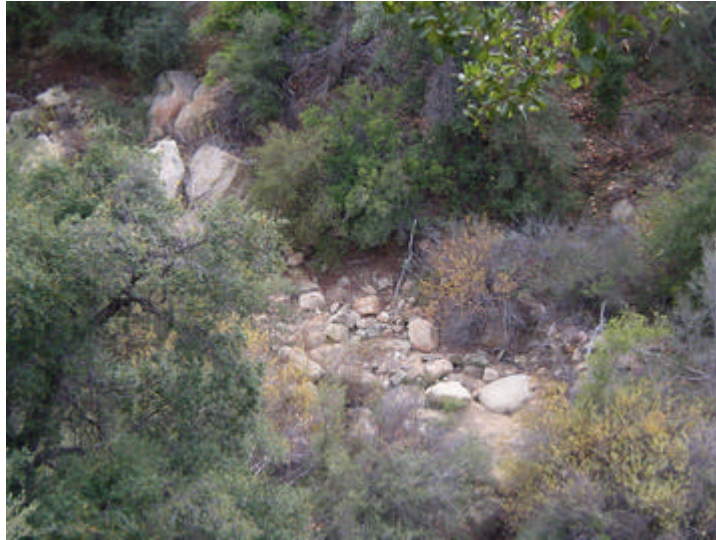
Barrier Status: Partial

Description: Upstream from the confluence with Steelhead Creek (the unnamed northern tributary at Upper Santa Ynez Campsite), the Santa Ynez River is a smaller, dry stream with insufficient flow and relatively poor salmonid habitat. Steep boulder gradients occur in this stream reach with drops up to 9 feet tall and limited downstream pool formation.

Diagnosis: Several steep boulder gradient sections occur downstream from this location and the absence of flows combine to make upstream passage extremely difficult and undesirable. During high stream flows, the boulder configuration may change and allow limited upstream migration. Perennial flows and high quality salmonid habitat extend upstream on Steelhead Creek and likely mark the upstream headwater habitat for the Santa Ynez River rainbow trout and historic steelhead runs.

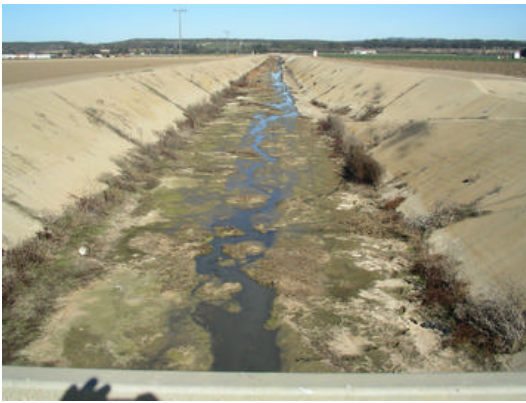
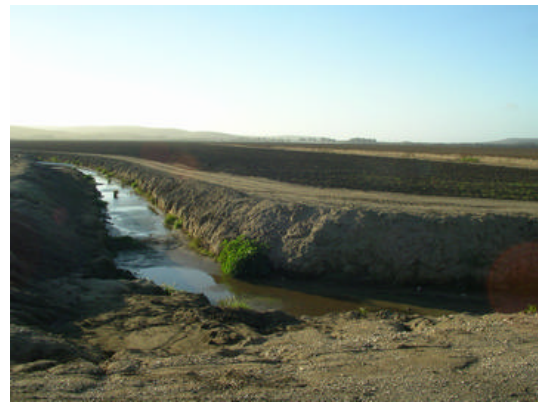
Barrier Status: Unknown

Description: The original configuration of lower Sloans Creek and La Salle Creek across the flatlands west of Lompoc has been highly altered and rerouted for agricultural development, irrigation, and flood control. Both La Salle Creek and Sloans Creek have been channelized in concrete where they flow out of the foothills and combine to form one large trapezoidal concrete channel that crosses the flatlands in a straight line north to the Santa Ynez River. A network of irrigation ditches, canals, and what appear to be detached remnant stream channels occur adjacent to the main concrete channels. Without access to private lands, observations of this network of waterways were extremely limited. Downstream from the Central Ave. crossing, the trapezoidal flood control channel is approximately 25 feet wide with 8 feet tall angled walls. The concrete bottom has varying concentrations of deposited sediment and vegetation. The USGS map shows a possible dam and storage or debris basin at the confluence of these two creeks that may divert flows into irrigation canals.

La Salle Creek- To the west of the main Sloans Creek concrete channel a large irrigation ditch occurs that may not even connect to the stream, but may accept diverted water from lower La Salle Creek or be a former stream channel and/or irrigation ditch. Whether this waterway connected to the Santa Ynez River could not be determined. Roads with culverts were observed crossing this irrigation canal at Artesia Rd. and Central Ave. While not directly observed, it appears that a dam may divert La Salle Creek flows from the lower creek into this irrigation canal approximately three tenths of a mile up La Salle Creek from the Ocean Avenue road crossing.

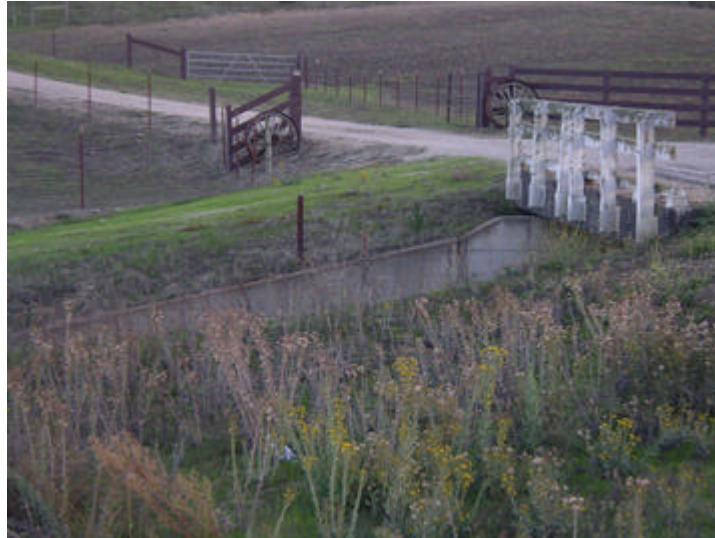
Description: Permission to access and survey this structure was not obtained and limited observations were made from La Salle Canyon Road. This concrete channel extends under a private bridge and appears to be approximately 8 feet wide. It appears to extend downstream to the lower flood control channel that connects La Salle to Sloans Creek.

Diagnosis: This concrete channel is likely impassable due to the excessive length and absence of resting areas for fish. Shallow water depth during low flows and excessive velocities during higher flows would likely prevent upstream fish passage.

Recommended Action: Further assess upstream habitat conditions and salmonid potential with landowner permission. Should adequate habitat conditions occur upstream, assess hydraulic and channel conditions at the crossing and downstream channelization and investigate passage alternatives with the county and other stakeholders. The most effective solution for fish passage would involve removal of the channel, biotechnical bank stabilization, and installation of a wide-span bridge.

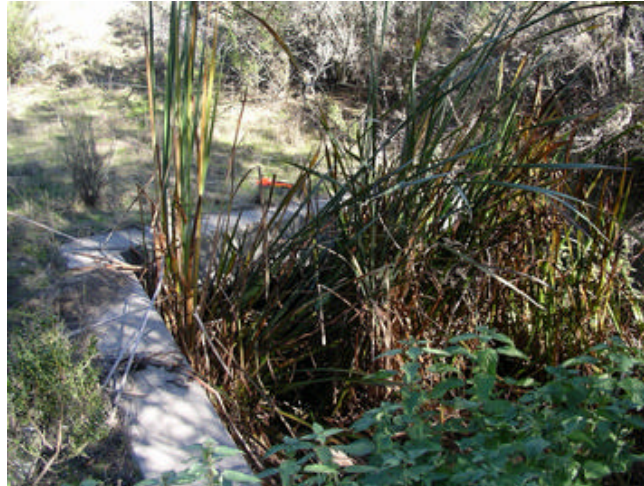
Description: Each box of this double box culvert measured 6 feet wide by 3 feet tall at the downstream end. The adjacent stream channel has a silt bottom with dense cattail growth forming a significant blockage. Fine sediment is backed up into the culvert. The culvert boxes at the upstream end measure 6 feet tall and this is likely the same height as the downstream end, which has 3 feet of silt deposited inside the culvert. Angled concrete wingwalls extend downstream for 30 feet. The length of the culvert is approximately 275 to 300 feet based on the road width and earth fill. Trickling surface low was observed.

Diagnosis: This culvert is most likely impassable to upstream migrating salmonids during low flows due to the shallow flow conditions encountered inside the culvert and thick growth of cattails at the downstream end. During higher flows, excessive velocities through the entire structure likely impede or block upstream passage. The cattail growth may be forming a sediment blockage while causing sediment to deposit inside the culvert. This blockage may be reducing the flow capacity of the culvert and may also be preventing salmonid passage.

Recommended Action: Due to the observed late-fall, spring flows, providing effective passage at this site might provide a direct benefit to the Santa Ynez River steelhead population. Conduct a more detailed analysis of upstream habitat conditions and crossing characteristics with adjacent landowner permission. Investigate passage alternatives at this site with CALTRANS. The most effective solution for both fish passage and stream and transportation benefits would involve removal of the culvert and installation of a wide-span bridge.

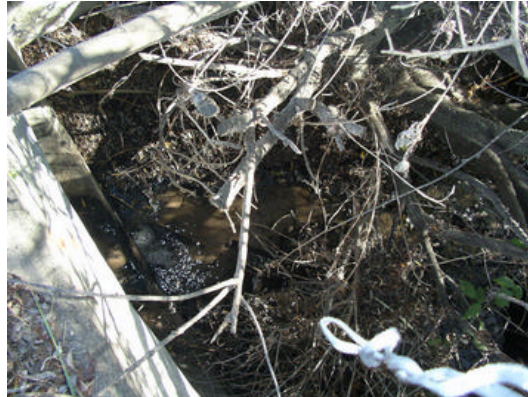
Description: Permission to ground survey the private land adjacent to the culvert was not obtained and limited observations were made from Burton Mesa Road. This corrugated metal culvert pipe has a diameter of 6 feet. There is a concrete apron extending downstream at an angle for approximately 6 feet on river-right and 14 feet on river-left. The observed surface flow crosses the middle of the apron for approximately 9 feet. Sacrete revetment occurs along the downstream banks and connects to the end of the apron. The height from the lip of the apron to surface of the downstream pool is approximately 2 feet 6 inches. The height from the lip of the metal culvert pipe down to the apron is approximately 6 inches. The total length of the culvert is approximately 90 to 100 feet based on road width and earth fill. Stream flow of approximately 0.2 c.f.s was observed and potential salmonid habitat is present in this apparently spring-fed creek.

Diagnosis: This culvert is most likely impassable to upstream migrating salmonids during low flows due to the shallow flow conditions encountered, small jump below the apron and culvert, and minimal pool depth. During higher flows, access into the culvert is possible, but excessive water velocities likely limit or completely block upstream passage.

Recommended Action: Providing effective passage at this site might provide a direct benefit to the existing Santa Ynez River steelhead population. Assess upstream habitat conditions and investigate passage alternatives at this site with the County. The most effective solution for fish passage involves removal of the culvert and installation of a bridge.

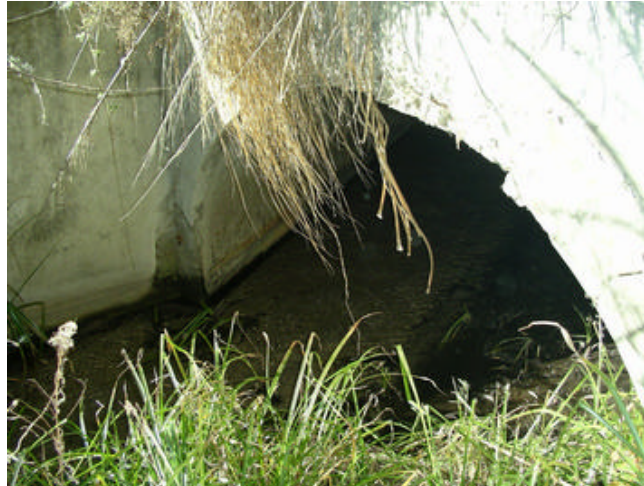
Description: Permission to ground survey the private land adjacent to the culvert was not obtained and limited observations were made from Burton Mesa Road. This culvert measured approximately 120 feet long, 4 feet tall, and 6 feet wide at the base (surface of the deposited substrate inside the culvert). Due to the amount of deposited substrate inside the culvert it was impossible to determine if the culvert is circular and highly embedded or if it is an arch culvert. Angled wingwalls extend downstream for approximately 15 feet. A channel has been scoured out inside the culvert and runs the entire length. Surface flow and adequate salmonid habitat were observed at the upstream end of this culvert.

Diagnosis: This culvert is likely passable with a low degree of difficulty for salmonids during low and moderate flows due to the low gradient, natural substrate bottom, and adequate water depth in the scoured channel. During higher flows, excessive velocities through the culvert may flush out the substrate and limit or completely block upstream passage. This structure likely impedes upstream fish passage during certain flows and its severity is dependant on substrate deposition inside the culvert.

Recommended Action: Providing effective passage at this site might provide a direct benefit to the existing Santa Ynez River steelhead population. Conduct a more detailed analysis of this crossing with adjacent landowner permission and County involvement. Investigate passage alternatives at this site with the County. The most effective solution for fish passage is removal of the culvert and installation of a bridge.

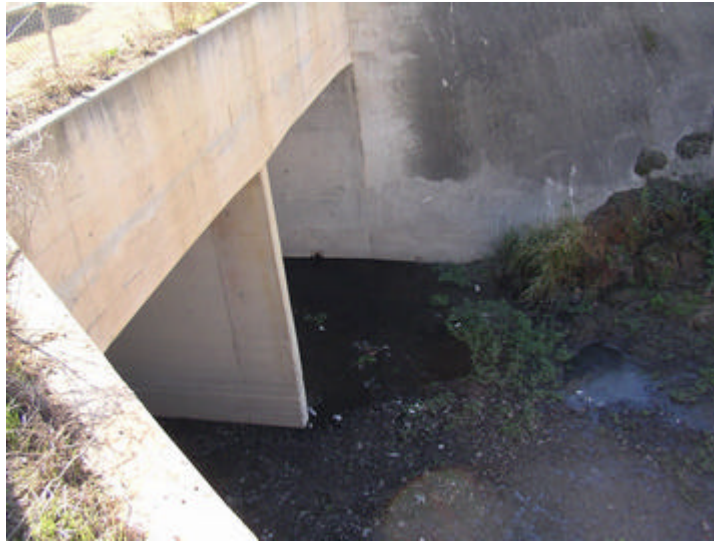
Description: Permission to ground survey the entire culvert and adjacent channel was not obtained and limited observations were made from public roads. The culvert is approximately 140 feet long with two concrete boxes measuring approximately 15 feet tall by 15 feet wide. Wingwalls angle downstream for approximately 30 feet. The downstream creek channel has been channelized but has a “natural” stream bottom.

Diagnosis: A detailed survey of this structure is needed to adequately determine the severity to fish passage. The long culvert likely impedes or prevents upstream salmonid passage due to shallow water depths and excessive water velocities encountered during lower and higher stream flows, respectively. San Miguelito Creek contains adequate salmonid spawning and rearing habitat as well as a contemporary salmonid population. Effective fish passage should be provided at this barrier and other upstream barriers.

Recommended Action: Contact adjacent landowners and the County and seek permission to survey the crossing and adjacent channel. Fish passage improvements should be implemented at this site if salmonid passage is significantly impeded. The most effective fish passage project and transportation improvement may be to remove the crossing and replace it with a bridge that does not impact the stream channel. Any project would need to consider upstream channelization and flood control developments.

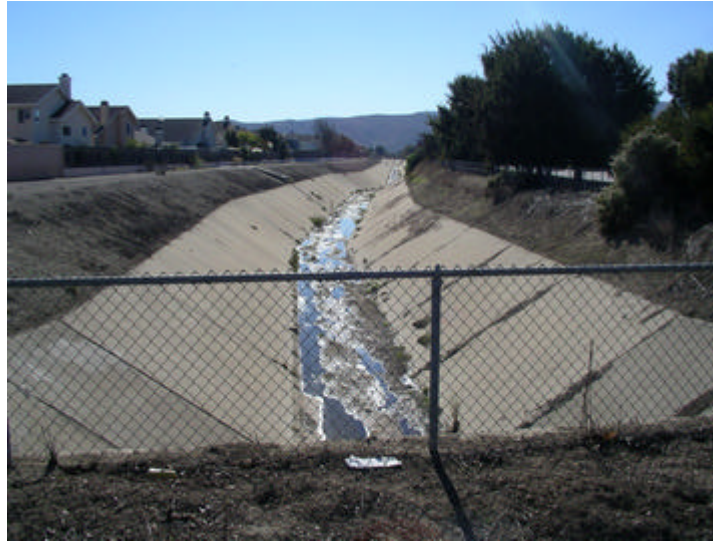
Upstream from Central Ave. Crossing

Description: Permission to ground survey the entire concrete channel and adjacent private lands was not obtained and limited observations were made from public roads. Downstream from the North Avenue crossing the channel is trapezoidal and upstream the channel has vertical walls. The flat concrete bottom has a mild gradient at the locations observed.

Recommended Action: Fish passage improvements should be implemented at this site following discussions with stakeholders and an alternatives analysis. The most effective fish passage and stream restoration project would involve removal of the concrete channel and stabilization of the adjacent banks using biotechnical techniques. This may be possible by expanding current capacity and further protecting adjacent development with the construction of flood retention walls/berm outside of a naturalized channel.

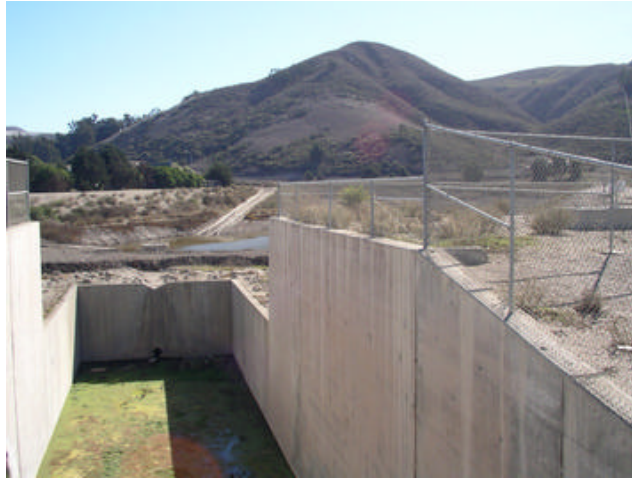
Description: Access to ground survey the entire flood control basin and adjacent land was not obtained and limited observations were made from Olive Road. Downstream from the large flood control basin a dam is constructed at the upstream end of the long, concrete flood control channel. The upstream end of the concrete channel terminates at the dam with a vertical concrete wall measuring greater than 9 feet tall.

Diagnosis: This structure blocks all upstream salmonid passage due to the excessive jump height and lack of downstream pool depth. Excessive turbulence and water velocity also prevents upstream passage during high flows when sufficient water depth occurs in the downstream channel. San Miguelito Creek contains adequate salmonid spawning and rearing habitat as well as an existing salmonid population upstream and effective fish passage should be provided at this and other barriers.

Recommended Action: This dam and downstream flood control channel directly block endangered Santa Ynez River steelhead from accessing a significant amount of adequate spawning and rearing habitat found upstream in San Miguelito Creek. Fish passage should be provided. Due to developments in Lompoc and the constriction of the creek from this debris dam downstream, a comprehensive alternatives analysis should be conducted by the County and a long-term creek restoration and fish passage plan should be developed with stakeholders. A naturalized San Miguelito Creek with adequate flood protection and a restored steelhead run would likely improve the quality of life in the Lompoc area and increase water quality. Realigning the lower creek outside city limits in a naturalized channel is an option worth studying.

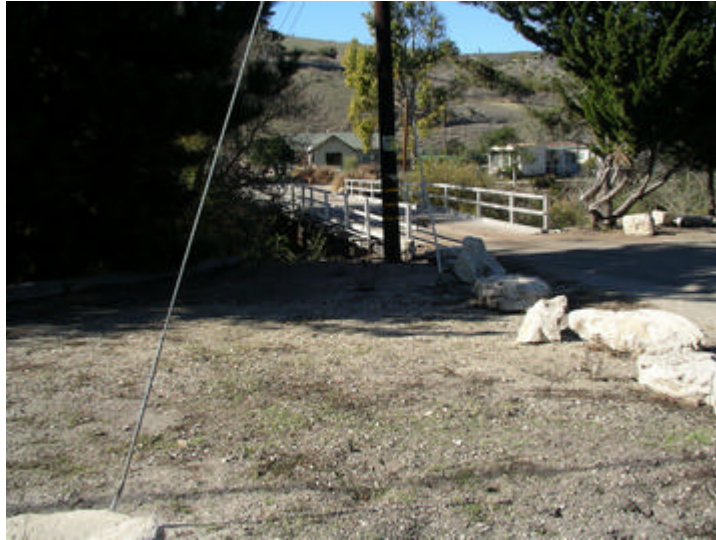
Description: Permission to access and ground survey this crossing and the adjacent channel was not obtained and limited observations were made from Miguelito Road.

Diagnosis: Fish passage conditions at this site are unknown.

Recommended Action: Contact landowner and seek access to survey the crossing and channel at this site.

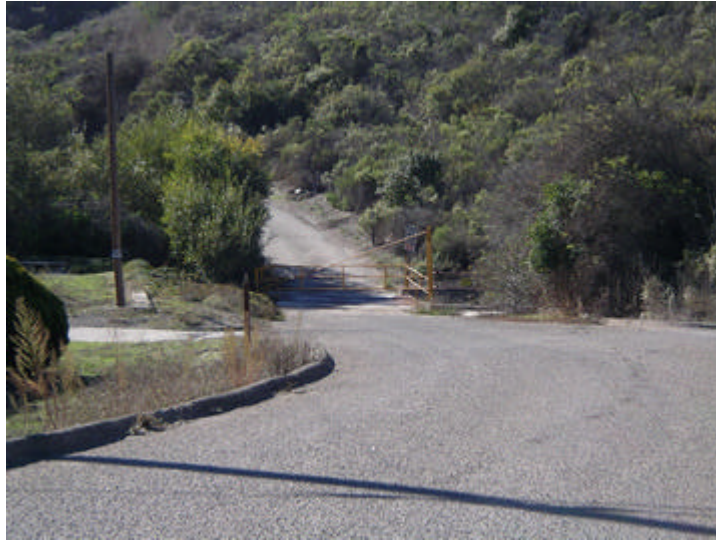
Description: Permission to access and survey this crossing and the adjacent channel was not obtained and limited observations were made from Miguelito Road.

Diagnosis: Fish passage conditions at this site are unknown.

Recommended Action: Contact landowner and seek access to survey the crossing and channel at this site.

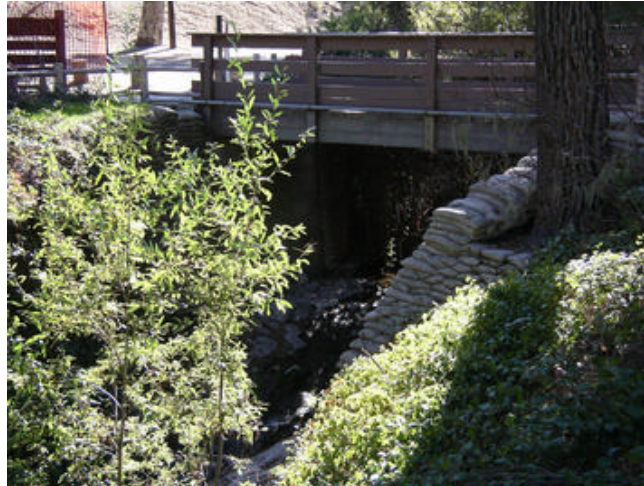
Description: The stream channel underneath the bridge has been protected with concrete and boulder riprap. The riprap channel extends approximately 30 feet underneath the bridge and spans 16 feet wide across the channel. Sacrete bank revetment extends downstream from the bridge for 12 feet and measures approximately 12 feet tall. This revetment is anchored into the riprap channel bottom. The lower end of the riprap channel and the south bank revetment are both damaged and cracked. The approximate height from the downstream lip of the riprap channel to the downstream pool measured 2 feet 8 inches. The pool depth measured 6 to 8 inches. Surface flow and adequate salmonid habitat are present.

Diagnosis: The natural channel below this structure is relatively confined allowing the downstream pool to backfill during moderate to high flows. This backfilling will create sufficient depth for salmonids to jump or swim onto the riprap channel. The irregular riprap channel has sufficient roughness to allow upstream passage by larger salmonids during high flows. Excessive velocities and shallow depth during moderate and low flows would likely prevent passage. Downstream scour and the need for bank revetment may be the result of an under-sized bridge and confined stream channel.

Recommended Action: A more detailed investigation of hydraulic and channel characteristics should be conducted to determine alternatives for improving fish passage at this site. Removal of the concrete channel and bank revetment and potentially widening of the bridge and channel may provide the most effective fish passage alternative at this site.

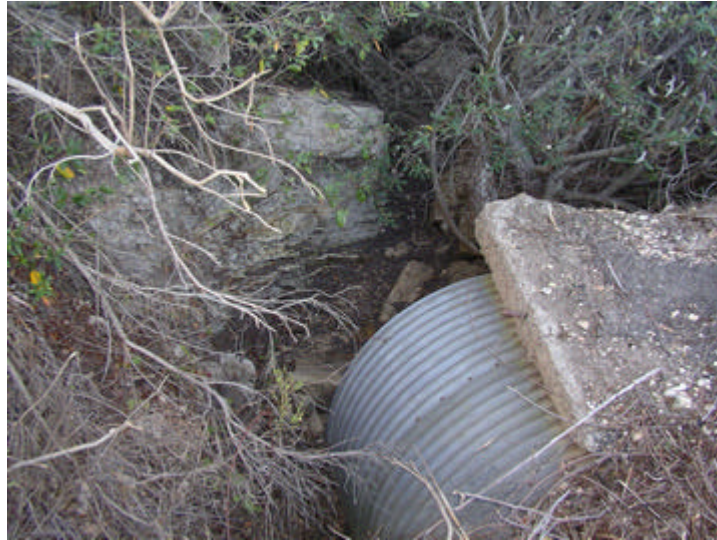
Description: This 5-foot diameter corrugated metal culvert pipe measured 60 feet long and has a moderately steep slope. The height from the lip of the downstream end of the culvert to the streambed below measured 12 inches. This culvert appears to be undersized for this channel.

Diagnosis: This long culvert impedes or prevents upstream salmonid passage due to shallow water depths and excessive water velocities encountered during low and high flows, respectively. Depending on velocities encountered during migration flows, the culvert may allow extremely difficult upstream migration for larger salmonids during moderate flows. No ground surveying was conducted upstream of this structure. Scott Engblom of COMB has identified a waterfall approximately 5 feet tall with a limited downstream pool approximately 1.0 mile upstream from the County Park. This waterfall likely impedes or prevents upstream passage, but may allow limited passage for adult steelhead during high stream flows.

Recommended Action: Due to the presence of salmonids in this stream, passage conditions at this site should be improved to facilitate habitat connectivity. Protecting and improving habitat conditions for the San Miguelito Creek rainbow trout population may have direct benefits for the Santa Ynez River steelhead population by providing adequate passage for outmigrating smolts.

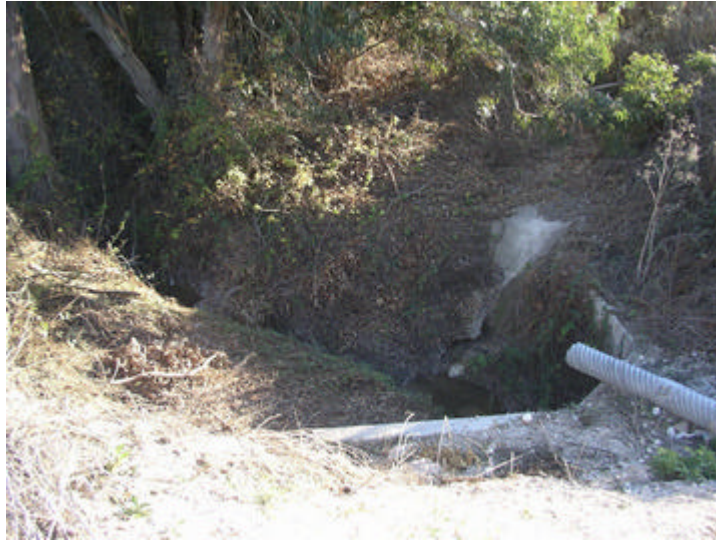
Upstream end of culvert

Description: Permission to access and survey the culvert and adjacent channel was not obtained and limited observations were made from the public road. The culvert appears to be a box culvert measuring approximately 200 feet long based on the road width and fill.

Diagnosis: Passage conditions at this site and upstream salmonid habitat conditions are not known. This long culvert likely prevents upstream salmonid passage due to shallow water depths or excessive water velocities encountered during low and high flows, respectively.

Recommended Action: Contact the County and landowner(s) to seek permission to survey upstream habitat conditions and the culvert. Should adequate upstream salmonid habitat occur, fish passage alternatives should be identified and discussed with the crossing stakeholders.

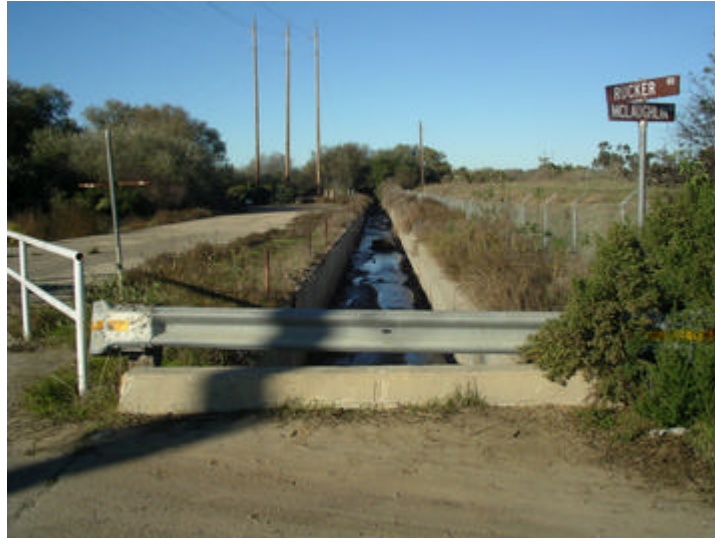
Rucker Road Crossing

Description: Permission to ground survey this entire structure and adjacent private land was not obtained. Observations of this culvert crossing were made from public roads and are limited in detail. This concrete channel has 6-foot tall walls and measured 6 feet wide along the bottom. The concrete channel appears to extend all the way downstream to the confluence with the Santa Ynez River and extends upstream to the Purisima Road crossing.

Diagnosis: During high flows, this concrete channel is likely impassable due to the lack of roughness and resting spots for fish. During low flows, the structure is impassable due to the shallow water depths encountered. During moderate flows, limited upstream migration may be possible depending on the overall length, slope changes, and outlet conditions. A detailed assessment of the entire channel is needed to accurately assess fish passage severity.

Recommended Action: Work with the county to assess this channel and investigate passage alternatives at this site. The most effective solution for fish passage would involve removal of the concrete channel and stabilization of the banks using biotechnical techniques.

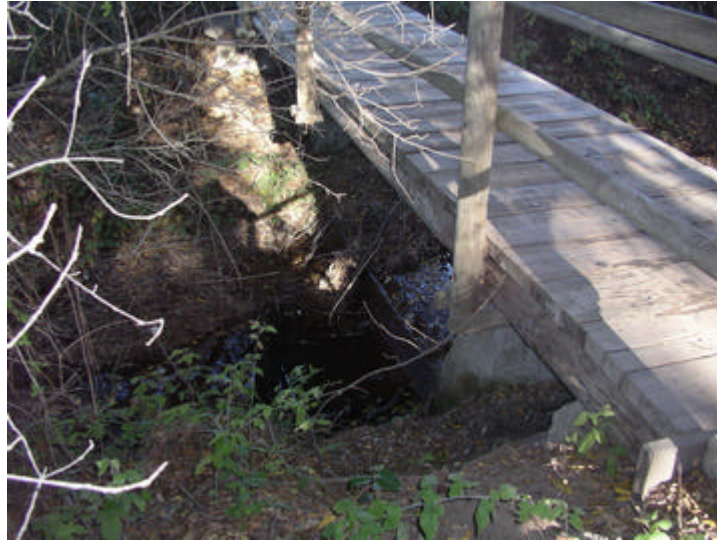
Description: This footbridge sits on a 15-inch thick concrete footing that spans the stream channel and only extends underneath the bridge. The height from the downstream lip of the footing to the downstream pool surface measured 1-foot. The maximum pool depth downstream measured 10 inches.

Diagnosis: During moderate and higher flows salmonids can migrate upstream of this structure with a low to moderate degree of difficulty due to the minimal jump height onto the concrete, mild slope, and short distance across the structure. Fish passage is prevented during very low flows due to the shallow water depth encountered on the concrete footing. Spring flow is present in this reach.

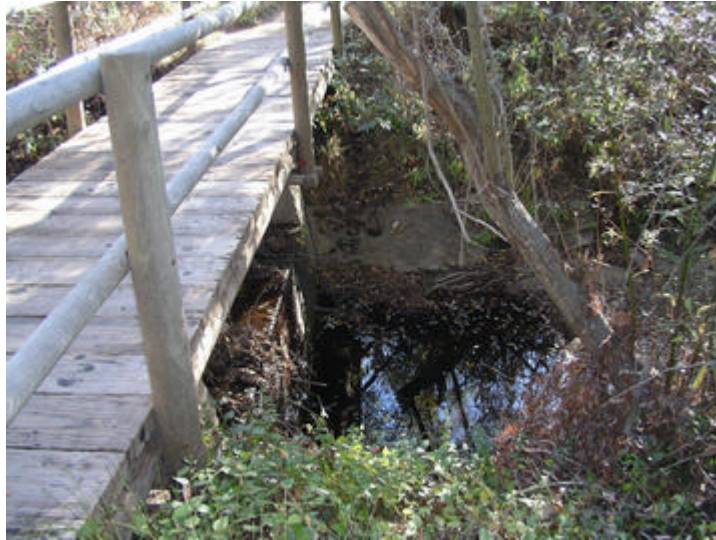
Description: This concrete footing measured 20 inches thick and crossed the entire stream channel. The height from the surface of the downstream pool to the top of the footing measured 2 feet 8 inches. The maximum pool depth measured 22 inches.

Diagnosis: During moderate and higher flows salmonids can migrate upstream of this structure with a low to moderate degree of difficulty due to the short jump height onto the concrete and short distance across the footing. Fish passage is prevented during very low flows due to the shallow water depth encountered on the concrete footing.

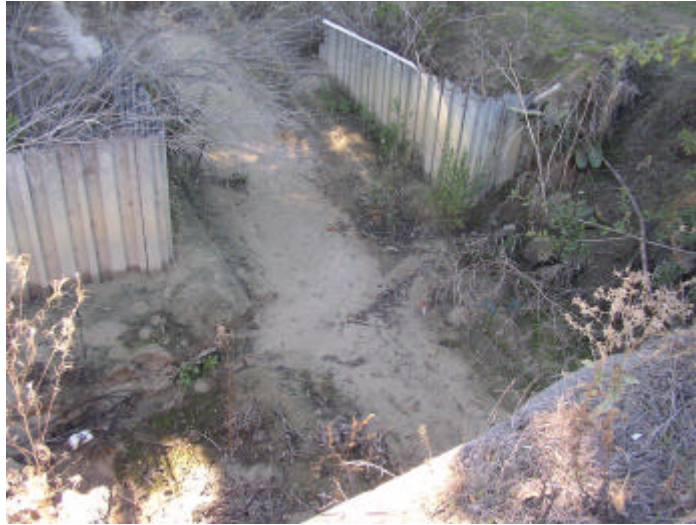
Metal revetment downstream from culvert

Description: Permission to ground survey this structure was not obtained and limited observations were made from Calle Lindero Road. This culvert appears to be a box culvert measuring approximately 40 feet long.

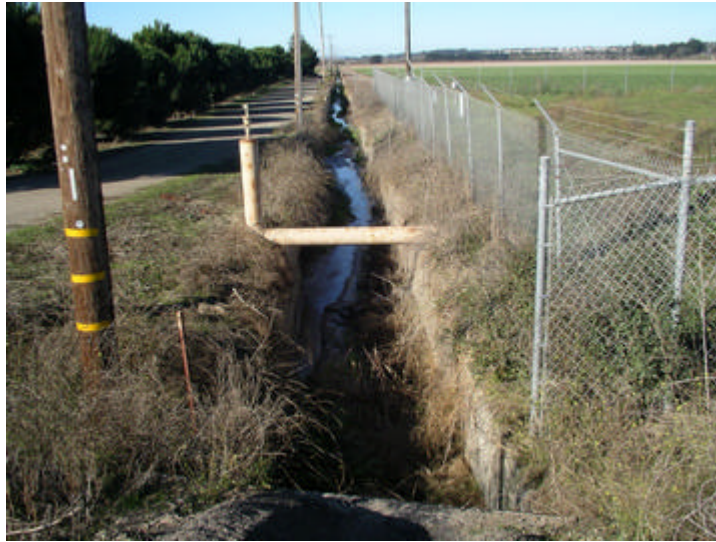
Downstream from Mission Gates Road Crossing

Description: Permission to survey this entire structure and adjacent private lands was not obtained and limited observations were made from public roads. This concrete channel is constructed with 4-foot tall walls and measured 6 feet wide at the base. The channel is relatively flat and has a small amount of deposited silt along the bottom.
