Steelhead Migration Barrier Inventory and Recovery Opportunities for the Santa Ynez River, Ca.

Prepared by:
Matt W. Stoecker
Stoecker Ecological Consulting

Prepared for:
Community Environmental Council
Santa Barbara, Ca.

January 29, 2004

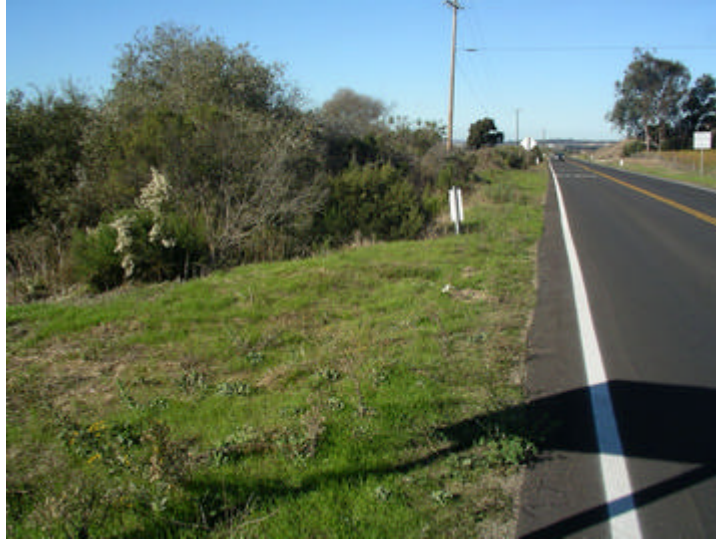
Description: Permission to ground survey this structure from adjacent private land was not obtained. Observations of this culvert crossing were made from Purisima Road and are limited in detail. Judged by the road width, the culvert measures approximately 100 to 120 feet in length.

Diagnosis: Additional information is needed to assess fish passage severity at this crossing, should passage upstream be warranted. Is likely that this culvert impedes passage to some degree during low and high flows due to insufficient flows and excessive water velocities, respectively.

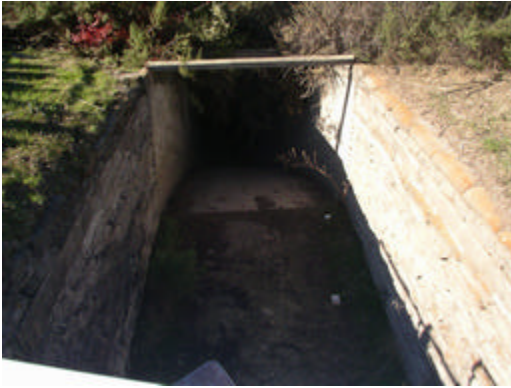
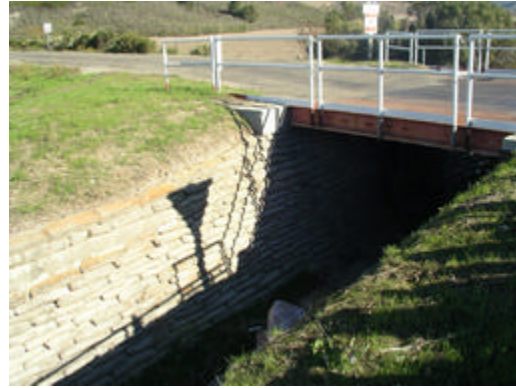
Description: This concrete channel is approximately 65 feet long. Sacrete walls that are 7 feet tall run the distance of the concrete channel for all but the downstream 20 feet. The downstream 20 feet of the concrete channel becomes an apron with a steep slope to the stream channel below. The apron drops a vertical height of approximately 10 feet. Concrete block walls extend downstream to the end of the structure for the last 20 feet.

Diagnosis: This is most likely a barrier during all flow conditions due to excessive velocities produced across the steep slope of the downstream apron and lack of resting areas. During high stream flows, the downstream channel may fill up enough to allow a difficult jump across the apron and onto the relatively flat channel bottom and facilitate extremely difficult upstream passage.

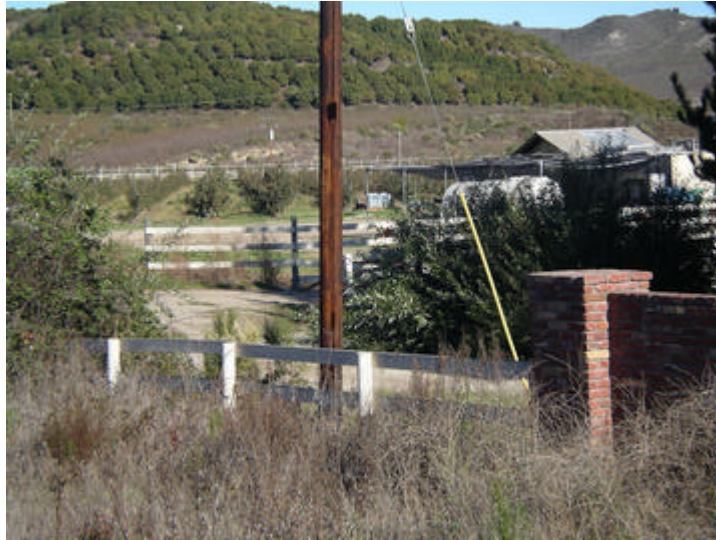
Description: Permission to survey this structure and adjacent private land was not obtained and limited observations were made from Cebada Canyon Road. The crossing appears to be a low-flow road that is constructed at or near streambed level.

Diagnosis: A more detailed assessment of the structure is needed to determine fish passage severity.

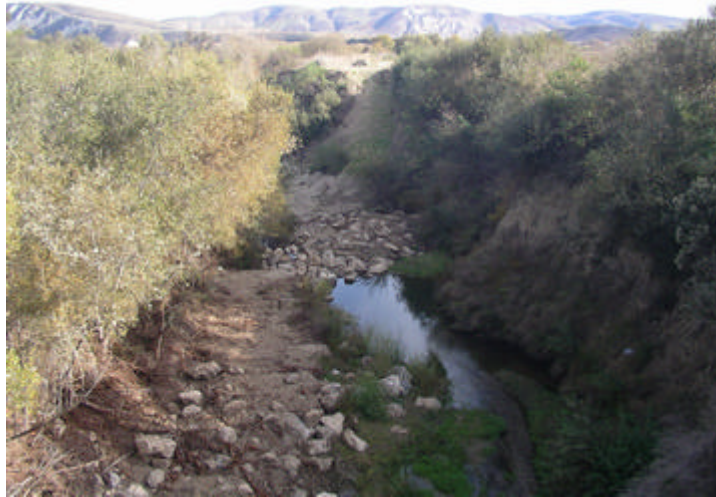
Description: Permission to ground survey this ford and adjacent stream channel was not obtained and limited observations were made from the Santa Rosa Road Bridge. This structure consists of medium to large boulders that have been placed in and across the creek channel. Tractor tread marks were present in the bottom of the stream channel and willow trees have been removed by large machinery. The structure was reportedly built by the County Roads Division as a control point (pers. comm. Engblom).

Diagnosis: This structure acts like a small dam and impedes stream flow, blocking fish passage. High flows will likely blow this temporary ford out, but moderate and low flow conditions before high flows may not be able to break apart the ford preventing salmonid passage. Reducing low and moderate flow salmonid migration in this highly important steelhead spawning and rearing tributary will significantly delay or prevent upstream migration.

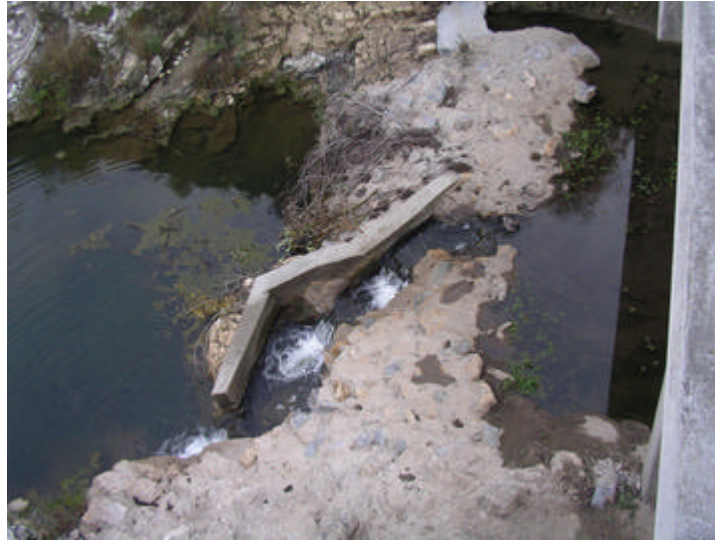
Barrier Status: Partial

Description: A boulder and concrete grade control structure occurs immediately downstream from the bridge and spans approximately 60 feet across the entire stream channel. The downstream length varies from approximately 12 to 20 feet. The vertical height from the top of the grade control to the surface of the downstream pool measured approximately 5 feet. The structure was modified to enhance upstream steelhead passage. A series of three pools were created in the grade control by notching them out and a concrete wall was constructed along the downstream river-right edge of the pools that angles toward the river-left and downstream pool. A low elevation point in the grade control was created at the upstream end of the step pools to focus low flows into the fishway.

Diagnosis: Prior to the construction of this fishway, the grade control was impassable during low-moderate flows due to the combined vertical and horizontal jump distance across the structure and shallow water depth on top. The existing fishway provides low to moderate flow fish passage for adult and juvenile steelhead by creating adequate water depth, jump heights, and resting pools across the structure. The structure and fishway have significantly improved the window of opportunity for salmonids to migrate upstream during a wider range of flows, but may continue to limit upstream migration of smaller salmonids during certain flow situations. During high flows, the capacity of the fishway is exceeded and water conditions inside may become too turbulent for salmonids to migrate through it. During these high flows, however, the downstream pool depth

increases to the point where adult steelhead can jump over the entire structure with a moderate degree of difficulty. Upstream juvenile migration may be prevented during these high flows, but the importance of their upstream migration during such high stream flows is questionable. The fishway design appears to be effective under current conditions and proper maintenance. The effectiveness of this fishway depends on the resting pools being free of substrate deposition and debris blockages.

Recommended Action: Continued monitoring and maintenance of this fishway and grade control is needed to ensure that the resting pools, concrete curb, and downstream pool provide adequate passage through the site. This site should be checked immediately following high winter flows to ensure that the fishway is free of debris and large substrate. A long-term consideration at this site, in coordination with maintenance plans and available funding, is the removal of the entire grade control structure, stabilization of the stream grade and bridge using biotechnical techniques, and creation of a naturalized stream channel. This option would provide the most effective and sustainable fish passage, reduce or eliminated maintenance and monitoring costs, and may provide significant downstream sediment movement benefits to the watershed.

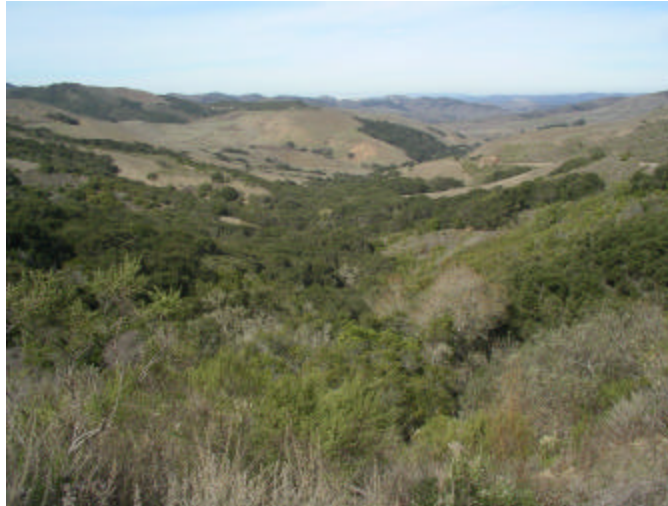
Barrier Status: Complete

Description: Permission to access and survey this upper reach of Salsipuedes Creek was not obtained and limited observation were made from the road. This natural steep gradient feature occurs immediately downstream from the upper Jalama Road crossing and extends downstream for several hundred feet. The stream in this reach is dry and does not appear to contain adequate salmonid habitat and flow.

Diagnosis: Further upstream steelhead migration is not likely due to the excessive gradient and lack of sufficient flow and adequate salmonid habitat.

Recommended Action: No recommended action for this natural feature.

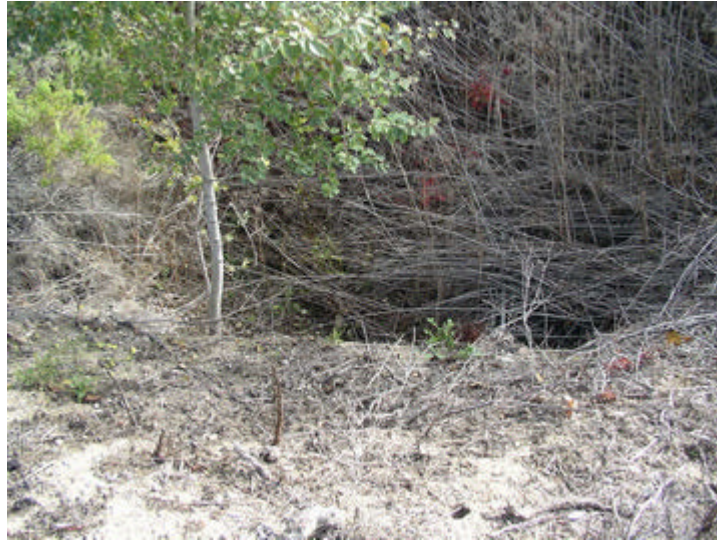
Barrier Status: Partial

Description: Permission to ground survey the stream channel adjacent to this crossing was not obtained and limited observations were made from Jalama Road. The box culvert appears to measure approximately 45 feet long and 5 feet wide by 6 feet tall inside. The downstream end of the culvert is at streambed level.

Diagnosis: Fish passage severity at this site could not be accurately determined, but is likely impeded due to shallow water depth or excessive velocities encountered within culverts of this type. This small and dry tributary may not contain adequate salmonid habitat upstream and may not warrant any fish passage project.

Recommended Action: Contact the landowner(s) to seek access to survey upstream habitat conditions and the crossing. Should adequate upstream salmonid habitat occur, fish passage alternatives should be identified and discussed with the County. Removal of the crossing and installation of a bridge that does not impact the stream channel would provide the most effective fish passage alternative and transportation option.

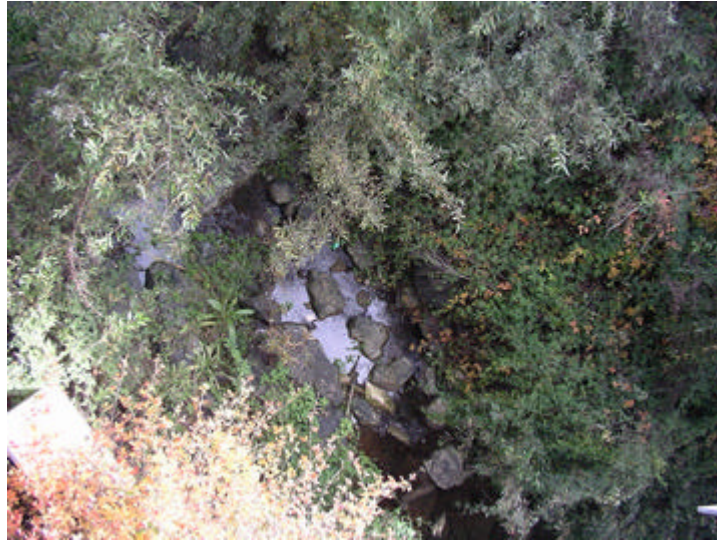
Barrier Status: Not a Barrier

Description: Permission to access and ground survey the private land adjacent to the crossing was not obtained and limited observations were made from Jalama Road. Boulders appear to have been placed in the stream channel and on the banks underneath the bridge. The boulders extend upstream for approximately 25 feet and downstream for approximately 45 feet. The stream channel still functions like a natural creek.

Diagnosis: No barrier was observed as a result of the boulders. Excellent salmonid habitat and late summer/fall stream flow occurs in this tributary. Three “springs” are shown to occur at the head of upstream tributaries that likely contribute to the observed surface flows at the crossing. This tributary appears to have adequate salmonid habitat and direct benefits for the steelhead population of Salsipuedes Creek.

Recommended Action: No recommended action.

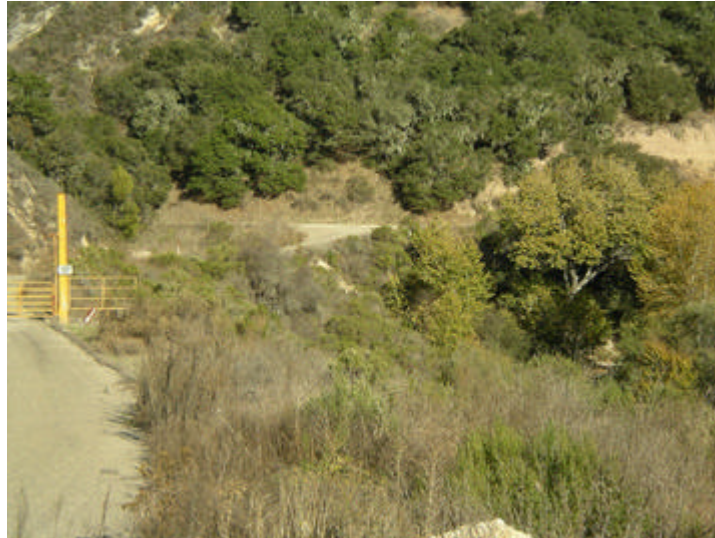
Barrier Status: Unknown

Description: Permission to ground survey the crossing and adjacent stream channel was not obtained and limited observations were made from Highway 1. The private crossing appears to be dirt fill on top of a culvert. This crossing occurs on Long Canyon Creek just upstream from the confluence with El Jaro Creek.

Diagnosis: Additional analysis is needed to determine the severity of this culvert. The culvert may be impassable to upstream migrating salmonids during low flows due to shallow flow conditions encountered in the culvert. During higher flows, excessive velocities through the culvert may limit or completely block any upstream passage.

Recommended Action: Providing effective passage at this site might provide a direct benefit to the existing Santa Ynez River/Salsipuedes Creek steelhead population. Contact the landowner(s) and seek permission to survey upstream habitat conditions and the crossing. If adequate salmonid habitat occurs upstream and a significant barrier is present at the crossing then fish passage alternatives should be identified and discussed with the landowner. The most effective solution for fish passage and transportation benefits would involve removal of the culvert and installation of a bridge.

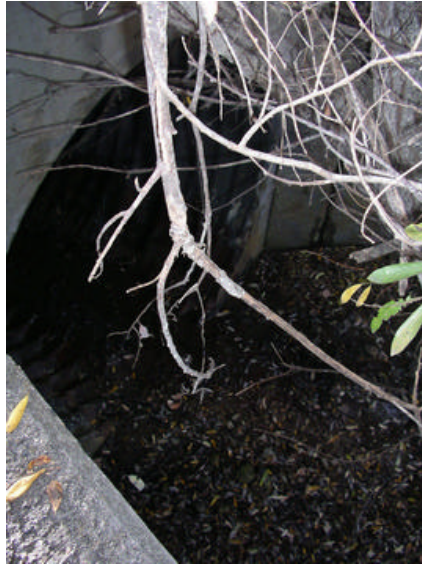
Barrier Status: Partial

Description: Permission to ground survey the private land adjacent to the culvert was not obtained and limited observations were made from Highway 1. This corrugated metal culvert measured 5 feet in diameter and approximately 275 feet long. Surface flow and adequate salmonid habitat were observed at the upstream end of this culvert.

Diagnosis: This culvert is most likely impassable to upstream migrating salmonids during low flows due to the shallow flow conditions encountered and small downstream jump. During higher flows, excessive velocities through the entire structure likely limit or completely block any upstream passage. During ideal moderate flow conditions, a large healthy adult may be able to swim through this structure with a high degree of difficulty. The presence of good surface flow during late-fall indicates that this tributary may provide valuable spawning and rearing habitat upstream for steelhead and fish passage should be improved at this site.

Recommended Action: Providing effective passage at this site would likely provide a direct benefit to the existing Santa Ynez River/Salsipuedes Creek steelhead population. Conduct a more detailed analysis of this crossing with landowner permission and CALTRANS involvement. Investigate passage alternatives at this site with CALTRANS. The most effective solution for fish passage and stream and transportation benefits would involve removal of the culvert and installation of a wide-span bridge.

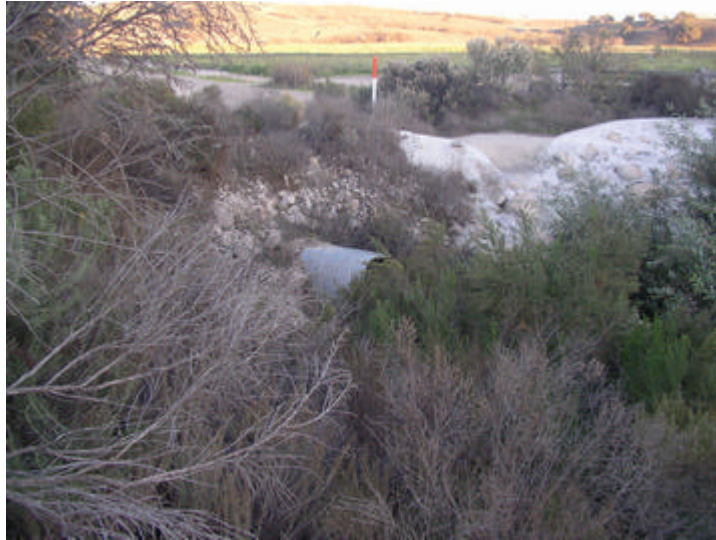
Barrier Status: Partial

Description: Permission to ground survey this crossing and adjacent channel was not obtained and limited observations were made from Drum Canyon Road. The culvert appears to be 3 to 4 feet in diameter and approximately 35 feet long. The downstream end of the culvert appears to be perched over 5 feet and the slope of the culvert steep.

Diagnosis: Fish passage severity at this site could not be accurately determined, but appears to be impassable due to the perched jump height and shallow water depth or excessive velocities encountered within the culvert. The culvert is likely undersized for a 100 year flow. The tributary may not contain adequate salmonid habitat or perennial flow and may not warrant fish passage improvements.

Recommended Action: Contact the landowner(s) to seek access to survey upstream habitat conditions and the crossing. Should adequate upstream salmonid habitat occur and a barrier exists at the crossing, fish passage alternatives should be identified and discussed with the crossing stakeholders. Removal of the crossing and installation of a bridge that does not impact the stream channel would provide the most effective fish passage alternative.

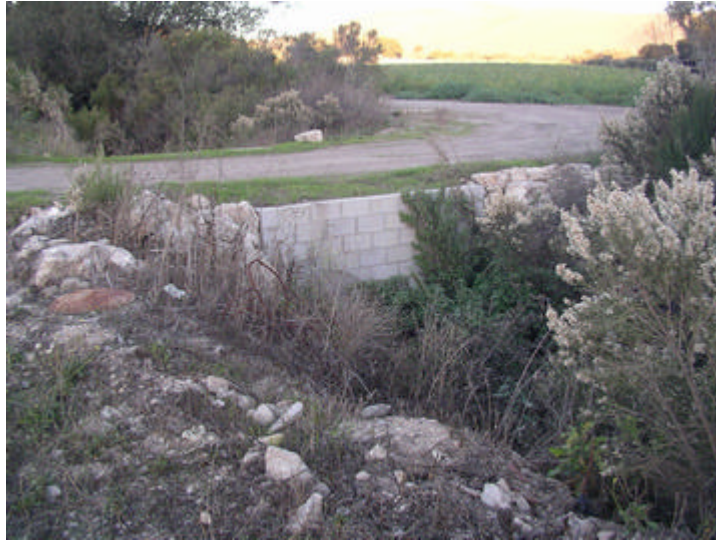
Barrier Status: Partial

Description: Permission to ground survey this crossing and adjacent channel was not obtained and limited observations were made from Drum Canyon Road. The culvert appears to be 3 to 4 feet in diameter and approximately 35 feet long. Walls constructed of concrete cinder blocks encase the ends of the culvert.

Diagnosis: Fish passage severity at this site could not be accurately determined, but may be impeded due to the shallow water depth or excessive velocities encountered within culverts of this type. The culvert is likely undersized for a 100 year flow. The tributary may not contain adequate salmonid habitat or perennial flow and may not warrant fish passage improvements.

Recommended Action: Contact the landowner(s) to seek permission to survey upstream habitat conditions and the crossing. Should adequate upstream salmonid habitat occur and a significant barrier be present at the crossing, fish passage alternatives should be identified and discussed with the crossing stakeholders. Removal of the crossing and installation of a bridge that does not impact the stream channel would provide the most effective fish passage alternative and transportation option.

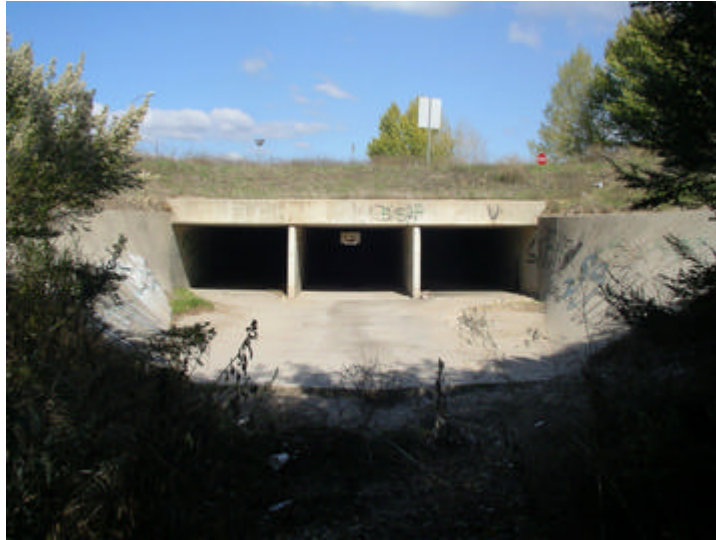
Barrier Status: Complete

Description: This culvert consists of three concrete boxes each measuring 8 feet wide by 5 feet tall. There is a 30-foot concrete apron at both the upstream and downstream end of the culvert. There is another 7 feet of recently poured concrete added to the downstream end of the downstream apron. The combined length of the culvert and aprons measured 353 feet long. The height from the lip of the downstream apron measured 3 inches to the downstream substrate. Wingwalls extend out for the length of the aprons both upstream and downstream of the culvert.

Diagnosis: This culvert is impassable to upstream migrating salmonids during low flows due to the shallow water depth encountered inside the culverts and on the aprons. Excessive velocities across the steep downstream apron and inside the culvert, in addition to the long distance of the structure, block upstream passage during moderate and high stream flows.

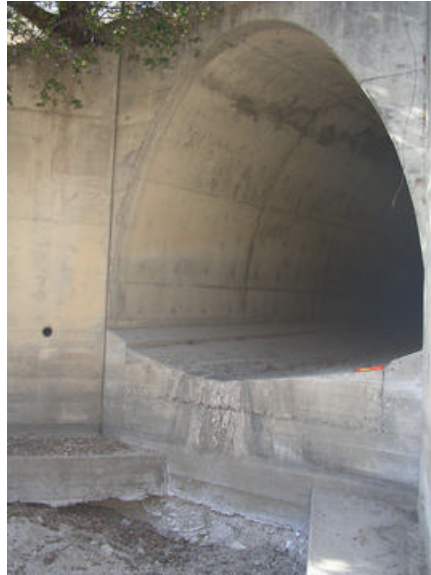
Barrier Status: Complete

Description: This culvert measured 12 feet tall by 13 feet wide, at the maximum base length, and 195 feet long. Angled wingwalls extend downstream from the culvert mouth on river-right for 35 feet and on river-left for 18 feet. The height from the downstream lip of the culvert bottom to the natural streambed below measured 5 feet 6 inches.

Diagnosis: Excessive jump height and shallow water depths inside the culvert would prevent any upstream salmonid passage during low flows. During moderate to high flows, the downstream pool will likely backfill to a depth that is adequate for adult salmonids to jump into the culvert. While adequate water depth inside the culvert occurs during migration flows, excessive water velocities, moderate slope, long culvert length, and lack of resting spots would likely prevent all upstream salmonid migration.

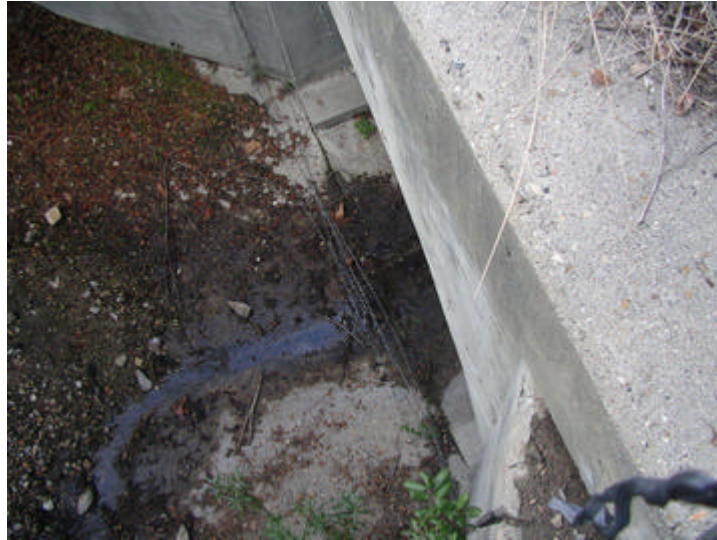
Barrier Status: Partial

Description: Permission to ground survey the crossing from adjacent private land was not obtained and limited observations were made from the upstream end of the culvert on top of Highway 101. No access to survey the downstream end of culvert was possible. This culvert is approximately 9 feet wide by 12 feet tall and 250 feet long. Angled wingwalls extend upstream for the length of the apron that measures approximately 20 feet long.

Diagnosis: Shallow water depth inside the culvert would prevent upstream salmonid passage during low flows. During moderate to high flows, adequate water depth inside the culvert occurs but, excessive water velocities, long culvert length, and lack of resting spots would likely prevent all upstream salmonid migration. Additional information about this culvert is needed to determine the fish passage severity.

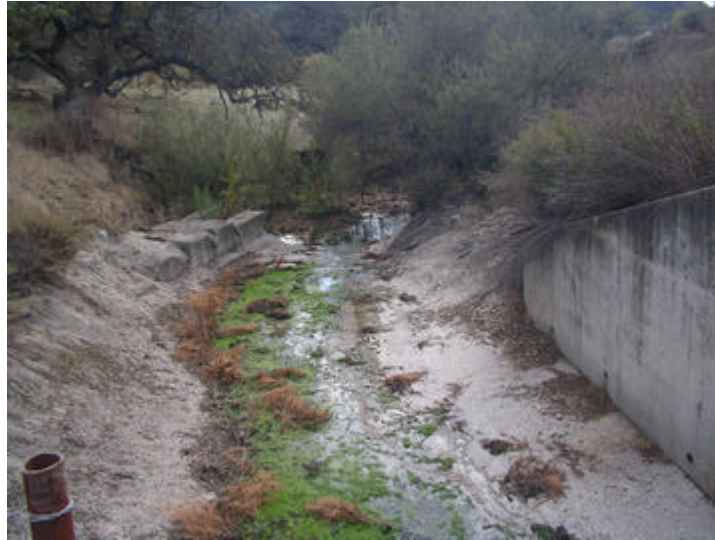
Barrier Status: Partial

Description: Permission to ground survey the crossing from adjacent private land was not obtained and limited observations were made from Highway 101. This culvert is approximately 8 feet wide by 12 feet tall and 300 feet long. From the top of the culvert the observed jump height from the surface of the downstream pool to the lip of the concrete apron appeared to be 2 feet. Angled wingwalls extend downstream for approximately 40 feet on river-right and for 25 feet on river-left.

Diagnosis: Shallow water depth across the downstream apron and inside the culvert would prevent any upstream salmonid passage during low flows. During moderate to high flows, adequate water depth for salmonids to swim or jump onto the apron and inside the culvert occurs. Excessive water velocities, long culvert length, and lack of resting spots would likely prevent all upstream salmonid migration through the culvert.

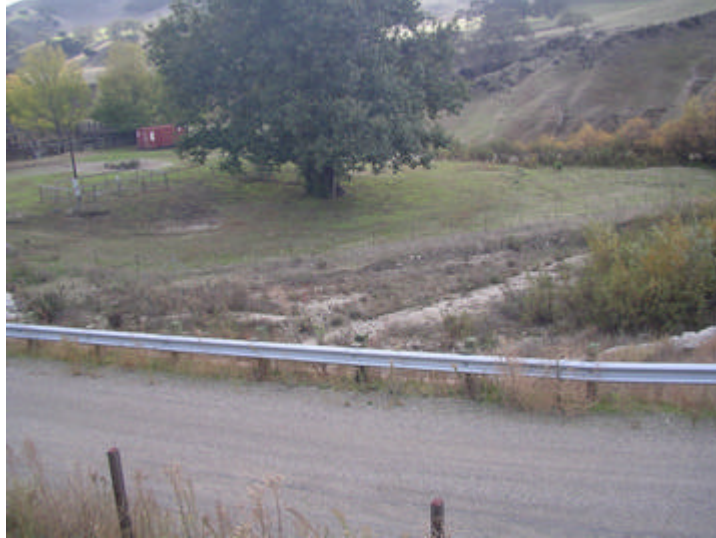
Barrier Status: Unknown

Description: Permission to ground survey the crossing from adjacent private land was not obtained and limited observations were made from Highway 101. This culvert has three separate roadways crossing over it and measures over 300 feet long. Two private roads cross the culvert on either side of Highway 101.

Diagnosis: Shallow water depth inside the culvert would likely prevent any upstream salmonid passage during low flows. Adequate water depth inside the culvert likely occurs during moderate to high flows but, excessive water velocities, extremely long culvert length, and lack of resting spots likely prevents all upstream salmonid migration.

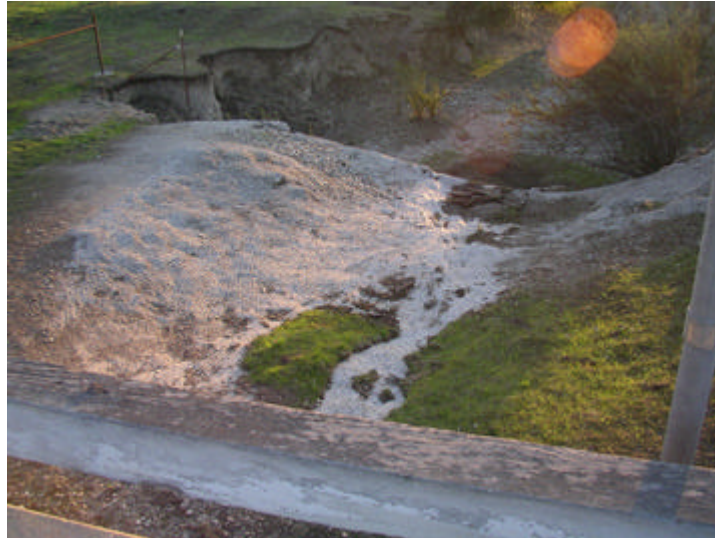
Barrier Status: Partial

Concrete apron below bridge

Description: Permission to access or ground survey the concrete apron from adjacent private land was not obtained and limited observations were made from Zaca Station Road. This concrete apron extends downstream from the bridge for approximately 25 feet. The height from the bottom of the downstream substrate up to the lip of the apron is approximately 5 feet. Downstream scour has undercut the apron and caused significant bank erosion. Natural substrate occurs underneath the bridge.

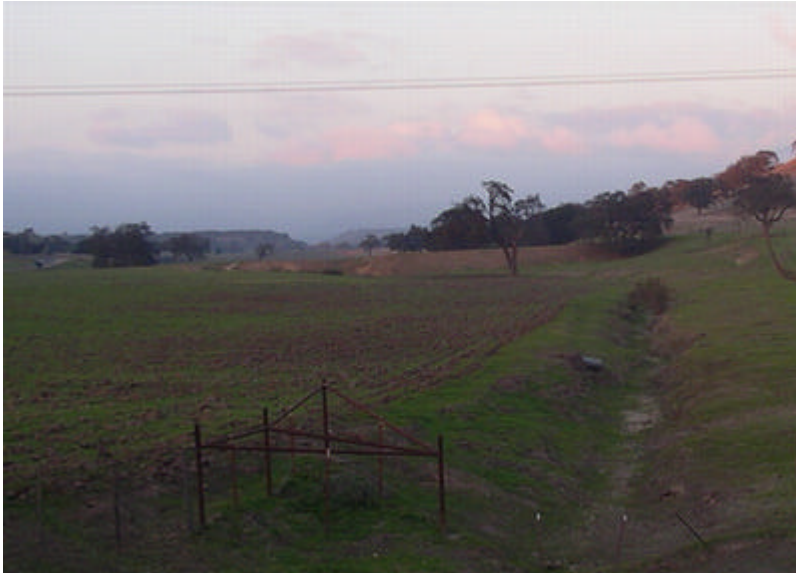
Barrier Status: Unknown

Description: Permission to ground survey the culvert was not obtained and limited observations were made from Zaca Station Road. One or two corrugated metal pipes with approximately 3-foot diameters appear to convey flows through an earth-fill crossing. The creek channel is extremely degraded throughout this reach.

Diagnosis: Fish passage would likely be prevented during low flows due to shallow water conditions that occur inside the culvert(s). During high water flow, excessive water velocities inside the culvert(s) would limit the ability of salmonids to migrate upstream.

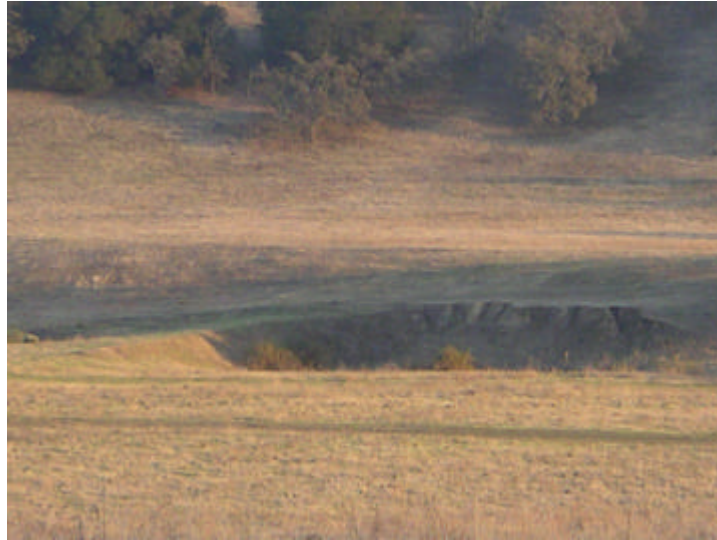
Barrier Status: Unknown

Description: Permission to ground survey the crossing was not obtained and limited observations were made from Zaca Station Road. Presumably this earthen crossing has one or more corrugated metal pipes associated with it, as do the others downstream.

Diagnosis: Fish passage would likely be prevented during low flows due to shallow water conditions that occur inside the culvert(s). During high water flow, excessive water velocities inside the culvert(s) would likely limit the ability of salmonids to migrate upstream. Limited upstream passage may be possible during ideal, moderate flows.

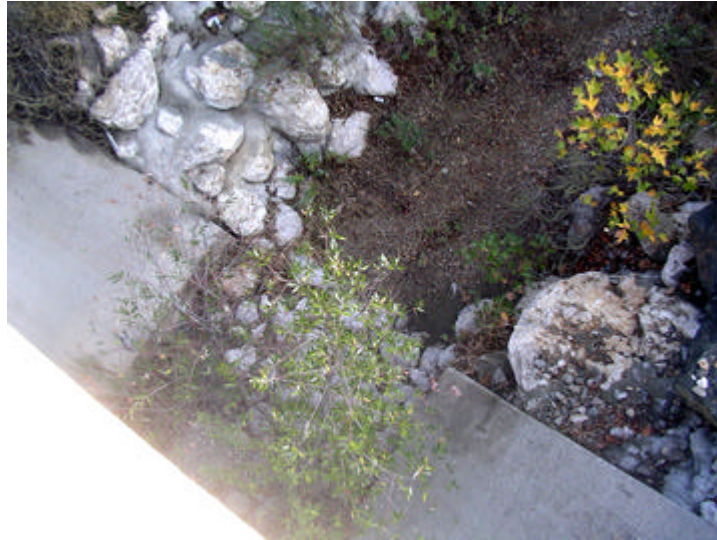
Barrier Status: Partial

Description: Permission to ground survey the adjacent stream channel was not obtained and limited observations were made from the Foxen Canyon Road Bridge. Sloping concrete revetment walls have been constructed underneath the bridge, but do not extend into the streambed. Small boulder revetment occurs between the sloping walls and on the streambed. Upstream boulder and concrete revetment occurs on the banks.

Diagnosis: While water velocities may be slightly accelerated as they are confined between the bank revetments, salmonid passage is not significantly impeded at this site. The small boulder revetment in the channel is at grade level and sufficiently rough to allow upstream migration during all migration flows.

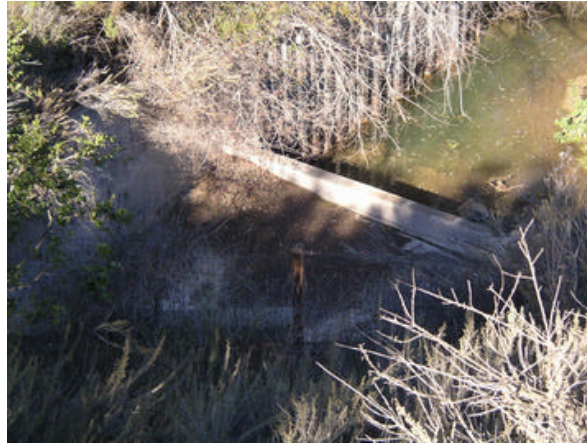
Barrier Status: Complete

Description: Permission to ground survey the private lands adjacent to the culvert was not obtained. Limited observations of this culvert crossing were made from Highway 101. A concrete apron with wingwalls extends downstream from a concrete box culvert for approximately 25 feet. Metal wall revetment 10 feet tall extends 20 feet further downstream from the apron at river-left. There is a concrete curb across the downstream end of the apron that measured approximately 1-foot taller than the apron and is approximately 10 inches thick. A small notch in the curb and the apron has been worn or created. The height from the top of the concrete curb at the downstream end of the apron to the surface of the downstream pool measured approximately 3 feet. The downstream pool depth was less than 12 inches deep. The total length of the culvert appears to be greater than 300 feet.

Diagnosis: High quality salmonid habitat occurs in Nojoqui Creek upstream of this barrier and *O. mykiss* was trapped migrating into the creek in 1997 (pers. comm. Engblom). The excessive length of the culvert and the absence of resting areas for fish prevents upstream migration at this site. Entrix has conducted a detailed analysis of this culvert and identified it as an impassable velocity barrier (pers. comm. Engblom).

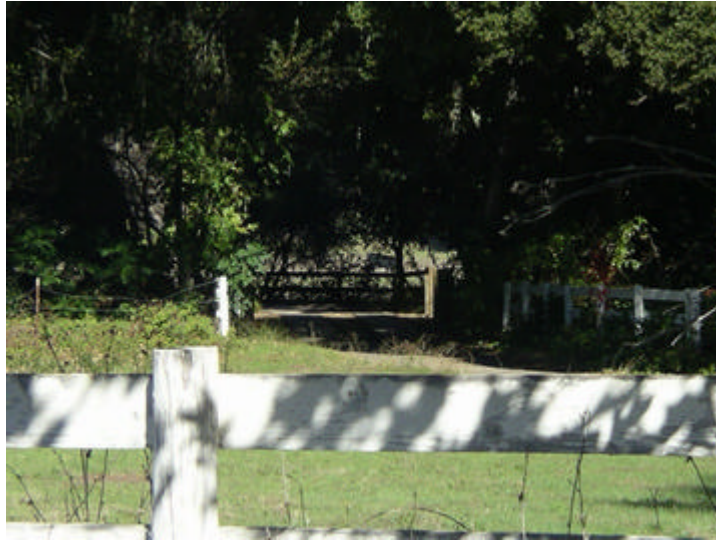
Barrier ID: SY_NI_6
Stream: Nojoqui Creek
Barrier Type: Bridge
Physical Location: Folded Hills Ranch Bridge
GPS Location: N/A
Ownership/Interest: Private
Surveyor(s) and Date: Shaw Allen 11/20/03
Barrier Status: Unknown

Description: Permission to ground survey this structure was not obtained and this limited observation was made from Alisal Road. The bridge appears to be constructed of wood and steel. No observations of the stream channel could be made.

Diagnosis: The stream channel was not observed and fish passage not assessed.

Recommended Action: Seek landowner permission to further assess fish passage and channel conditions at the crossing.

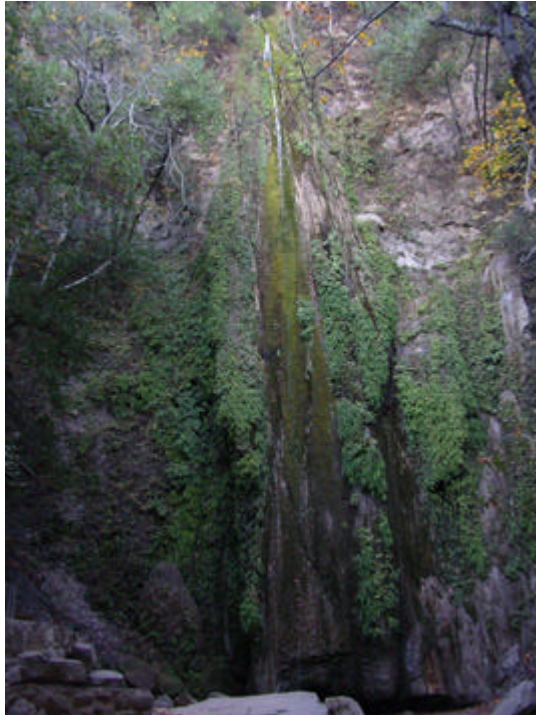
Description: This spectacular waterfall is well over 75 feet tall and composed of solid bedrock.

Diagnosis: This is the natural upstream limit for salmonid migration due to the excessive height.

Recommended Action: No recommended action for this natural feature.

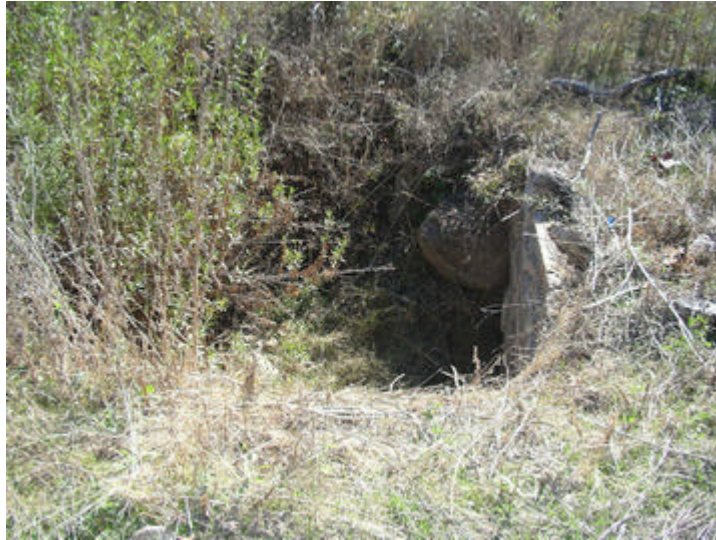
Description: Permission to ground survey land adjacent to this structure was not obtained and limited observations of this culvert crossing were made from Alisal Road. The downstream end of the culvert was not visible from the public roadway road. Based on the roadway and fill length this culvert is approximately 50 feet long.

Diagnosis: This culvert likely impedes salmonid passage to some degree due to the length and confined natural of culverts.

Recommended Action: Seek landowner permission to further assess this culvert and upstream salmonid habitat conditions. Should adequate salmonid habitat conditions occur upstream, assess hydraulic and channel conditions at the crossing and investigate passage alternatives at this site with the County. The most effective solution for fish passage is removal of the culvert and installation of a bridge or large embedded culvert.

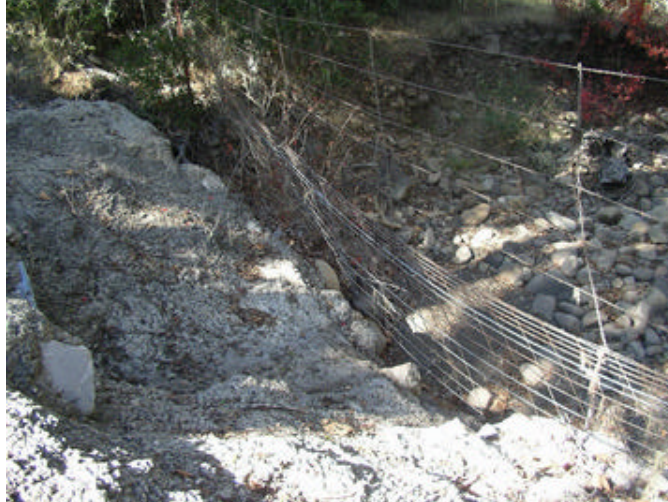
Description: This 4-foot diameter corrugated metal culvert pipe measures 40 feet long and is encased in concrete. There is a concrete and boulder riprap apron extending downstream for 9 feet below the culvert pipe. The height from the lip of the downstream end of the culvert pipe to the creek bed is 4 feet. The rust line inside the culvert pipe indicates that water depths up to 1-foot occur in the culvert pipe during winter flows. Many woodpeckers were flying around while surveying this structure and so this unnamed creek was named.

Diagnosis: This structure is impassable to all salmonids during low flows due to the lack of adequate water depth on the apron and inside the culvert. The downstream pool appears to backfill during migration flows to a depth of 2 to 3 feet. During moderate to high flows salmonids should be able to jump from the downstream pool into the culvert with a moderate degree of difficulty. During these migration flows, excessive water velocities will occur inside the culvert and the absence of resting areas will impede or prevent upstream passage for salmonids. The culvert appears to be undersized for a 100-year flow.

Recommended Action: Seek adjacent landowner permission to further assess upstream habitat potential for salmonids. If adequate conditions occur, investigate passage alternatives with the County. The most effective solution for fish passage is removal of the culvert and installation of a bridge.

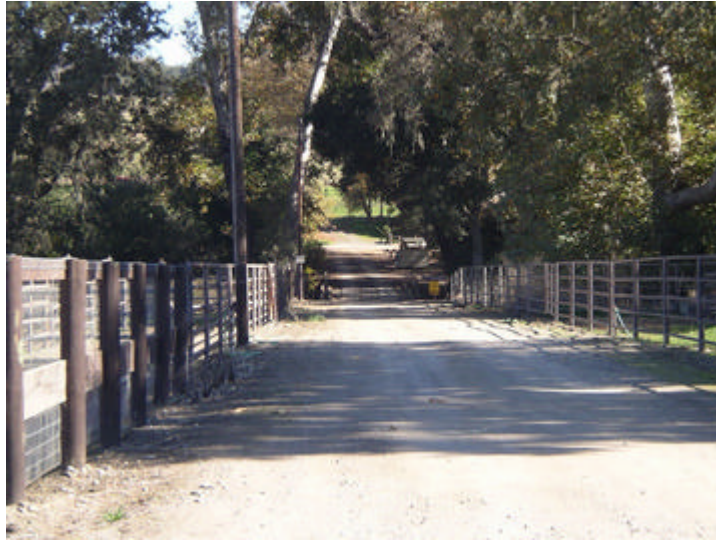
Description: Access to ground survey this bridge was not obtained and observations are limited to the bridge itself. The stream channel and potential instream structures could not be observed.

Diagnosis: Passage conditions at this site are unknown.

Recommended Action: Contact landowner and seek access to survey the channel at this site.

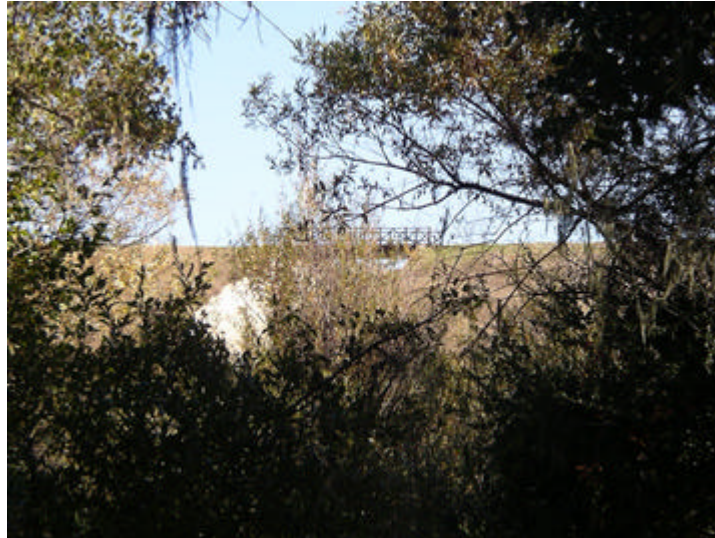
Description: Access to ground survey this dam was not obtained and observations were limited to the adjacent private road. The following information was obtained from Department of Water Resources (1988). Alisal Dam is an earth-filled structure with a crest height of 28 feet, crest length of 1,100 feet, and an original storage capacity of 2,342 acre-feet (pers. comm. Capelli).

Diagnosis: Fish passage facilities are not known to exist at this dam and therefore upstream fish passage is likely not possible. Water releases from this dam likely dramatically influence downstream steelhead habitat in Alisal Creek and migratory connectivity. This large dam prevents upstream steelhead migration to several miles of stream habitat to as many as 6 tributaries with sources in the Los Padres National Forest.

Recommended Action: Stream habitat is known to exist upstream of this dam in several tributaries that drain from the Los Padres National Forest. Providing steelhead passage up Alisal Creek to, and potentially past, the dam could have significant benefits to the existing Santa Ynez River steelhead population. Fish passage discussions should be initiated with the owner(s) and relevant stakeholders and access sought to survey the dam and surrounding stream reaches, including the tributary habitat upstream of the dam and natural limits to salmonid migration. Adequate salmonid habitat is reported to occur downstream of the dam and golfers at Alisal have reported several recent observations of adult steelhead in the lower creek (pers. comm. Engblom).

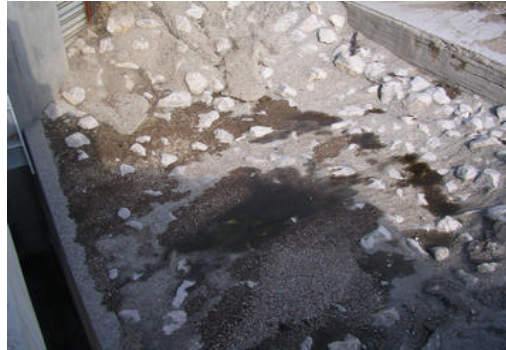
Description: This structure was observed from the road without access to adjacent private property. The structure is an awkward combination of what appears to be the remnants of an old bridge crossing and the addition of grade control features designed to protect the newer Figueroa Mountain Road Bridge. Immediately upstream from the newer bridge there is a concrete wall across the stream channel that is approximately 13 feet tall and 1 foot thick. Concrete and boulder riprap extends upstream from the wall for approximately 25 feet to the remains of an old bridge structure. The upstream structure consists of a concrete channel and walls. The lip of this upstream concrete channel drops approximately 3 feet down to the riprap below. The upstream concrete channel is approximately 18 feet wide and 50 feet long.

Diagnosis: The excessive 13-foot height of the downstream concrete wall and lack of downstream pool represent what appears to be an impassable structure (having only viewed it during dry flow conditions). Should the downstream channel fill up with 6-7 feet of water depth during high stream flows, this structure may provide limited, extremely difficult upstream passage for adult steelhead. Even with this situation, there would be limited upstream resting areas, lack of pool depth for the 3-foot jump upstream, and extremely turbulent water and excessive velocities throughout this reach. Scott Engblom reported that *O. mykiss* were observed in the creek approximately 3 years ago.

Recommended Action: This lowest observed downstream barrier might directly block endangered Santa Ynez steelhead from accessing fair to good quality habitat in the upper headwaters (Birabent Canyon). More detailed channel and hydraulic information should be collected, with private landowner permission, and an alternatives analysis completed to determine feasible options for fish passage at this site. Additional barrier surveying downstream on private land should be conducted. Removal of the entire structure and replacement with a bridge would provide the most effective fish passage solution.

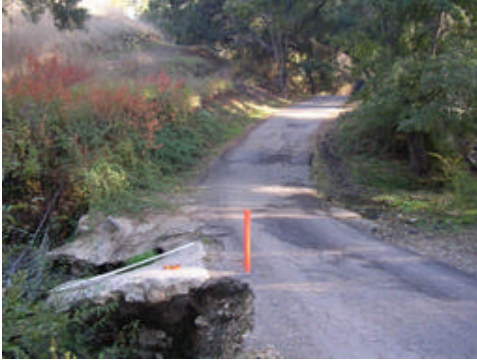
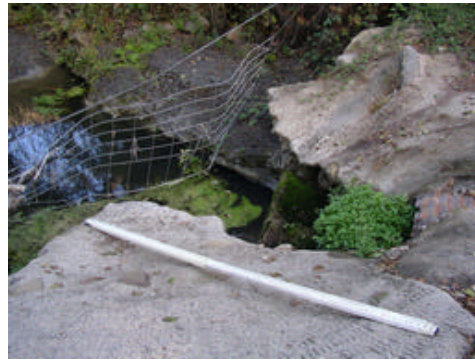
Description: This low-flow road crossing measured 18 feet wide and spans the active stream channel for 36 feet. There is a 1-foot diameter corrugated metal culvert pipe in the center of the crossing with 2 inches of sediment deposited on the bottom. A riprap apron has been added to the downstream side of the road crossing. This apron extends downstream for a maximum length of 9 feet and crosses the stream channel for 30 feet before a 10-foot section at the river-left side broke off. This entire apron is severely undercut and broken. A 6-foot long notch has been worn through the apron directly below the culvert pipe. The height from the downstream pool surface to the top of the road measured 4 feet. The maximum pool depth measured 2 feet 6 inches.

Diagnosis: The downstream pool appears to backfill to a depth of approximately 4 to 5 feet during moderate to high flows. With the notch in the apron, the distance across the road to the upstream pool is reduced to 21 feet. This low-flow crossing is impassable during low flows due to insufficient water depth across the road surface and jump height. The crossing may become passable for adult steelhead during moderate to high flows due to the sufficient jump depth produced and adequate water depth across the relatively short and flat crossing. The crossing will only be passable when there is enough flow to create a sufficient downstream pool depth and water depth over the road.

Recommended Action: The County is reportedly planning to remove this severe barrier and replace it with a bridge, allowing unimpeded upstream fish passage (pers. comm. Engblom). The County plan to replace this crossing with a bridge is highly encouraged and recommended.

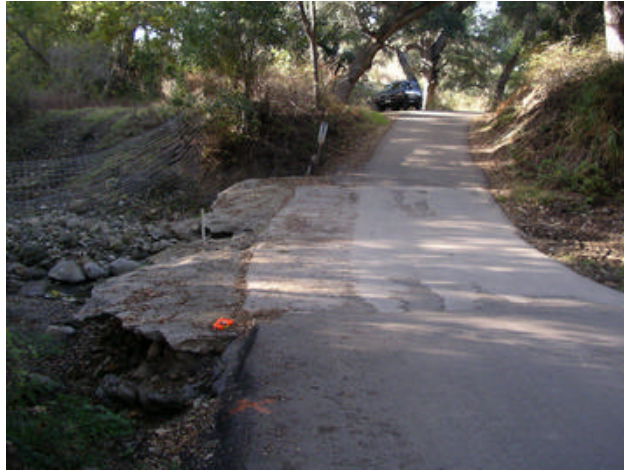
Description: This low-flow crossing is 20 feet wide and crosses the active channel for 43 feet. There is a 1-foot diameter corrugated metal culvert pipe in the center of the crossing. A riprap apron extends downstream for a maximum of 6 feet and is severally undercut and damaged. The apron has a 4-foot long notch worn directly below the culvert pipe. The height from the surface of the downstream pool to the downstream lip of the road crossing measured 4 feet 3 inches. The maximum pool depth measured 4 inches.

Diagnosis: The downstream pool shows signs that it fills up to a depth of at least 2 to 3 feet during winter flows. The distance across the road from upstream edge of the notch in the apron measured 22 feet. During lower flows the crossing is impassable to all salmonids due to insufficient water depth across the road and excessive jump height and limited downstream pool depth. During moderate to high flows the downstream pool likely develops sufficient jump depth to allow a moderately difficult jump onto the road and sufficient water depth across the road to allow for moderate to highly difficult passage. Excessive water velocities across the road during high flows may prevent passage to some/all salmonids.

Recommended Action: COMB has proposed to modify the existing crossing with a low-flow channel, upstream vortex weir, and downstream roughened ramp fishway. More project detail is outlined on the COMB website. The CDFG and NMFS are apparently considering this proposed action and considering other alternatives (pers. comm. Engblom). Modifying the existing crossing, as proposed, is not recommended and is not a preferred alternative of either agency. The most effective fish passage project and transportation safety improvement is to remove the crossing and replace it with a bridge.

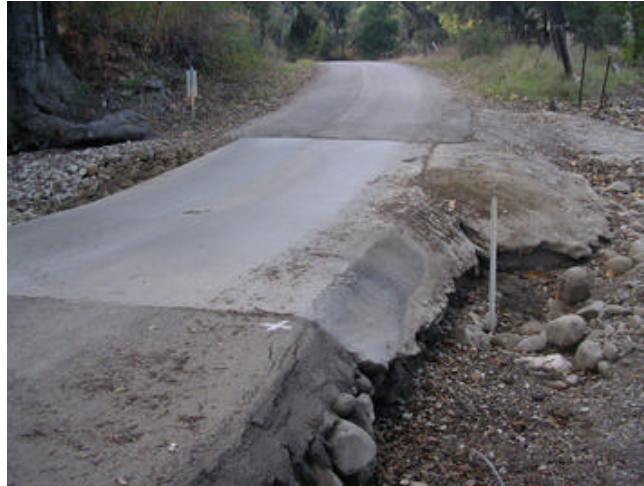
Description: This low-flow road crossing measured 18 feet wide and crosses the active stream channel for 50 feet. There is a 1-foot diameter corrugated metal culvert pipe in the center of the crossing. A riprap apron has been added to half of the crossing on the downstream river-left side. The apron extends downstream for a maximum length of 9 feet. The other half of the road crossing, without a riprap apron, has been severally undercut. The height from the downstream substrate to the top of the road crossing measured 3 feet 8 inches.

Diagnosis: This crossing is impassable to all salmonids during low flows when insufficient water depth is spread out over the road crossing and minimal jump pool depth and excessive jump height prevent access to the road crossing. During moderate to high flow conditions the downstream pool depth and water depth across the road is sufficient to allow steelhead to make a moderately difficult jump and swim across the road. Excessive velocities across the road during high flows and spread out shallower flows during moderate flows may severely impede or prevent upstream passage.

Recommended Action: COMB has proposed to modify the existing crossing with a low-flow channel, upstream vortex weir, and downstream roughened ramp fishway. More project detail is outlined on the COMB website. The CDFG and NMFS are apparently considering this proposed action and considering other alternatives (pers. comm. Engblom). Modifying the existing crossing, as proposed, is not recommended and is not a preferred alternative of either agency. The most effective fish passage project and transportation safety improvement is to remove the crossing and replace it with a bridge.

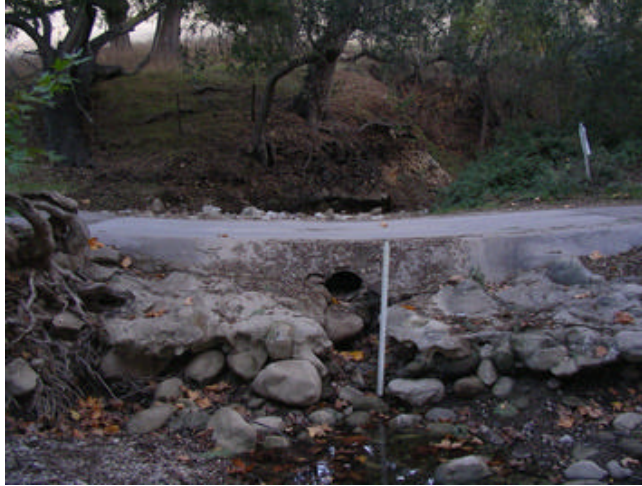
Description: This low-flow crossing measured 18 feet wide at the road surface and crosses the channel for 29 feet. There is a 1-foot diameter corrugated metal culvert pipe in the center of the crossing. A riprap apron extends downstream for 6 feet and is considerably undercut and cracked. The apron has a 4-foot long notch worn directly below the culvert pipe. The height from the surface of the downstream pool to the top of the road crossing measured 4 feet 9 inches. The maximum pool depth measured 4 inches.

Diagnosis: The downstream pool appears to fill up to a depth of 3 feet during moderate to high winter flows. The upstream distance across the road at the notch in the apron measured 20 feet. This crossing is impassable during low and possibly moderate flows due to insufficient downstream jump pool depth, excessive jump height, and insufficient water depth across the road surface. During higher flows the downstream pool depth will allow salmonids to jump onto the road surface, but excessive water velocities across the surface may limit/prevent upstream passage for smaller steelhead. A narrow window of ideal flows will likely pass some larger steelhead for a short duration of flows.

Recommended Action: COMB has proposed to modify the existing crossing with a low-flow channel, upstream vortex weir, and downstream roughened ramp fishway. More project detail is outlined on the COMB website. The CDFG and NMFS are apparently considering this proposed action and considering other alternatives (pers. comm. Engblom). Modifying the existing crossing, as proposed, is not recommended and is not a preferred alternative of either agency. The most effective fish passage project and transportation safety improvement is to remove the crossing and replace it with a bridge.
