Steelhead Migration Barrier Inventory and Recovery Opportunities for the Santa Ynez River, Ca.

Prepared by:
Matt W. Stoecker
Stoecker Ecological Consulting

Prepared for:
Community Environmental Council
Santa Barbara, Ca.

January 29, 2004

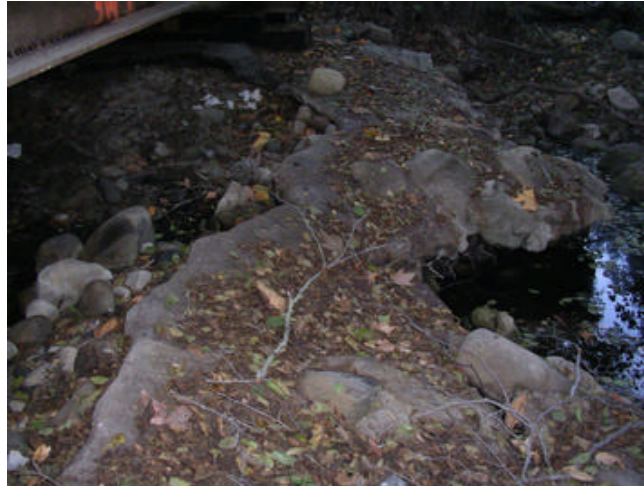
Description: The original low-flow road crossing has been replaced with a steel and wood bridge that appears to be temporary. The riprap apron that was attached to the downstream end of the original road crossing still exists across most of the stream channel. The apron extends downstream for a maximum distance of 6 feet. A notch exists where the 1-foot diameter corrugated metal culvert pipe ran under the old crossing. An 8-foot long section of the culvert pipe remains. At the notch, the apron length to the upstream pool measures 3 feet. The height from the surface of the downstream pool to the upstream end of the riprap apron measured 2 feet 8 inches. The maximum downstream pool depth measured 1-foot 8 inches. The apron is undercut and damaged.

Diagnosis: The riprap apron is passable during moderate to high flows when sufficient water depth in the downstream pool allows salmonids to jump over the apron. During lower flows the apron is impassable due to the lack of jump-pool depth, excessive jump height, and subsurface flows under the apron.

Recommended Action: The County is reportedly planning to replace this temporary bridge with a permanent bridge, allowing unimpeded upstream fish passage (pers. comm. Engblom). The County plan to install a bridge at this site is highly encouraged and recommended. The remnant apron should be completely removed to allow unimpeded passage during all flow conditions.

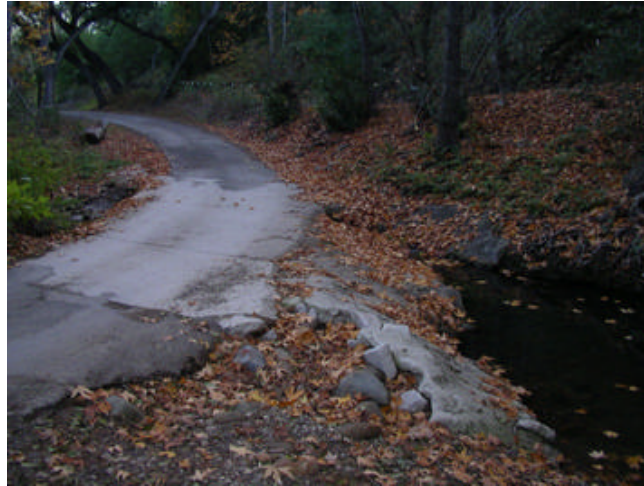
Description: This low-flow road crossing measured 18 feet wide and crosses the stream channel for 35 feet. A 1-foot diameter corrugated metal culvert pipe passes under the road at the river-left side of the crossing. A boulder and concrete riprap apron extends downstream at a steep angle for 7 feet. Surface flow was observed spilling out of the culvert pipe. The height from the downstream pool surface to the top of the road surface measured 2 feet 10 inches. The downstream pool depth measured 2 feet 6 inches.

Diagnosis: This low-flow crossing is impassable during low flows due to insufficient water depth across the road surface. The culvert diameter is very small and likely produces excessive velocities and/or shallow depth for upstream passage in addition to having a very small area to jump into. During higher flows the downstream pool depth will allow salmonids to jump onto the road surface, but excessive water velocities across the surface may limit/prevent upstream passage for smaller steelhead. A narrow window of ideal flows will likely pass some larger steelhead for a short duration.

Recommended Action: COMB has proposed to modify the existing crossing with a low-flow channel, upstream vortex weir, and downstream roughened ramp fishway. More project detail is outlined on the COMB website. The CDFG and NMFS are apparently considering this proposed action and considering other alternatives (pers. comm. Engblom). Modifying the existing crossing, as proposed, is not recommended and is not a preferred alternative of either agency. The most effective fish passage project and transportation safety improvement is to remove the crossing and replace it with a bridge.

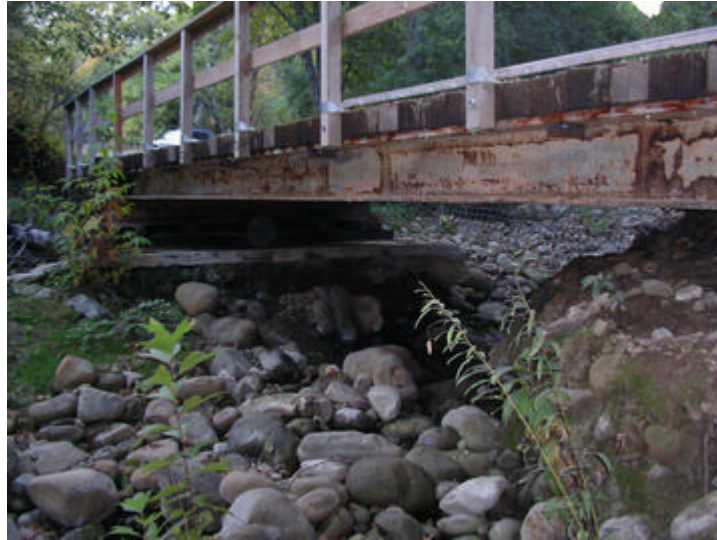
Description: The old low-flow road crossing has been removed and replaced with a steel and wood bridge to allow unimpeded salmonid passage at this former barrier site. The bridge may be temporary. Most of the old low-flow crossing has been removed, except for a small section on river right, which is now being used as a foundation for the bridge on that side of the creek. A natural streambed now exists underneath the bridge.

Diagnosis: This former low-flow crossing barrier, that was similar to the many crossings downstream, has been removed and replaced with a bridge and natural streambed allowing unimpeded fish passage.

Recommended Action: The County is reportedly planning to remove this severe barrier and replace it with a bridge, allowing unimpeded upstream fish passage (pers. comm. Engblom). The County plan to install a permanent that does not impact the channel is highly encouraged and recommended.

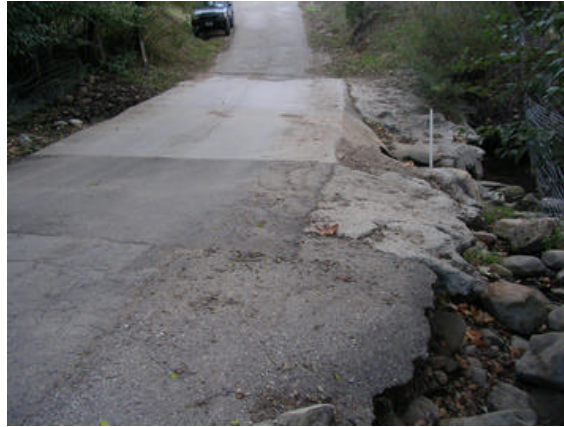
Description: This low-flow road crossing measured 18 feet wide and crosses the stream channel for 30 feet. There is a 1-foot diameter corrugated metal culvert pipe passing under the center of the road crossing. A riprap apron extends downstream for a maximum of 6 feet. A notch in the apron has been scoured out below the culvert pipe. The apron and road have been severally undercut. The upstream end of the road has filled up with deposited sediment. A recent effort has been made to dig out the sediment at the upstream opening of the culvert pipe. The height from the downstream substrate to the top of the downstream edge of the road measured 3 feet 6 inches.

Diagnosis: This crossing is impassable during low and possibly moderate flows due to insufficient downstream jump pool depth, excessive jump height, and insufficient water depth across the road surface. During higher flows the downstream pool depth will allow salmonids to jump onto the road surface, but excessive water velocities across the surface may limit/prevent upstream passage for smaller steelhead. A narrow window of ideal flows will likely pass some larger steelhead for a short duration.

Recommended Action: COMB has proposed to modify the existing crossing with a low-flow channel, upstream vortex weir, and downstream roughened ramp fishway. More project detail is outlined on the COMB website. The CDFG and NMFS are apparently considering this proposed action and considering other alternatives (pers. comm. Engblom). Modifying the existing crossing, as proposed, is not recommended and is not a preferred alternative of either agency. The most effective fish passage project and transportation safety improvement is to remove the crossing and replace it with a bridge.

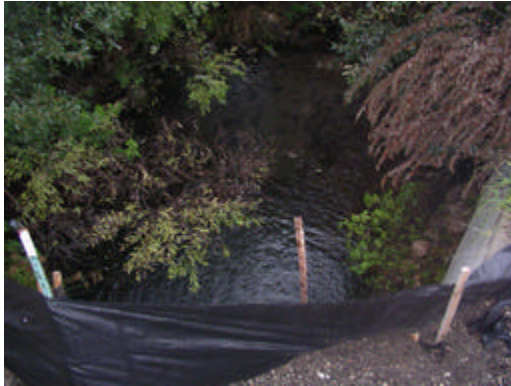
Downstream pool

Description: Permission to ground survey the crossing from adjacent private land was not obtained and limited observations were made from Highway 246. This concrete box culvert is approximately 50 feet long and has angled wingwalls extending downstream for approximately 20 feet. Angled wingwalls extend upstream for approximately 15 feet. The height from the surface of the downstream pool to the lip of the concrete culvert bottom was approximately 5 feet. The downstream pool depth was approximately 2 feet. Excellent late summer/fall stream flows and adequate salmonid spawning and rearing habitat occurs in this stream reach.

Diagnosis: Excessive downstream jump height and shallow water depth inside the culvert prevents any upstream salmonid passage during low flows. During moderate to high flows, adequate water depth in the downstream pool and inside the culvert will develop but excessive water velocities, culvert length, and lack of resting spots may prevent upstream salmonid migration. Extremely limited and difficult upstream migration may be possible during ideal moderate flow conditions depending on the culvert.

Recommended Action: Providing improved passage at this sight may provide a direct benefit to the existing steelhead population of the Santa Ynez River. Conduct a more detailed analysis of this structure, adjacent stream channel, and overall stream habitat with landowner permission. Identify alternatives for fish passage at this site with CALTRANS. The most effective fish passage and stream restoration alternative would be to remove this entire structure and replace it with a bridge that does not impact the stream channel.

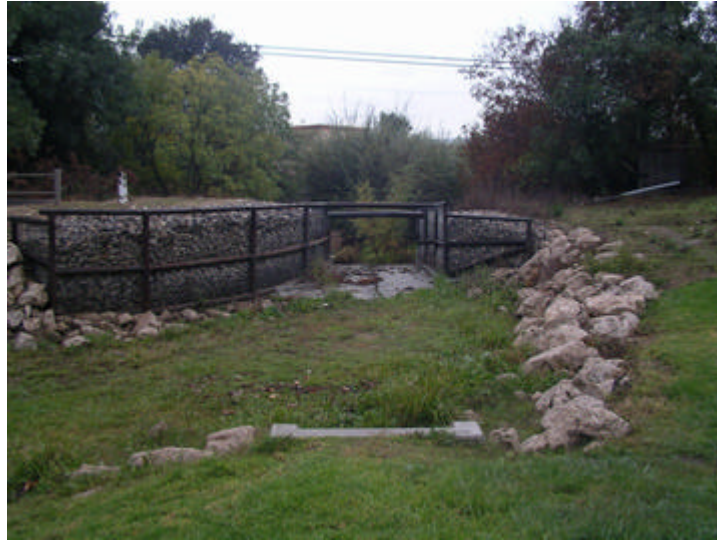
Description: This concrete apron extends approximately 40 feet between pipe and wire revetment that is filled with small stone and surrounded by bank-lined boulder revetment. The width of the concrete-lined streambed measured 12 feet between the bank revetments. The walls of the pipe and wire revetment measured 6 feet tall. The structure occurs at the downstream end of Santa Ynez County Park. The park is built in, and on top of, the stream channel. The structure appears to protect a utility pipeline crossing.

Diagnosis: This concrete apron is likely a barrier during low flows due to the shallow water depths that occur. Moderately difficult salmonid passage likely exists during moderate to high flows due to the adequate water depth, short channel length, and mild slope.

Recommended Action: Determine the structure's purpose and discuss fish passage options with the County and other stakeholders in coordination with upstream and downstream fish passage improvements.

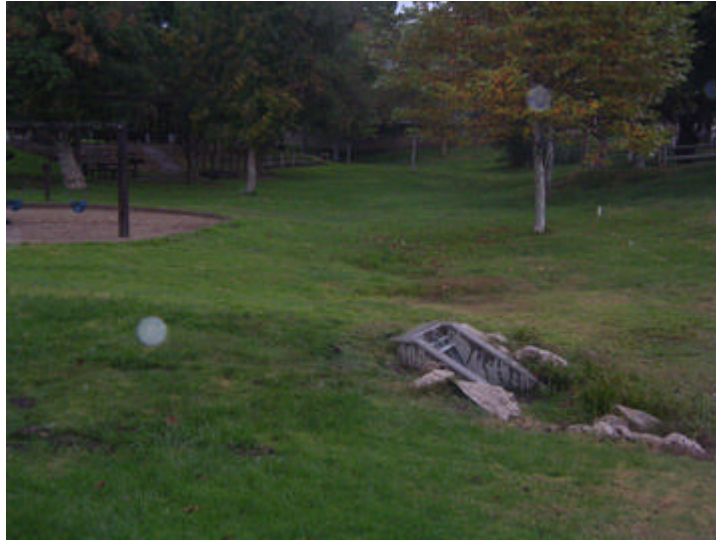
Description: Santa Ynez County Park is built on top of the former stream channel of Zanja De Cota Creek. Maintained lawns appear to occur where the original stream channel existed in this area. Low stream flows appear to be conveyed under the lawn in a small culvert and higher runoff may overflow onto the lawn area.

Diagnosis: With the observed absence of surface flow at this site it is difficult to determine what the lawn and stream reach look like in this area with migration flows. Passage appears to be unlikely through the small culvert due to either insufficient water depth during low flows or excessive water velocities during higher flows. The culvert is likely several hundred feet long.

Recommended Action: Further assess upstream salmonid habitat potential with landowner permission. Conduct further analysis of this park and stream reach with the County and identify long-term park objectives and potential creek restoration and fish passage. Removing the culvert and reestablishing a natural stream through the park might have significant and desirable water quality, recreational, and salmonid restoration benefits.

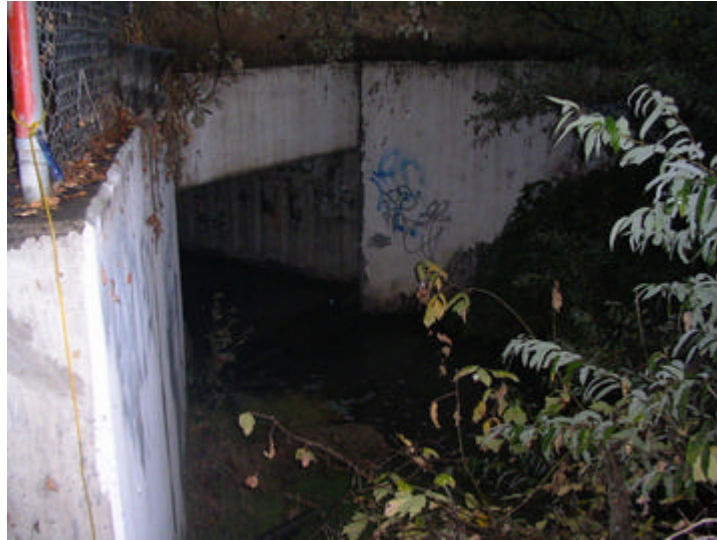
Description: This concrete box culvert measured 10 feet wide by 6 feet tall and 135 feet long. The upstream 15 feet of this box culvert has a steep gradient. The height from the surface of the downstream pool to the lip of the box culvert outlet measured 20 inches. The maximum downstream pool depth measured 2 feet.

Diagnosis: Upstream salmonid migration through this culvert would be prevented due to the excessively steep slope encountered at the upstream end of this culvert and associated velocities.

Recommended Action: Conduct a more detailed analysis of this crossing and upstream habitat conditions with landowner permission and County involvement. Investigate passage alternatives at this site with the county following downstream fish passage improvements. The most effective solution for fish passage would involve removal of the culvert and installation of a wide-span bridge.

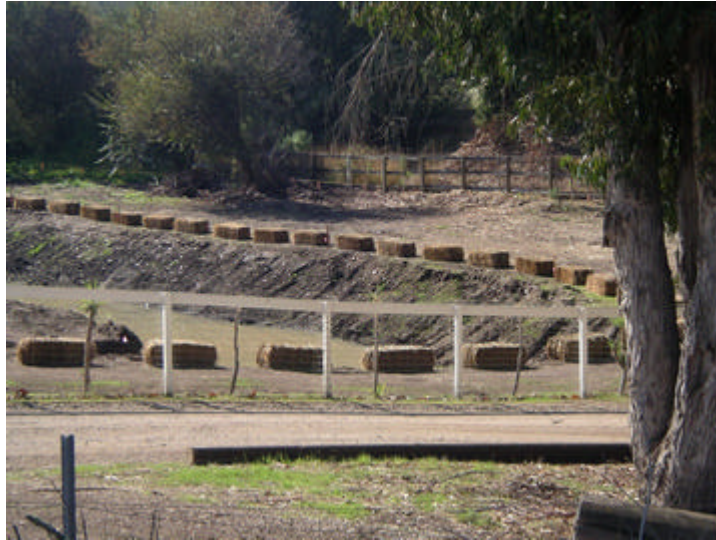
Description: Permission to ground survey this structure was not obtained and limited observations were made from Highway 154. The earth basin does not appear to have any connectivity to the upstream channel. The earthen dam is approximately 12 feet tall and the downstream outlet of the basin was not entirely visible. The exact intent of this structure was not clear, but appears to be a private flood control basin.

Diagnosis: This basin appears to be completely impassable due to the lack of connectivity with the upstream channel. High stream flows will likely blow out this earthen dam and reconnect surface flows. Additional assessment of this structure is needed to determine the severity and purpose.

Recommended Action: In coordination with downstream fish passage improvements, determine the desirability and purpose of this feature.

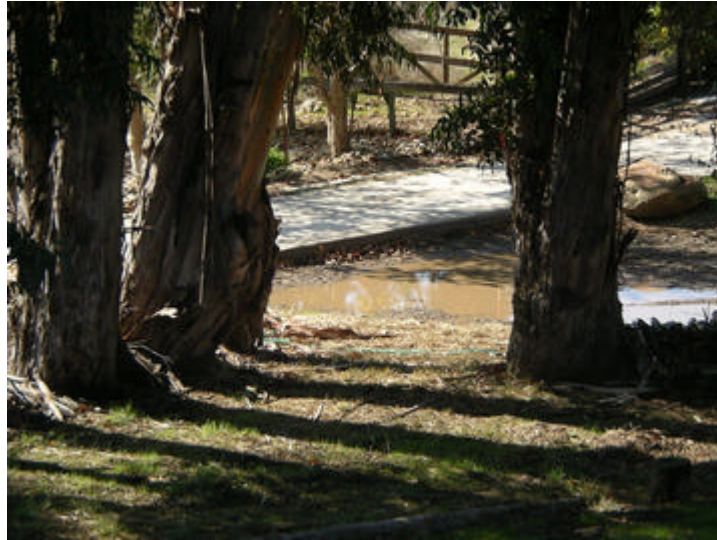
Description: Permission to ground survey this structure was not obtained and limited observations were made from Highway 154. This low-flow road crossing is directly upstream from an earth basin. The surface of the concrete crossing appears to be elevated approximately 1-foot above the natural streambed.

Diagnosis: This crossing presents a barrier to fish passage during low flows when insufficient water depth occurs across the road surface. During moderate to higher flows, salmonids would be able to jump or swim onto and across the short crossing with a low to moderate degree of difficulty. Excessive velocities may limit smaller fish passage during very high stream flows.

Recommended Action: Seek landowner permission to assess fish passage improvements, following downstream fish passage improvements. Removal of the crossing and replacement with a bridge or large, embedded culvert would provide effective fish passage.

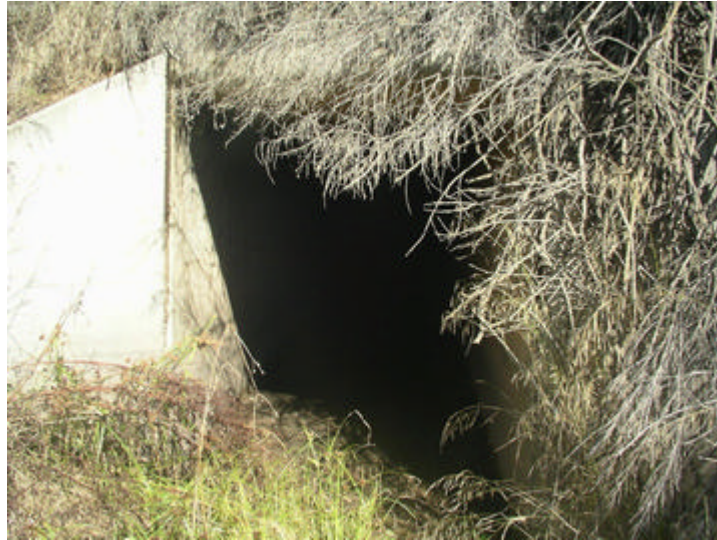
Description: Permission to ground survey the crossing from adjacent private land was not obtained and limited observations were made from Highway 154. This culvert is approximately 5 feet wide by 7 feet tall and 200 feet long. Angled wingwalls extend downstream for approximately 12 feet.

Diagnosis: Shallow water depth inside the culvert would prevent upstream salmonid passage during low flows. During moderate to high flows, adequate water depth inside the culvert occurs but excessive water velocities, long culvert length, and lack of resting spots would likely prevent upstream salmonid migration. Extremely limited and difficult upstream migration may be possible during ideal moderate flow conditions depending on the culvert slope and characteristics.

Recommended Action: In coordination with downstream fish passage improvements, conduct a more detailed analysis of this structure and adjacent stream channel with landowner permission and CALTRANS involvement. Identify alternatives for fish passage. The most effective fish passage and stream restoration alternative would be to remove this entire structure and replace it with a bridge that does not impact the stream channel.

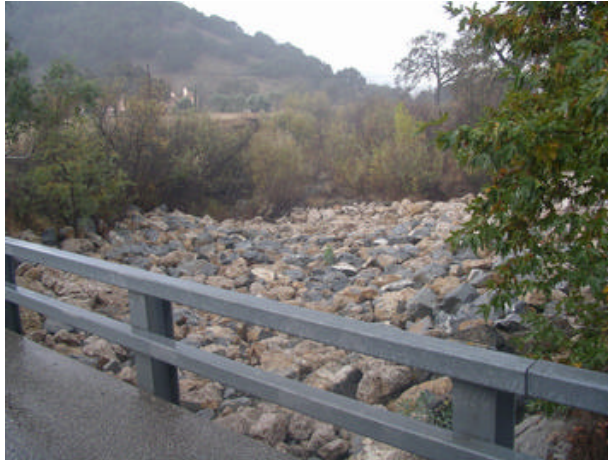
Description: Permission to ground survey this structure and access adjacent private land was not obtained and limited observations were made from Alisos Road. This large boulder revetment project extends downstream from the bridge for approximately 100 feet and covers the entire width of the streambed and extends up the banks for a short distance.

Diagnosis: The large boulders do not appear to be embedded in the streambed but rather laid on top without much packing of finer sediment into the voids between the boulders. The result of this high permeability and elevated construction is likely that lower surface flows are conveyed through the boulders rather than on top of them. This high permeability likely prevents upstream fish passage during low and moderate flows. During higher flows, water will likely begin to provide adequate water depth over the top of the boulders and may allow limited fish passage. From the bridge it was difficult to determine the characteristics of the downstream end of the structure and determine whether any drop and resulting jump height exists that may further impede upstream migration. This structure significantly reduces the window of opportunity for salmonids to migrate upstream, especially during low to moderate flows.

Recommended Action: Continue to monitor this site and seek landowner permission to further assess the characteristics and severity to fish passage. Sediment deposition may decrease the permeability of the revetment and improve fish passage in the future. Scour downstream of the structure may produce a jump downstream that produces a more severe barrier. Should this structure continue to significantly impede salmonid passage than stakeholders should look into alternatives to improve migration upstream.

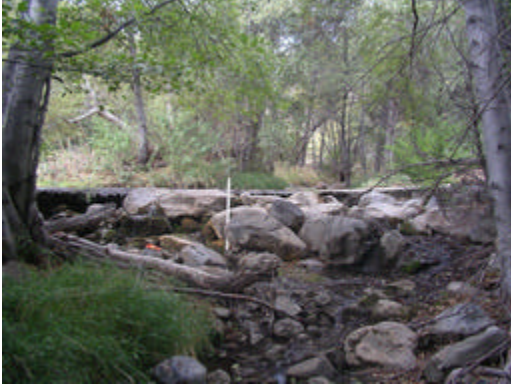
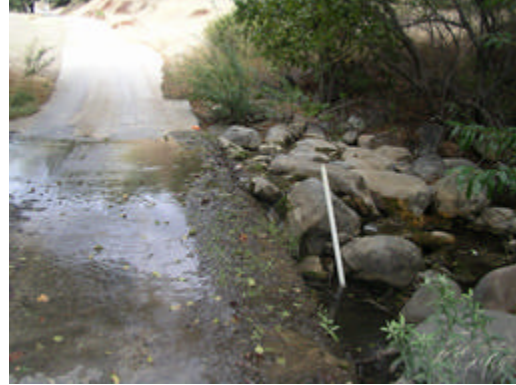
Description: The road crosses the main channel of the creek for 38 feet and measured 14 feet wide. Large boulders extend downstream for 15 feet. The maximum pool depth downstream from the road crossing measured 10 inches deep. The height from the surface of the downstream pool to the downstream lip of the road surface measured 3 feet. Rainbow trout were observed both below and above this road crossing.

Diagnosis: When adequate water depth occurs during moderate and high stream flows, trout can jump or swim onto the road surface with a moderate to high degree of difficulty. Due to a lack of roughness, water velocities become accelerated over the smooth concrete crossing during higher flows and may impede or prevent upstream passage for smaller salmonids. All fish passage is prevented during lower flows due to the 3-foot jump height and shallow water depth spread out over the crossing's surface. This crossing represents a partial barrier, especially during lower flows, and reduces the window of opportunity for existing trout passage at this site.

Recommended Action: Due to the presence of rainbow trout at this site and the moderate to high severity of the crossing, fish passage should be improved. Overall public transportation safety as well as fish passage would benefit most from the removal of this crossing and installation of a bridge. Seek permission to survey downstream private stream reaches to Cachuma Reservoir to determine if fish passage up this high is possible. Judging by topographic lines, it appears that a natural barrier may occur near the 1560-foot topographic line on the USGS 7.5 minute quad map. At least three downstream private road crossings may also limit upstream migration.

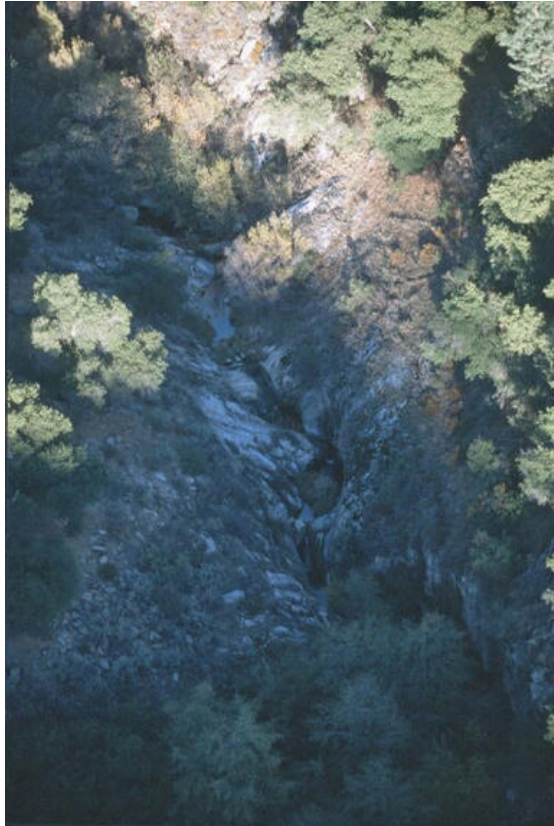
Description: This three-part bedrock waterfall was observed from a helicopter and one of the waterfalls measured approximately 20 feet tall. A large downstream pool was present and good summer stream flow and high quality salmonid habitat occurs downstream to at least the Los Padres National Forest Boundary with private property. Not downstream anthropogenic barriers are known to occur on Lazaro Creek.

Diagnosis: This bedrock waterfall represents the upstream natural limit to fish passage on Lazaro Creek due to the excessive jump height. High quality salmonid habitat occurs downstream of this feature.

Recommended Action: No recommended action for this natural feature.

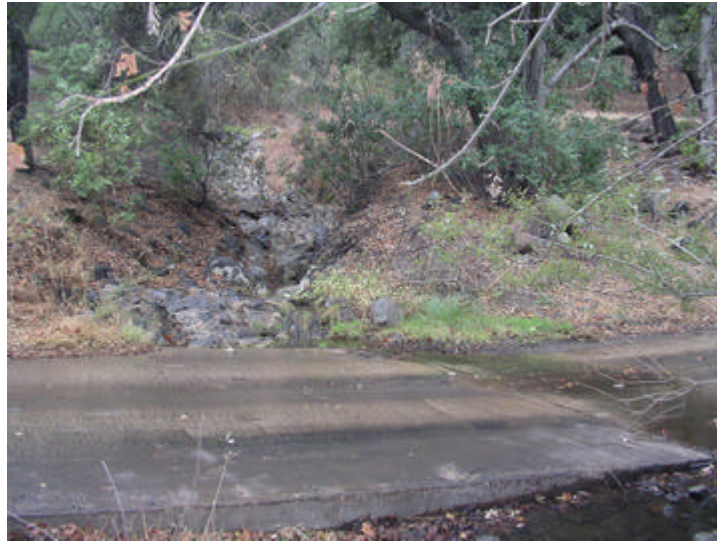
Description: The road crosses the active stream channel for approximately 20 feet and is 14 feet wide. The overall slope of the crossing is mild and stream flows are concentrated in a shallow V on river-left. Most of the crossing occurs at streambed grade.

Diagnosis: Due to the streambed grade of the crossing and shallow V shape, salmonids can swim onto and across this road during moderate and high flows. Due to a lack of roughness, excessive water velocities over the smooth concrete crossing during high flows may impede or prevent upstream passage for smaller salmonids.

Recommended Action: This crossing should be monitored to ensure that passage does not become more difficult due to downstream scour and increased jump height. The natural upstream limit occurs immediately upstream and modifying the crossing would not provide a significant benefit.

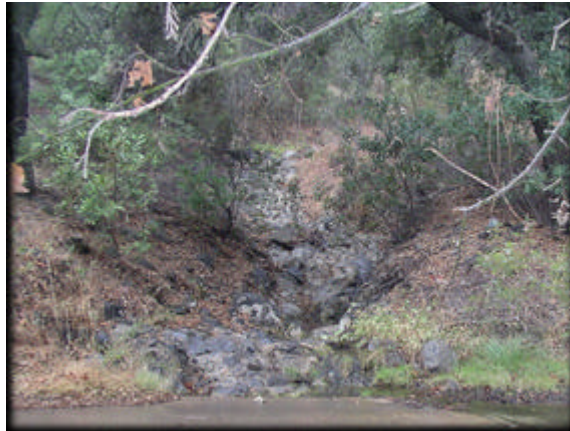
Description: This steep boulder gradient is approximately 75 feet long and has minimal resting pools and a steep, sustained gradient.

Diagnosis: This feature is impassable to fish during low flows due to the shallow depth and lack of pools encountered and likely during higher flows due to the excessive velocities, turbulence, and minimal resting stops. Habitat conditions are also fairly poor upstream.

Recommended Action: No recommended action for this natural feature.

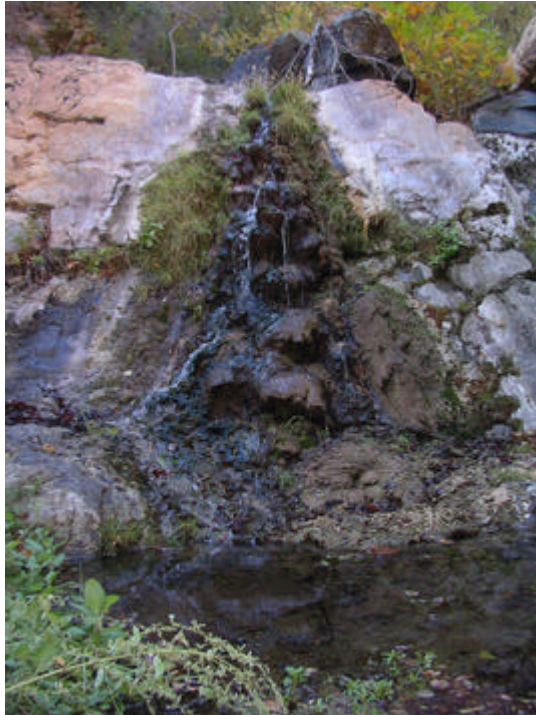
Description: This bedrock waterfall measured 13 feet tall and varied from vertical to steeply sloped with masses of mineral deposits and vegetation. The downstream pool measured less than 12 inches deep and does not appear to backfill enough to create a significant pool.

Diagnosis: This waterfall represents the upstream natural limit to fish migration due to the excessive jump height and lack of downstream pool depth.

Recommended Action: No recommended action for this natural feature.

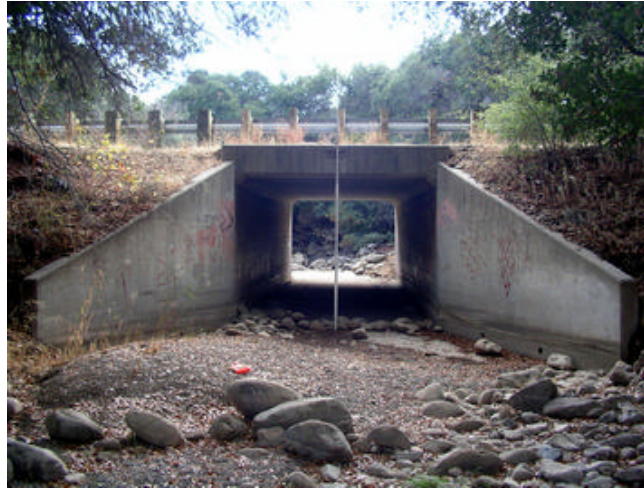
Description: This concrete box culvert measured 12 feet wide by 9 feet tall and 68 feet long. Substrate has settled on the bottom of the culvert and on both the upstream and downstream concrete aprons, which are at or near streambed level. Watermarks on the sides of the culvert and wingwalls indicate that during moderate to high flows the culvert fills to a depth ranging from 12 to 18 inches.

Diagnosis: This culvert is impassable during low flows due to insufficient water depth that is spread out inside the culvert. During moderate to high flows, when adequate water depth occurs, adult salmonids can swim into the culvert and may be able to make it through the culvert depending on the velocities encountered. The accelerated velocities and lack of resting areas in the culvert will limit some salmonid migration, especially smaller salmonids during higher flows.

Recommended Action: Tequepis Creek is a known rainbow trout, and former steelhead, spawning and rearing tributary and improving passage here would benefit the rainbow trout population. Coordinate with CALTRANS to determine long-term highway plans for this site and discuss fish passage alternatives. The preferred CDFG and NMFS treatment option for fish passage would involve removal of the culvert and installation of a bridge that does not impact the stream channel. A short-term project for improved rainbow trout passage could involve roughening the inside of the culvert along the edges for velocity breaks. Seek permission to survey private road crossings upstream.

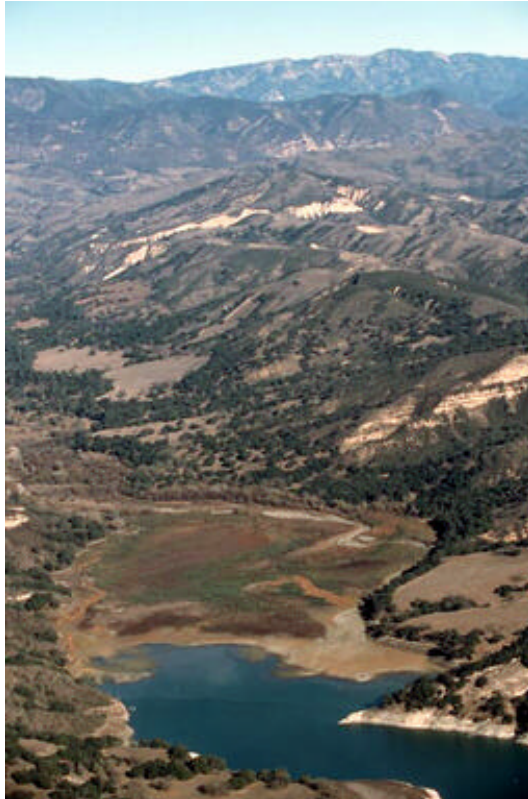
Description: Where Santa Cruz Creek encounters the large deposition of sediment at Cachuma Reservoir surface flows were observed to go subsurface into the mass of sediment. The lower 0.25 mile of creek upstream of the reservoir was dry. This sediment deposition is caused by the accumulation of sediment at the creek mouth associated with the construction of Cachuma Dam and filling of the reservoir. This permeable sediment transports the creek flow subsurface and disconnects the stream flow with the reservoir for much of the year.

Diagnosis: Significant precipitation events are required for the creek to maintain surface flow across the sediment deposit and connect to the reservoir allowing upstream fish passage. The duration of this stream connectivity is dependant on rainfall, but may only last for a limited amount of time during a year. During below average rainfall years, there may not be any connectivity between the reservoir and the creek preventing upstream spawning runs and fish passage. Santa Cruz Creek contains some of the highest quality

Recommended Action: The presence of this barrier is the direct result of Cachuma Dam operations and should be discussed in conjunction with overall dam and reservoir operations for the Santa Ynez River. Removal of Cachuma Dam and Reservoir would cause the eventual flushing out of sediment and elimination of this barrier and would open up the entire Santa Cruz Creek sub-watershed to steelhead migration. No anthropogenic migration barriers are identified on Santa Cruz Creek and restoration of steelhead to this tributary alone would likely produce thousands of adult steelhead annually and safeguard the Santa Ynez River steelhead population from extinction.

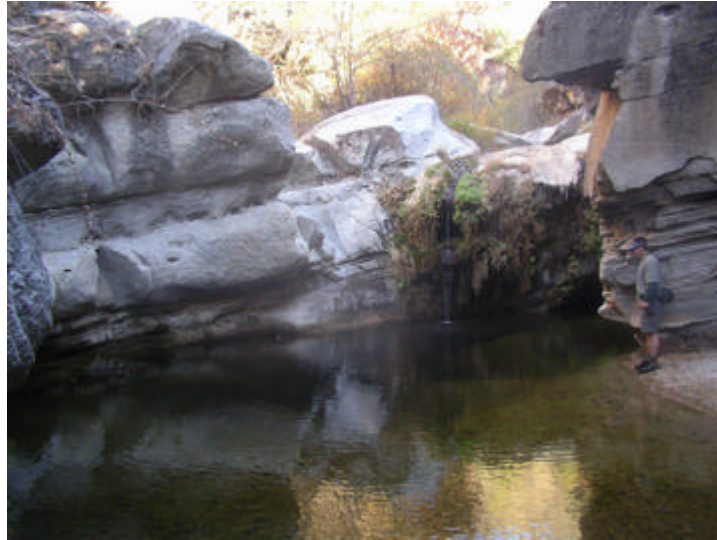
Description: This bedrock waterfall drops a total of 13 vertical feet from the highest upstream point to the surface of the 6-foot deep pool below. The lower 9 feet of the waterfall drops vertically and the uppermost 4 feet is a moderately steep bedrock chute that extends upstream 15 feet to a 3-foot deep pool.

Diagnosis: This waterfall is impassable to salmonids during low and moderate flows due to the excessive jump height and steep bedrock chute at the upper part of the falls. During high stream flows, the downstream pool depth likely increases up to 5 feet, reducing the overall jump height to 8 feet and producing a jump depth of 11 feet. Water velocities during these high flows would be extremely high, but limited upstream passage for large adult steelhead would likely be possible around the sides of the main waterfall flow. The large downstream pool would have deep side eddies on both sides of the waterfall that would provide jump locations around the projecting waterfall flow. This waterfall is a complete barrier to the existing rainbow trout during all flow conditions. Historically, adult steelhead may have been prevented from upstream migration at this waterfall during years with low rainfall and only moderate stream flows.

Recommended Action: No recommended action for this natural feature.

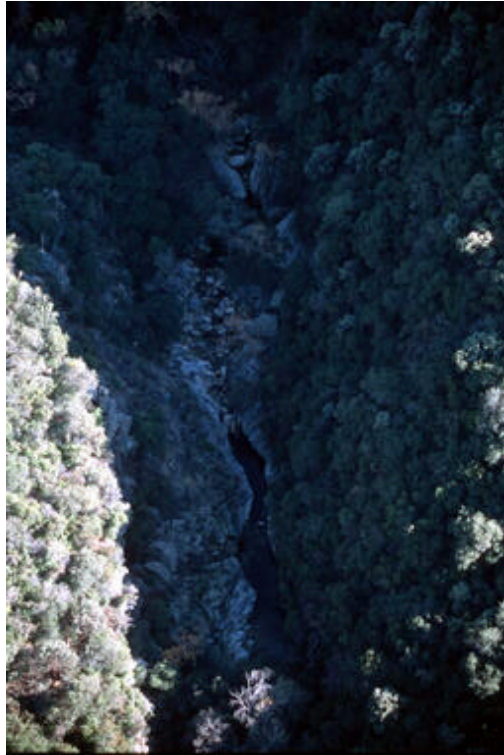
Description: Due to time constraints the East Fork and its tributaries were not ground surveyed upstream from the waterfall near the West Fork Santa Cruz Creek confluence (SY_SC_EF_1). These two waterfalls were identified from the air and the descriptions are limited in detail. Two bedrock and boulder waterfalls occur in this location approximately 175 feet from each other in a confined bedrock canyon. The downstream waterfall drops vertically 10-12 feet into a very large bedrock pool that extends downstream for over 100 feet. The upper waterfall is formed by steep canyon walls that have massive boulders wedged in between them creating a 12 to 15-foot drop into a large pool.

Diagnosis: Both of these waterfalls appear to be impassable to salmonids during all flows due to the excessive jump heights that would experience excessive velocities and turbulence during migration flows. It is hard to completely rule out upstream migration at this sites based upon a 30 second aerial observation during low-flow conditions. High winter flows and modifications to the stream channel and associated boulders may allow

future upstream passage. A backcountry ranger we spoke with at the Santa Cruz Cabin told us that rainbow trout occur in Grapevine Creek, but he thought they were planted there. Excellent pool habitat and flows were observed downstream to the West Fork and upstream to approximately 2 miles past Grapevine Creek. Grapevine Creek also had flow and several large pools. Large stream reaches could not be observed due to the dense riparian growth and additional surveying of this drainage is needed to determine if additional barriers occur on the East Fork and the severity and configuration of these two waterfalls.

Recommended Action: No recommended action for these natural features. Conduct additional ground surveying of the East Fork and its tributaries.

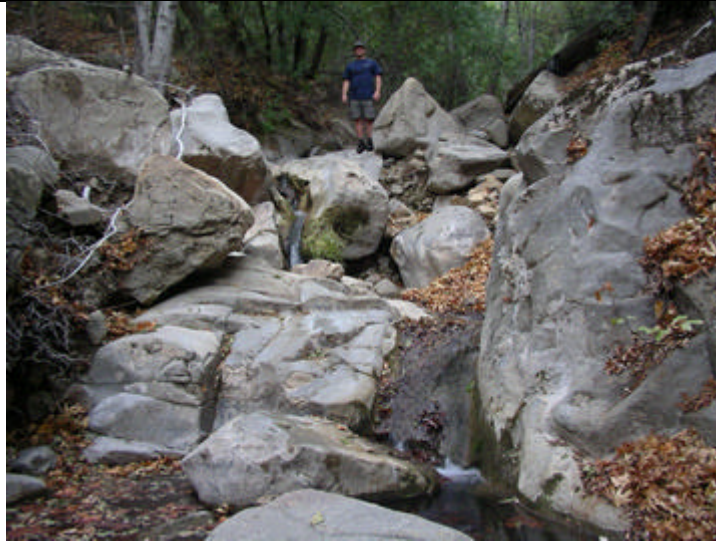
Description: This series of bedrock chutes and steep downstream gradient occurs immediately downstream from the largest unnamed western tributary that begins near the Mission Pine Basin Campsite. The two-part bedrock chutes have a total height of 10 feet 6 inches. The lower chute measured 4 feet 6 inches and the upper chute measured 6 feet tall. No pool exists between the chutes. Several steep gradient features occur downstream of this location that may also prevent upstream passage.

Diagnosis: The steep downstream gradient, minimal downstream jump pool, steep bedrock chutes, and further impassable upstream features prevent further upstream salmonid passage. Excessive gradients occur upstream of this feature on both tributaries including a bedrock waterfall over 75 feet tall immediately upstream on the unnamed tributary.

Recommended Action: No recommended action for this natural feature.

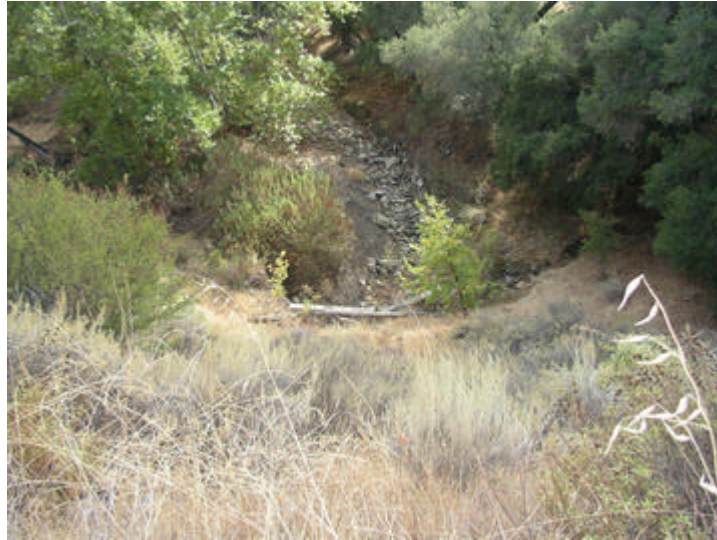
Upstream end of Highway 154 culvert

Description: Permission to access and ground survey private lands adjacent to the culvert was not obtained and limited observations were made from the surface of Highway 154. Based on the road and fill width observed, the culvert is approximately 200 feet long.

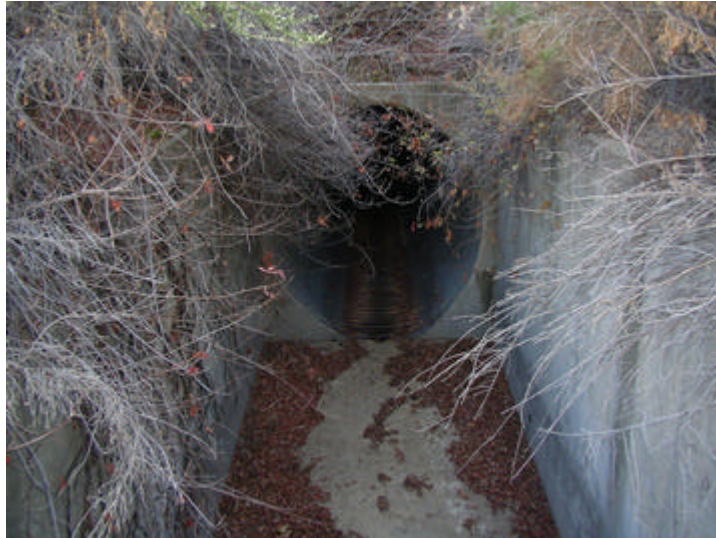
Description: Two roads cross over this long culvert. A concrete box culvert occurs under the county road from Highway 154 to the Live Oak Camp. This box culvert measured 10 feet wide by 10 feet tall and is 35 feet long. Upstream from the county road, the box culvert opens up into a concrete channel with no ceiling for 25 feet where it is attached to an oval corrugated metal culvert that measures 8 feet wide by 9 feet tall and is approximately 200 feet long. This culvert is under the Highway 154 road crossing. The total length of the entire structure is approximately 260 feet long.

Diagnosis: The downstream end of the structure is at streambed level allowing easy access for salmonids into the bottom end of the box culvert. This structure is impassable during low flow conditions due to insufficient water depth and during high flows due to the excessive water velocity through the long structure and absence of resting areas. During moderate flow conditions, a large healthy adult may be able to swim through this structure with a high degree of difficulty. This structure is likely impassable during most flows and severely impedes or blocks access to this tributary.

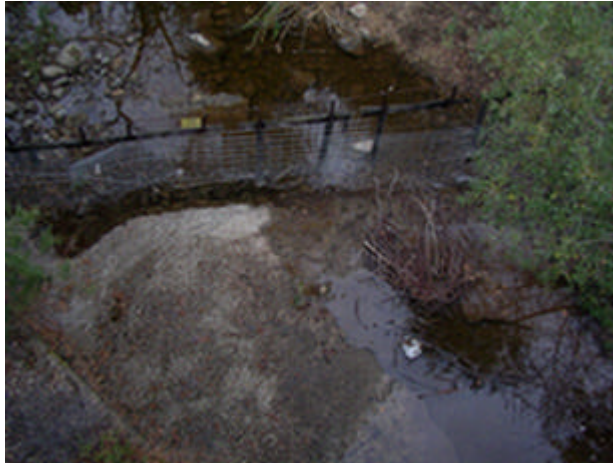
Concrete channel under bridge

Description: This concrete channel is approximately 70 feet long and 50 feet wide running underneath the bridge. The concrete bottom has experienced a moderate to high degree of scour. Holes occur in the concrete providing pools with natural substrate bottoms for almost the entire length of the structure. The height from the downstream pool surface to the lip at the downstream end of the concrete channel measured approximately 12 inches. The downstream pool's maximum depth measured 12 inches.

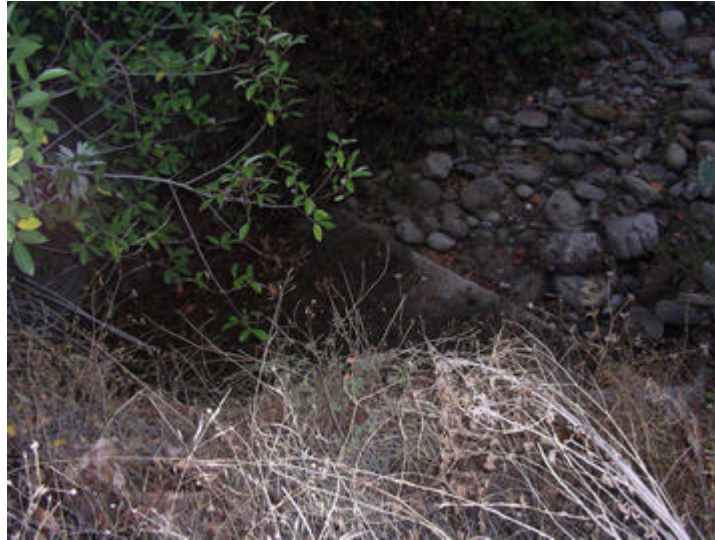
Concrete apron at upstream end of culvert

Description: Observations of this structure are limited to the surface of Stagecoach Road and permission to access adjacent private property was not obtained. This concrete box culvert measures approximately 10 feet tall by 10 feet wide and 50 feet long. The downstream lip of the culvert measured approximately 1-foot above the surface of the downstream pool, which had a maximum depth of 2 feet.

Diagnosis: During most flows, salmonids can jump into the culvert due to the short jump height and presence of downstream pool depth. The culvert is impassable to upstream migrating salmonids during low flows due to shallow flow conditions and during high flows due to excessive velocities and lack of resting areas. During moderate flow conditions, difficult upstream migration may be possible for healthy adults when water depths are adequate and water velocities are not at a maximum. This structure is likely impassable to most fish at most flows and severely impedes or blocks access to most of this tributary.

Recommended Action: Further assess culvert and channel conditions with landowner permission and investigate passage alternatives at this site with the County and other stakeholders. The most effective solution for fish passage is removal of the culvert and installation of a wide-span bridge. High quality salmonid habitat occurs in Bear Creek upstream of this barrier.

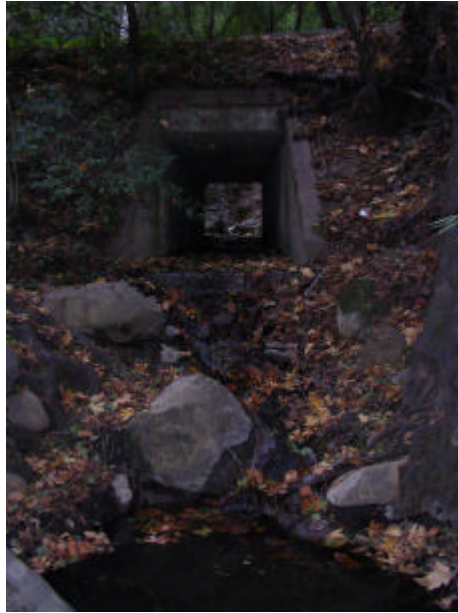
Description: This concrete box culvert measured 5 feet tall by 5 feet wide and fifty feet long. The downstream jump-height measured 5 feet 6 inches tall over a horizontal distance of 6 feet. The downstream pool measured 3 feet deep.

Diagnosis: Passage conditions downstream on private property could not be determined and it is unknown if steelhead could historically migrate this far upstream. This crossing prevents upstream passage during low flows due to shallow water depth and high flows due to excessive water velocities. During moderate flows the crossing is likely impassable due to excessive velocities inside the culvert, but fish may be able to jump into the culvert and attempt the swim through.

Recommended Action: Seek landowner permission to survey the private reach of lower Cold Spring Creek upstream of Kelly Creek for natural barriers.

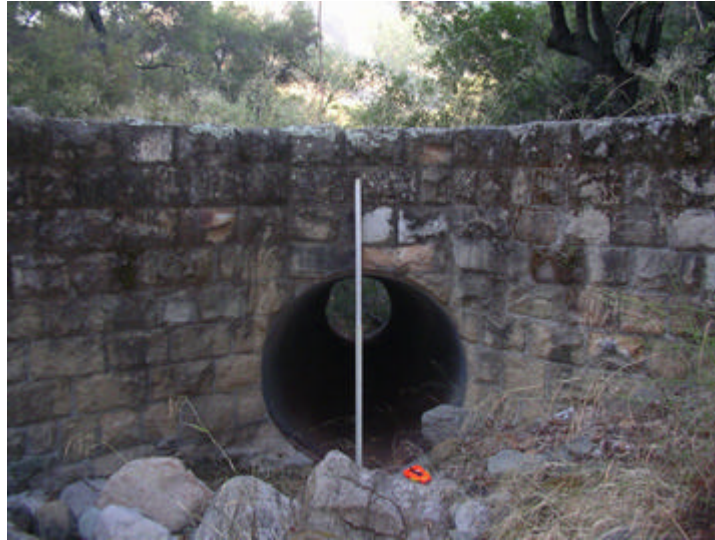
Looking downstream at corrugated metal culvert

Description: This perched, corrugated metal culvert measured 6 feet in diameter and 50 feet long. The jump height from the downstream pool to the lip of the culvert measured 15 feet.

Recommended Action: Further assess upstream salmonid habitat conditions with landowner permission. Should adequate habitat conditions occur upstream, assess hydraulic and channel conditions at the crossing and investigate passage alternatives at this site with the county and other stakeholders. The most effective solution for fish passage is removal of the culvert and installation of a wide-span bridge.

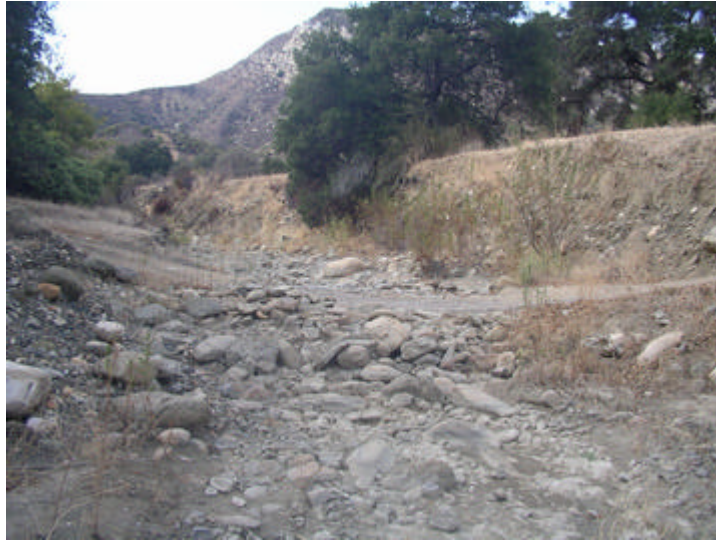
Description: This natural bottom ford crossing consists of native rocks and small boulders formed to a maximum downstream height of 18 inches tall.

Diagnosis: This ford is created each year following the subsidence of high stream flows and blows out with winter flows producing a natural stream bottom. Fish passage is not significantly impeded.

Recommended Action: Ensure that the crossing remains a natural ford and is not “improved” with any in stream construction.

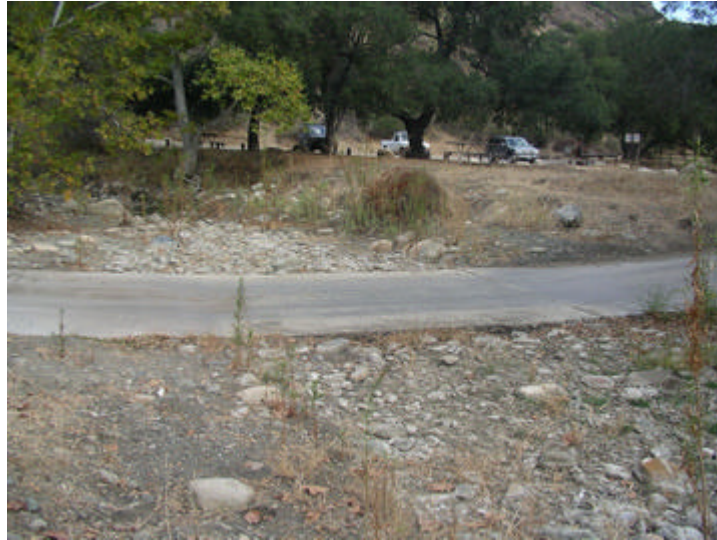
Description: This low-flow concrete crossing spans 35 feet across the stream channel and measured 14 feet wide. The crossing is elevated above the natural streambed a maximum of 5 inches and has a mild to flat slope.

Diagnosis: When adequate water depth occurs during moderate and high stream flows, salmonids can jump or swim onto the road surface with a low to moderate degree of difficulty. Due to a lack of roughness, water velocities are accelerated over the smooth concrete crossing during higher flows and may impede or prevent upstream passage for smaller salmonids. All fish passage is blocked during low flows due to shallow water depth spread out over the crossing's surface.

Recommended Action: This crossing should be monitored to ensure that passage does not become more difficult due to downstream scour and increased jump height. Future efforts should be made to improve passage at this site, in conjunction with scheduled maintenance. Concentrating low flows, and water depth, over the crossing in a roughened channel would improve passage conditions.

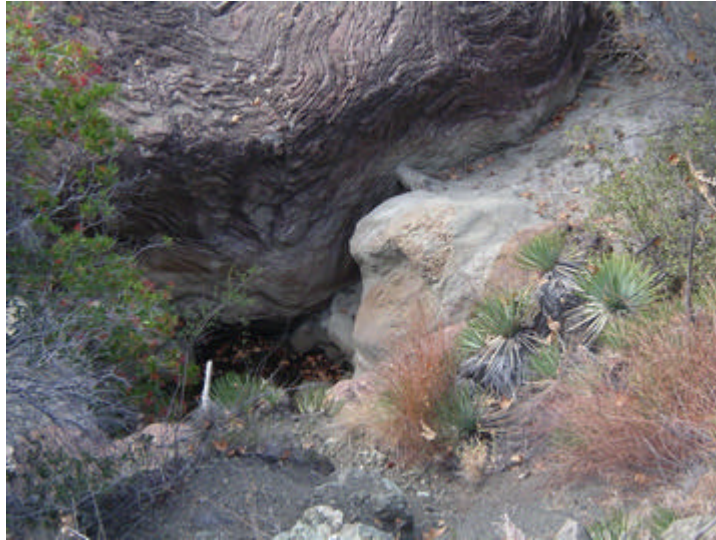
Description: Oso Creek was ground surveyed from the Santa Ynez River upstream to the Upper Oso Campsite crossing. This waterfall was observed from the trail while returning from Santa Cruz Creek surveying. This stream reach was observed from the trail and no downstream barriers were observed. No surface flows were observed upstream from this feature and several adequate pools and trickling surface flow continued downstream to Upper Oso Campsite. This unique looking bedrock waterfall drops vertically 10 feet into a small 12-inch deep pool downstream.

Diagnosis: The excessive jump height and insufficient downstream pool depth prevent further upstream salmonid passage in Oso Creek.

Recommended Action: No recommended action for this natural feature.

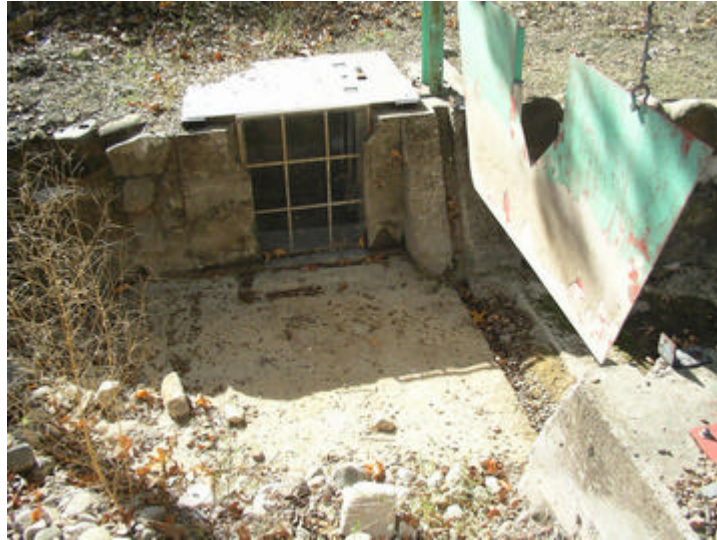
Description: This diversion occurs in a braided stream reach and the diversion inlet and dam gate occur on the river-left braid of the creek. A concrete channel conveys non-diverted flows back to the main creek. The diversion uses a 6-foot wide concrete side-channel with 3-foot tall rock and concrete walls to divert water directly out of the main creek channel. The concrete channel reconnects to the natural channel immediately above the road crossing and extends upstream for 110 feet. The metal flashboard structure is 3 feet tall. There is a notch in the top of the flashboard, which appears to limit the intake of water into the diversion.

Diagnosis: This diversion structure does not span the entire stream channel and does not impede upstream migration during moderate to high flows. The reduction in downstream flows caused by the diversion may reduce downstream connectivity and increase barrier severity. The intake of the diversion is not adequately screened and can entrap downstream migrating trout.

Recommended Action: The diversion should be immediately screened to prevent entrapment of existing trout. Additional assessment of this structures operation should be conducted to determine impacts on downstream flows and stream connectivity.

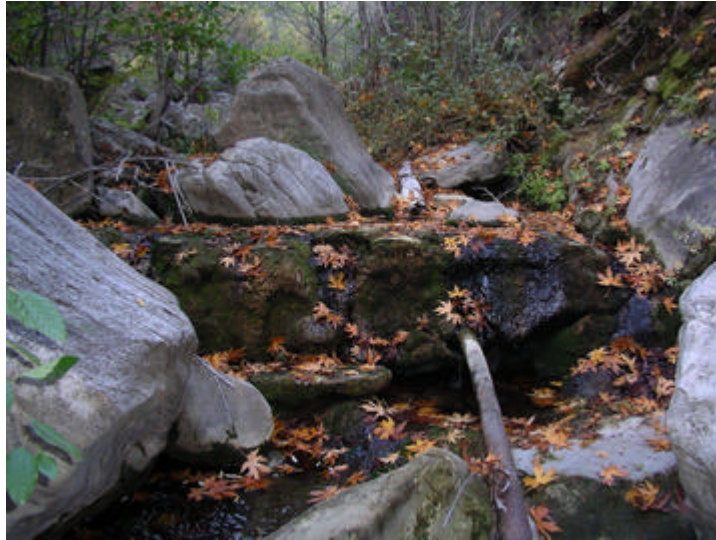
Description: This old dam is constructed with small boulders and concrete. The dam measured 3 feet tall and is 2 feet 6 inches thick. There is a 4-inch diameter steel diversion pipe extending out of the dam downstream for 15 feet. The dam is completely filled-in with sediment and not longer appears to function as a diversion.

Diagnosis: A natural side channel occurs to the river-right of this dam where no remains of the structure occur. This side channel provides access to salmonid passage similar to the surrounding natural substrate features.

Recommended Action: Remove the metal pipe to prevent future downstream blockage and observe the dam during winter flows to assess if it impairs passage in any way. If the dam negatively influences fish passage or sediment transport it should be broken apart.
