Steelhead Migration Barrier Inventory and Recovery Opportunities for the Santa Ynez River, Ca.

Prepared by:
Matt W. Stoecker
Stoecker Ecological Consulting

Prepared for:
Community Environmental Council
Santa Barbara, Ca.

January 29, 2004

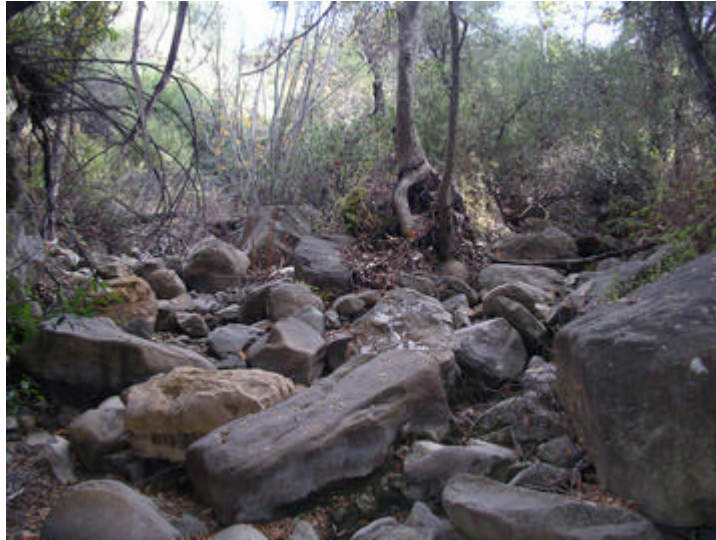
Description: Two tributaries form a confluence at this location approximately 0.33 mile upstream from the last observed surface flow.

Diagnosis: It is likely that this area represents the natural upstream limit to salmonid migration due to the steepness of the boulder gradient, lack of summer flow, multiple drops associated with boulder cascades, and higher quality habitat downstream.

Recommended Action: No recommended action for this natural feature.

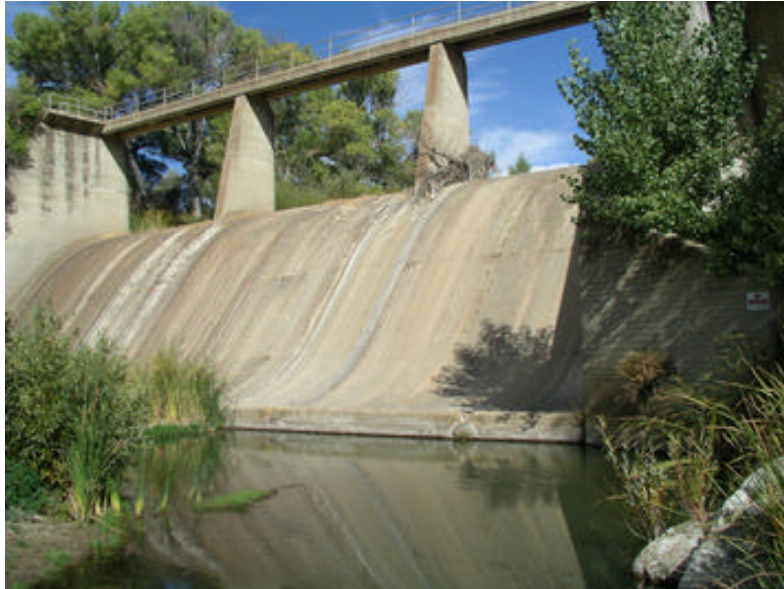
Description: The Mono Debris Dam was constructed between 1935-1936 by the Civilian Conservation Corps in coordination with the City of Santa Barbara. The height of the dam from the downstream pool surface to the top of the spillway measures approximately 18 feet. A catwalk passes through the center of the dam allowing access through the dam and observation of the internal chambers within. This dam was designed to catch downstream migrating sediment bound for Gibraltar Reservoir in order to prolong the life of the reservoir. Sediment composed of sand, fine silts, and cobbles has accumulated to the top of the upstream side of the dam's spillway.

Diagnosis: The lack of fish passage facilities and height of the structure prevents all upstream fish passage at this site during all flow conditions.

Recommended Action: This filled-in debris dam no longer serves a significant purpose for catching sediment transported downstream. Salmonid passage to upstream perennial habitat that would provide access to one of the largest reaches of spawning and rearing habitat in the Santa Ynez River watershed. Provision of fish passage at this site should be included in a Forest-wide program for restoring fish movement within the Los Padres National Forest.

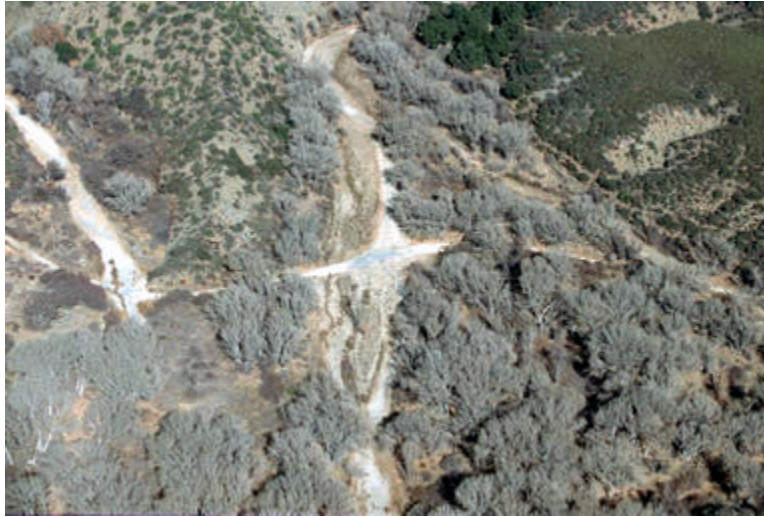
Indian Creek and (SY_MO_IN_1) on left. Mono Creek and (SY_MO_2) at center.

Description: This low-flow crossing is almost identical to the adjacent Camuesa Road crossing on Indian Creek. See barrier write-up SY_MO_IN_1.

Recommended Action: Passage conditions could be temporarily improved by designing and constructing a boulder ramp immediately downstream of the crossing where the current pool occurs. This sloping ramp of boulders should extend approximately 3 inches higher than the crossing surface at the lowest point in the crossing to ensure moderate backfilling of water across the crossing's surface. This crossing should continue to be monitored to ensure that adequate upstream salmonid migration conditions occur. Existing rainbow trout populations likely migrate between the Indian and Mono drainages.

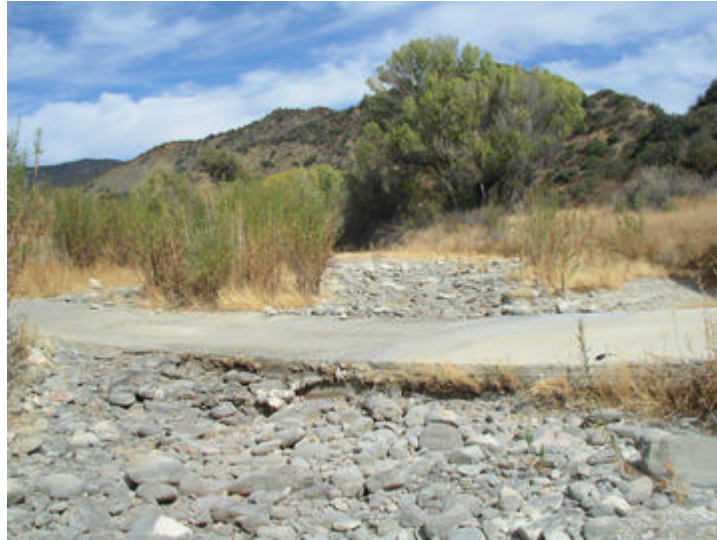
Description: This low-flow crossing spans 125 feet across the stream channel and measured 13 feet wide. The surface of the concrete crossing has a mild downstream slope. During the observed dry conditions, a vertical drop of 2 feet was measured from the downstream crossing surface lip to the downstream natural streambed.

Diagnosis: During moderate and high flows, salmonids can easily jump/swim onto the crossing surface and negotiate upstream with a low degree of difficulty. Water velocities would be slightly accelerated over the crossing during high flows and may impede or prevent upstream passage for smaller salmonids. Fish passage is prevented during low flows due to the shallow water depth spread out over the crossing's surface.

Recommended Action: Passage conditions could be temporarily improved by designing and constructing a boulder ramp immediately downstream of the crossing where the current pool occurs. This sloping ramp of boulders should extend approximately 3 inches higher than the crossing surface at the lowest point in the crossing to ensure moderate backfilling of water across the crossing's surface. A roughened low-flow channel could be cut in the crossing to the low-point of the boulder ramps.

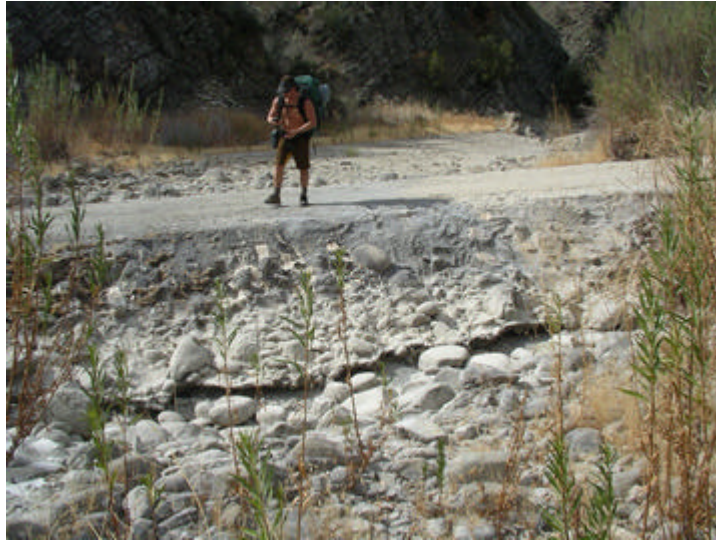
Description: This low-flow crossing measured 13 feet wide. The surface of the concrete crossing has a mild downstream slope. An apron extends 3 to 5 feet downstream of the crossing with a total drop of 4 feet from the crossing surface to the downstream natural streambed. The slope of the apron varies from approximately 30 to 45 degrees.

Diagnosis: During moderate and high flows, salmonids can jump/swim onto the crossing surface with a moderate degree of difficulty and negotiate across the crossing with a moderate degree of difficulty. Water velocities are accelerated over the crossing during high flows and may impede or prevent upstream passage for smaller salmonids. Fish passage is prevented during low flows due to the shallow water depth spread out over the crossing's surface.

Recommended Action: Passage conditions could be temporarily improved by designing and constructing a boulder ramp immediately downstream of the crossing where the current pool occurs. This sloping ramp of boulders should extend approximately 3 inches higher than the crossing surface at the lowest point in the crossing to ensure moderate backfilling of water across the crossing's surface. A roughened low-flow channel could be cut in the crossing to the low-point of the boulder ramps.

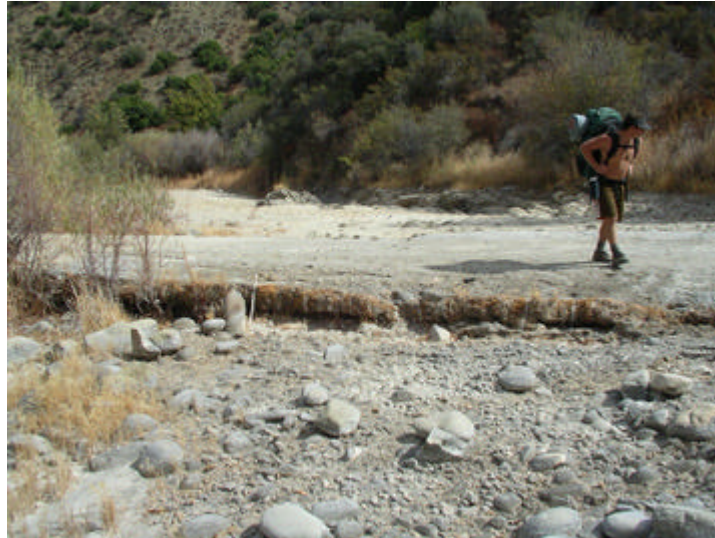
Description: This low-flow crossing measured 13 feet wide. The surface of the concrete crossing has a mild downstream slope. A vertical drop varying between 12 and 18 inches occurs from the crossing surface to the downstream substrate.

Diagnosis: During moderate and high flows, salmonids can jump/swim onto the crossing surface with a low degree of difficulty and negotiate across the crossing with a low to moderate degree of difficulty. Water velocities would be slightly accelerated over the crossing during high flows and may impede or prevent upstream passage for smaller salmonids. Fish passage would be impaired or prevented during lower flows due to the shallow water depth spread out over the crossing's surface.

Recommended Action: Passage conditions could be temporarily improved by designing and constructing a boulder ramp immediately downstream of the crossing where the current pool occurs. This sloping ramp of boulders should extend approximately 3 inches higher than the crossing surface at the lowest point in the crossing to ensure moderate backfilling of water across the crossing's surface. A roughened low-flow channel could be cut in the crossing to the low-point of the boulder ramps.

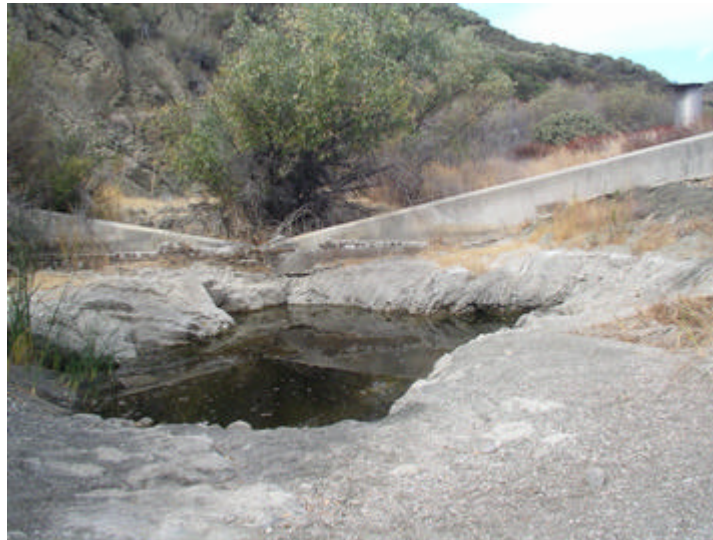
Description: This concrete weir spans the entire channel with a mild V-shape. A metal plate covers the upstream side of the weir to protect the concrete from downstream migrating debris. The weir is 16 inches thick. A vertical drop of 4 feet 6 inches occurs from the low point of the V to the surface of the downstream pool. The downstream pool had a maximum depth of 4 feet 6 inches. Deposited sediment occurred upstream of the weir to within 10 inches of the top.

Diagnosis: During moderate to high flows, the downstream pool depth will increase several feet and reduce the jump height while increasing the jump pool depth. During these conditions adult steelhead could jump over the weir with a moderate degree of difficulty. Existing rainbow trout would have a harder time, but larger trout could likely negotiate the weir during ideal flow conditions with a high degree of difficulty.

Recommended Action: Determine the current usefulness of the weir. If the weir is not essential it should be removed to ensure unimpeded upstream access for the current salmonid population that can become stranded downstream in this lowest observed pool on Indian Creek. This structure is a significant impediment to migration between the Mono and Indian Creek salmonid populations. Enhancing connectivity between these two “isolated” populations should be improved to limit inbreeding and promote genetic mixing.

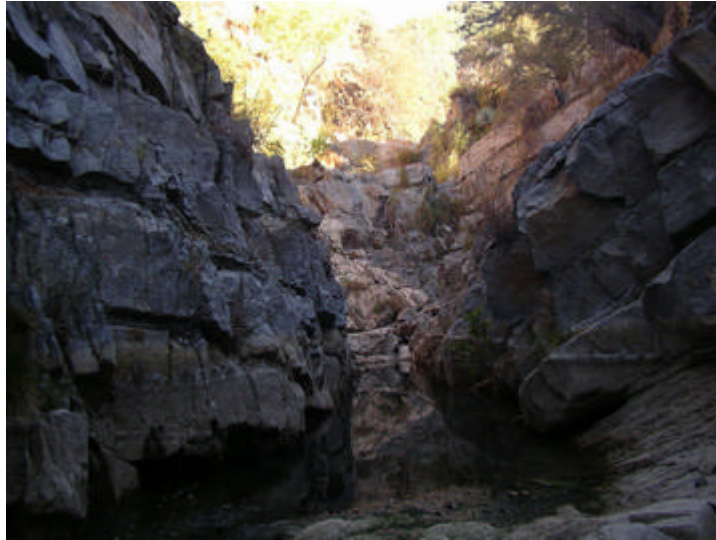
Description: This impressive two-stage bedrock waterfall drops 16 feet into a 9-foot deep pool that spills water down an additional 27-foot drop. This lower drop varies from a vertical waterfall drop to a steep chute with a slope of approximately 60 degrees. A long, narrow, gorge pool occurs downstream with a maximum depth of 12 feet.

Diagnosis: This stable bedrock feature is impassable to all salmonids due to the excessive height. No trout were observed for approximately 0.5 mile upstream of the waterfall. Rainbow trout have been reported upstream of this falls and may be the offspring from former stocking efforts (pers. comm. Capelli). Isolated reaches of flow and excellent pool habitat occur downstream of the waterfall and rainbow trout are present.

Recommended Action: Not recommended action for this natural feature.

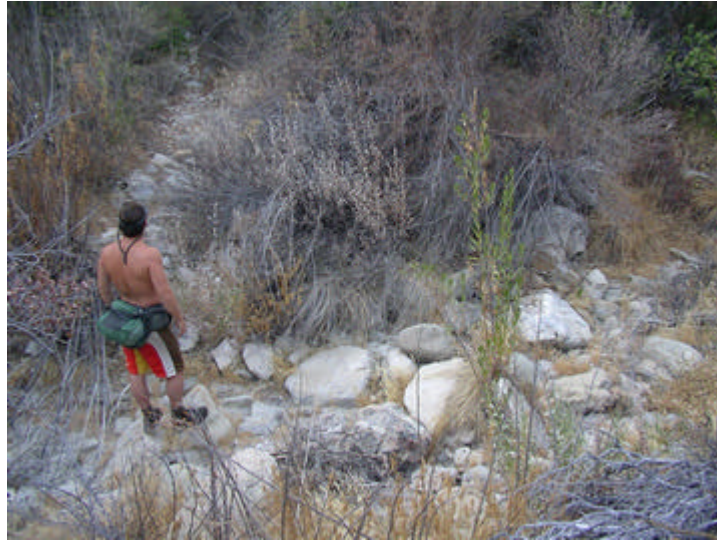
Description: At this location on Buckhorn Creek the channel has become a small 4-foot wide gully with upland grasses growing in the channel and no sign of perennial flow or adequate spawning habitat. Excellent salmonid habitat, spring flows, and rainbow trout occur from approximately 0.25 mile downstream from the second northern tributary downstream to the Lower Buckhorn Campsite. The second northern tributary appeared to be a flashy, dry tributary as well, but was double the size of the mainstem of Buckhorn Creek. The above photograph shows the Buckhorn Creek channel coming down from the top left to where Shaw Allen is standing (at the confluence) and the larger, dry, second northern tributary comes in from the right side of the photo. From this confluence, the Buckhorn flows out of the picture to the left.

Diagnosis: It is unlikely that any salmonid migration would occur beyond this point due to the poor habitat conditions and lack of flow.

Recommended Action: No recommended action.

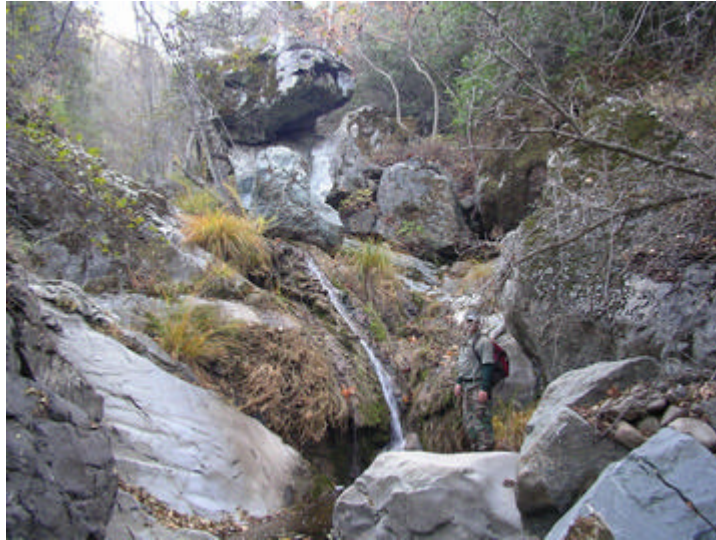
Description: This bedrock and boulder chute measured 12 feet 6 inches tall from the surface of the downstream pool. The chute is nearly vertical. The downstream pool had a maximum measured depth of 6 feet and was confined in a narrow bedrock pool 3 feet wide at the jump location. A 5-foot tall boulder cascade occurs immediately upstream of this feature.

Diagnosis: This feature likely prevents all upstream salmonid passage due to the excessive jump-height, and confined downstream pool that would be completely covered with a waterfall during high stream flows. Rainbow trout are present downstream of this feature.

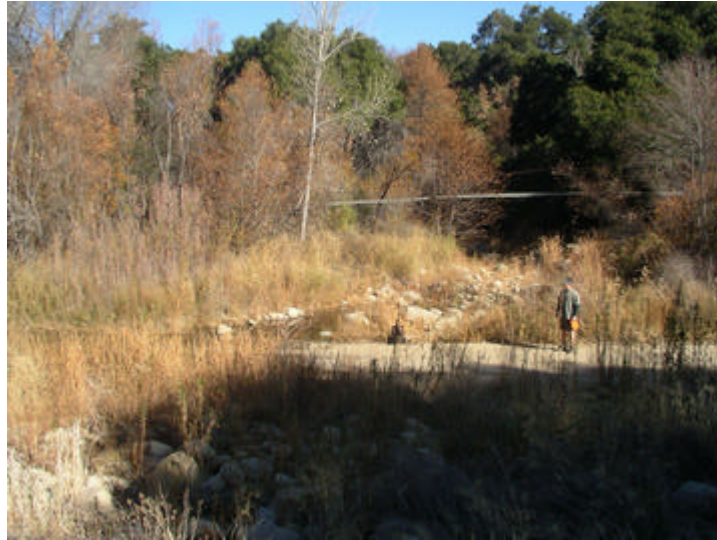
Description: This low-flow crossing spans 125 feet across the active stream channel and measured 14 feet wide. The total concrete crossing measured 240 feet long across the channel and up adjacent banks. The crossing occurs at streambed level with surface flows of 0.15 c.f.s pooling up to 3 inches deep onto the crossing from downstream and across to an upstream pool. A metal grate spans 14 feet across the road near the middle river-right side.

Diagnosis: Due to the connectivity of surface flow across the channel, this structure has a minimal impact on upstream salmonid migration. During exceptionally dry years the crossing may prevent upstream passage during lower flows and high velocities may have a small negative impact on upstream passage during high flows. Substrate downstream at, or above, crossing elevation should backfill the crossing during moderate flows and reduce velocities significantly during higher flows.

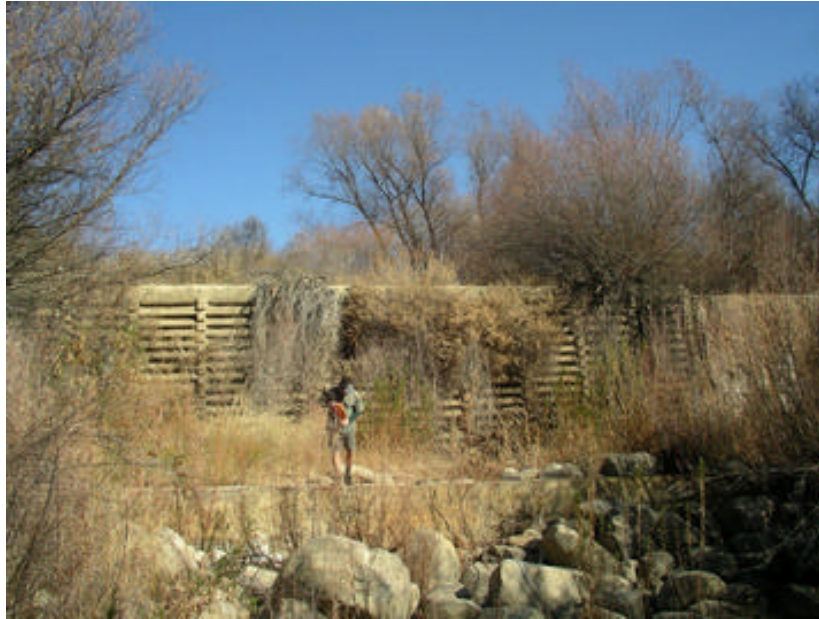
Description: The Pendola Debris Dam is constructed of interlocking concrete blocks on top of a concrete foundation. The concrete foundation measured at least 5 feet tall on the river-left side and continued into the substrate downstream. The dam measured approximately 170 across the stream channel from downstream. The top of the dam measured up to 7 feet thick. The vertical height from the downstream substrate to the top of the dam's notch at center measured 18 feet 6 inches. A concrete curb measuring 5 feet thick spans across the entire stream channel 40 feet downstream from the debris dam. This curb is partial buried in substrate in some locations and exposed in others. Sediment is deposited to the top of the upstream side of the dam rendering it full. Mature willows are growing on top of the dam. Tamarisk was also observed growing in the debris basin.

Diagnosis: The height of the structure completely blocks upstream salmonid passage under all flow conditions.

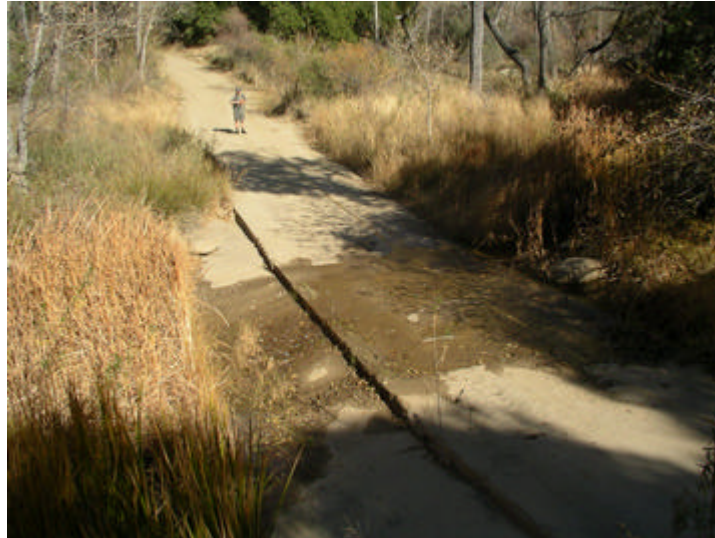
Barrier Status: Partial

Description: This concrete low-flow crossing spans 113 feet across the stream channel and adjacent banks with approximately 68 feet occurring in the active stream channel. The road measured 12 feet 6 inches wide with a concrete apron sloping an additional 6 feet downstream. The surface of the concrete crossing has a mild downstream slope. The moderately steep apron drops 2 feet over the 6-foot length. A 6-inch drop from the road surface occurs to the top of the concrete apron. Large boulders extend up to 12 feet downstream on the river-left side and drop a maximum height of 3 feet 6 inches. Deposited sediment has accumulated to the top of the upstream side of the crossing.

Diagnosis: During moderate and high stream flows, adult salmonids could jump or swim onto the crossing surface and negotiate upstream of the crossing with a moderate to high degree of difficulty. Water velocities would be accelerated over the crossing during high flows and may impede or prevent upstream passage for smaller salmonids. Fish passage is prevented during low flows due to the shallow water depth spread out over the crossing's surface and apron.

Recommended Action: Following downstream fish passage improvements at the Pendola Debris Dam, this crossing should be removed and replaced with a bridge or modified with a roughened low-flow channel and downstream boulder ramp.

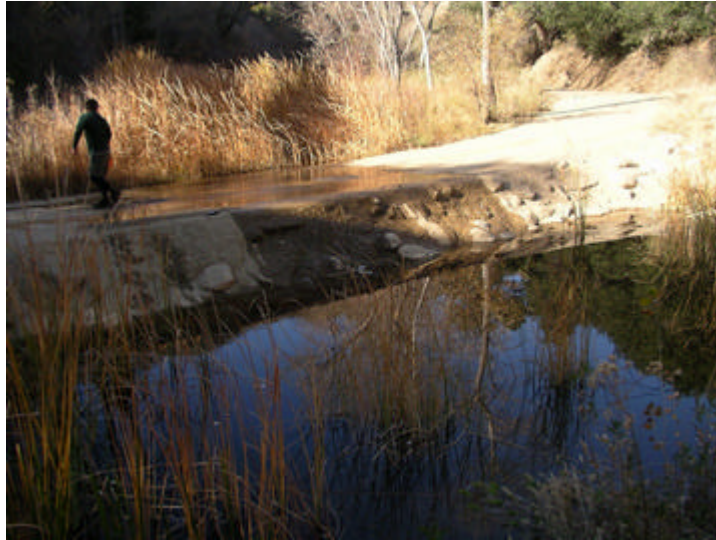
Barrier Status: Partial

Description: This low-flow crossing spans 117 feet across the stream channel and adjacent banks with approximately 65 feet occurring in the active stream channel. The road measured 12 feet wide with a concrete and boulder apron sloping an additional 8 feet downstream into the pool downstream. The surface of the concrete crossing has a mild downstream slope. The steep apron drops vertically 3 feet and projects horizontally 4 feet downstream from the crossing. The downstream pool had a maximum measured depth of 4 feet 6 inches and undercuts the crossing several feet. Deposited sediment has accumulated to the top of the upstream side of the crossing.

Diagnosis: During moderate stream flows, adult salmonids could jump onto the crossing surface and negotiate upstream of the crossing with a moderate to high degree of difficulty. Water velocities would be accelerated over the crossing during high flows and may impede or prevent upstream passage for smaller salmonids. Fish passage is prevented during low flows due to the shallow water depth spread out over the crossing's surface, excessively steep apron, and jump height.

Recommended Action: Following downstream fish passage improvements at the Pendola Debris Dam, this crossing should be removed and replaced with a bridge or lowered to stream grade and outfitted with a roughened low-flow channel and stabilized.

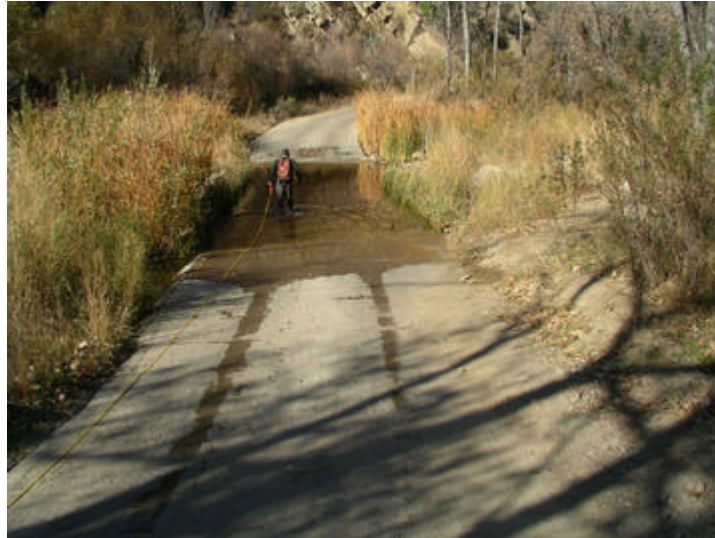
Barrier Status: Partial

Description: This low-flow crossing spans 165 feet across the stream channel and adjacent banks with approximately 80 feet occurring in the active stream channel. The road measured 16 feet wide including the concrete apron on the downstream side. The surface of the concrete crossing has a flat to mild slope. The apron drops at a 45-degree angle, but is submerged for the middle 30 feet of the crossing by up to 15 inches of water. Deposited sediment has accumulated to the top of the upstream side of the crossing.

Diagnosis: During observed low-flow conditions, salmonids could swim onto the crossing and upstream without difficulty. Water velocities would be accelerated over the crossing during high flows and may briefly impede upstream passage for smaller salmonids. This crossing would not significantly impact upstream fish passage, but may change configuration in the future.

Recommended Action: Continue to monitor this crossing, prevent downstream scour, and maintain effective fish passage conditions so that future downstream improvements may allow continued upstream fish passage.

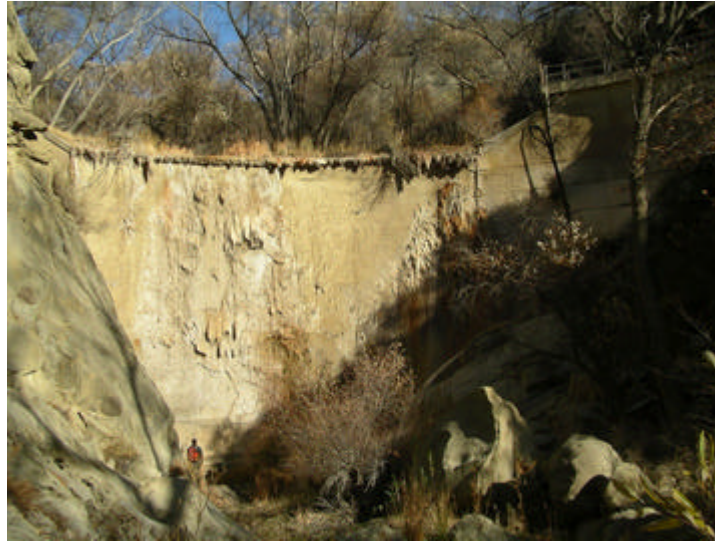
Barrier Status: Complete

Description: The Agua Caliente Dam was constructed between 1936-1937 by the Civilian Conservation Corps in coordination with the City of Santa Barbara. This dam was designed to catch downstream migrating sediment bound for Gibraltar Reservoir in order to prolong the life of the reservoir. This concrete arch dam measured 58 feet 6 inches tall from the surface of the downstream pool to the top of the main notch that spans 80 feet across the rim of the dam. On either side of the notch the dam height angles up an additional 12 feet. The downstream pool depth could not be determined, but exceeded 10 feet. The overall height of the dam likely exceeds 80 feet. At the notch on top, the dam measured 4 feet thick. The dam is built in an ideal location between confined bedrock walls that create a narrow canyon. The upstream dam basin is completely filled-in with accumulated sediment and covered with an extensive and impressive forest of mature willow trees that extend upstream for approximately 0.5 mile.

Diagnosis: The excessive height of the dam completely blocks upstream fish passage during all flow conditions.

Recommended Action: This filled-in debris dam no longer serves a significant purpose for blocking sediment transport downstream. Providing salmonid passage to approximately 3.5 miles of fair to excellent upstream habitat should be discussed with Los Padres National Forest and other stakeholders, in coordination with the Pendola Debris Dam. Determine and discuss the potential biological impacts to species that may have become established in the upstream willow forest, especially avian species.

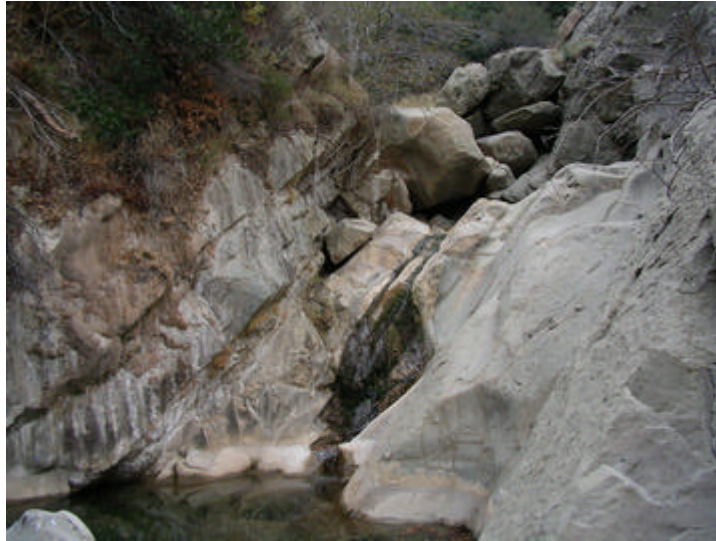
Barrier Status: Complete

Description: Confined bedrock walls produce a series of large boulder cascades, bedrock chutes, and small waterfalls for over 300 feet at this location. The most severe feature in this stream reach for fish passage is an 11-foot tall bedrock chute 100 feet upstream from the smaller chute and pool shown in the picture. This upper chute has another 13 feet of boulders piled on top of it.

Diagnosis: The upper chute is completely impassable during all flows to all salmonids due to the excessive jump height, steep chute, and limited downstream pool depth.

Recommended Action: No recommended action for this natural feature.

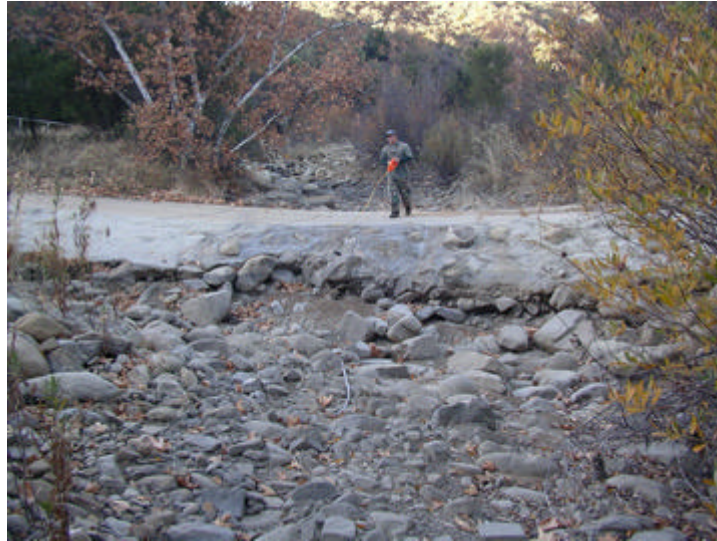
Barrier Status: Partial

Description: This road crossing measured 69 feet long, with 40 feet crossing the active stream channel. The crossing measured 14 feet wide and has a flat to mild slope. A boulder and concrete apron extends 6 feet downstream at a moderate gradient and with a maximum drop of 6 feet 5 inches on river-left. Native substrate extends up to the road crossing on the river-right downstream side and no drop occurs. The crossing is considerably undercut in some locations. Upstream salmonid habitat conditions were not determined.

Diagnosis: All fish passage is prevented during lower flows due to shallow water depth spread out over the crossing's surface. During moderate to high flows, adequate water depth may facilitate upstream migration of salmonids across the river-right side of the downstream substrate and short apron height onto the crossing. Extremely high flows may produce velocities that would prevent passage of smaller trout across the surface of the crossing.

Recommended Action: Determine the quality and extent of upstream habitat and pursue fish passage options if upstream salmonid habitat conditions warrant it.

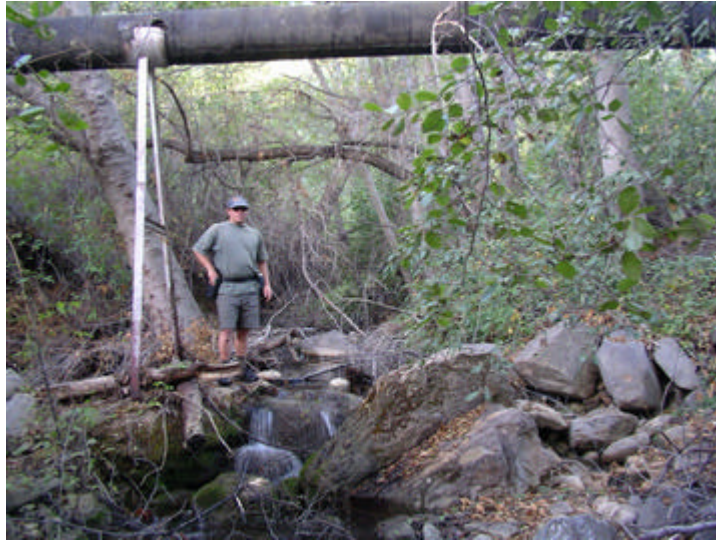
Barrier Status: Not a barrier

Description: Broken concrete blocks occur in the stream channel and partially support metal braces that carry an aerial water pipeline that crosses over the creek. The concrete footings span half of the stream channel. This pipeline is owned and operated by the Montecito Water District.

Diagnosis: Fish passage is not significantly impeded at this crossing due to half of the channel remaining in a natural state. The metal supports do present a significant blockage hazard to downstream migrating debris and boulders.

Recommended Action: Monitor this site and prevent future construction in the stream channel that may prevent salmonid access into this important rainbow trout tributary and perennial habitat. Removal of the in-stream concrete and metal braces would eliminate a blockage hazard and safeguard the pipeline. See barrier write up SY_AR_1 for an example of a previous pipeline retrofit project that the District completed and eliminated such a hazard.

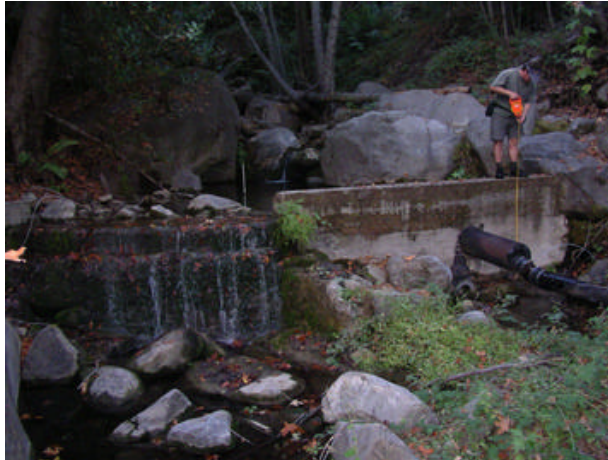
Barrier Status: Partial

Description: This concrete diversion dam spans 26 feet across the stream channel and contains a 10-foot wide notch near river-right that drops water vertically 4 feet to the surface of the downstream pool. The downstream pool depth measured only 3 inches. The dam measured 18 inches thick at the top and 22 inches thick at the notch. Flashboards can be inserted into the notch to raise the water level. The diversion pipe was covered at the upstream end by a finely meshed screen. The dam was observed to be diverting water and was seen leaking from the downstream diversion pipe. This pipe crossing the creek several times downstream connecting to the Montecito Water District pipeline (see SY_FX_1) and contributing to the water supply from Jameson Reservoir.

Diagnosis: Due to the absence of downstream pool depth and excessive jump height, upstream salmonid passage is prevented during the observed low flows. When adequate downstream water depth occurs during moderate and higher flows, salmonid passage is possible with a moderate to high degree of difficulty. With the flashboards inserted, fish passage may only be possible for larger salmonids during high flows when sufficient water depth occurs for jumping the entire dam. No salmonids were observed upstream.

Recommended Action: This tributary provides important spawning and rearing habitat for the Santa Ynez River rainbow trout and high quality habitat occurs upstream of this dam for approximately 750 feet to the upstream waterfall. Contact the structures owner(s) and the LPNF to discuss potential fish passage improvement options for this site and the need to maintain adequate downstream flows for the trout population. A small downstream boulder weir or creation of a concrete step pool, in conjunction with leaving the flashboards out during migration flows, would improve passage at this site.

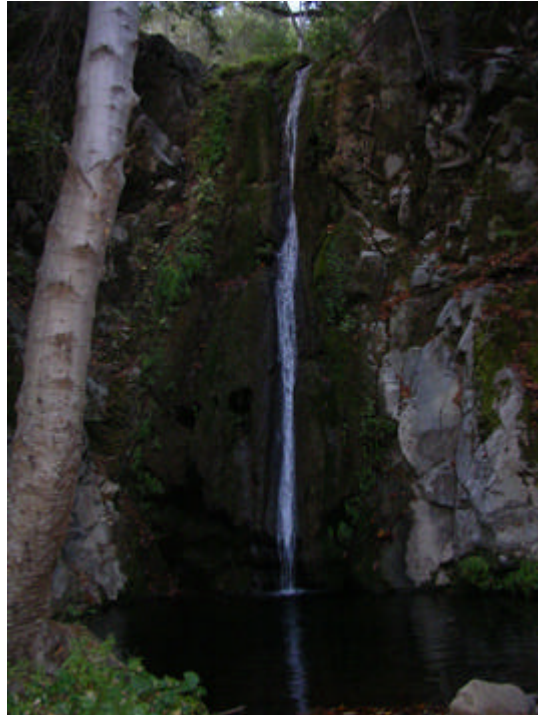
Barrier Status: Complete

Description: This bedrock waterfall measures approximately 30 tall. A 5-foot deep pool occurs downstream of the falls.

Diagnosis: All upstream fish passage is prevented at this waterfall due to the excessive jump height. Multiple boulder cascades and chutes downstream from this waterfall may limit or prevent upstream passage depending on stream flows and substrate movement with storm flows. This waterfall represents the first stabile and complete upstream barrier to fish passage.

Recommended Action: No recommended action for this natural feature.

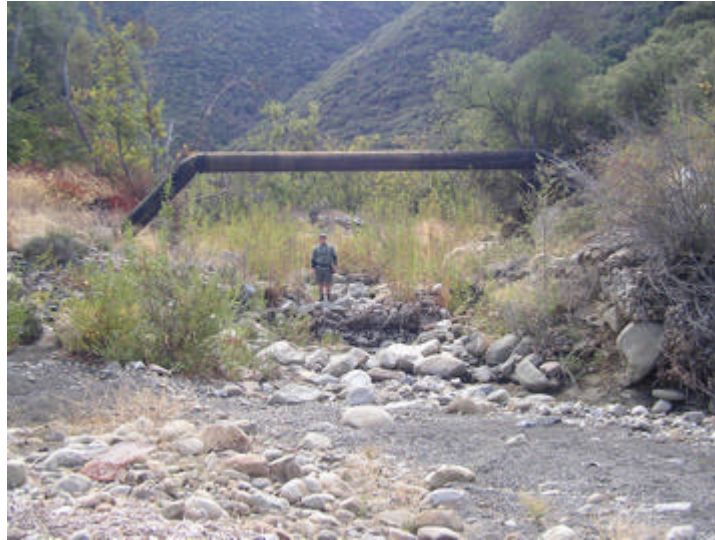
Barrier Status: Not a barrier

Description: This “non-barrier” is included in this report as an example of a former pipeline crossing that was recently modified and is no longer a fish passage barrier. When observed in the early 1990’s this pipeline crossed the creek channel and was protected within a wire-and-stone basket dam. A significant drop occurred downstream of the structure that impeded upstream trout passage. The pipeline was removed 7-8 years ago following damage from high stream flows and an aerial pipeline crossing was installed and natural stream channel restored. This aerial crossing no longer impedes fish migration into Alder Creek and provided safety to the Montecito Water District pipeline and water supply. Remnants of the wire-and-stone basket dam still occur downstream of the pipeline crossing on river-left, but do not impede passage.

Diagnosis: Natural channel conditions occur under the aerial crossing and do not impede fish migrate.

Recommended Action: Continue to monitor site and promote this type of pipeline barrier replacement at other utility crossing barrier sites, such as on the Santa Ynez River downstream of Cachuma Dam (see barrier write up SY_5).

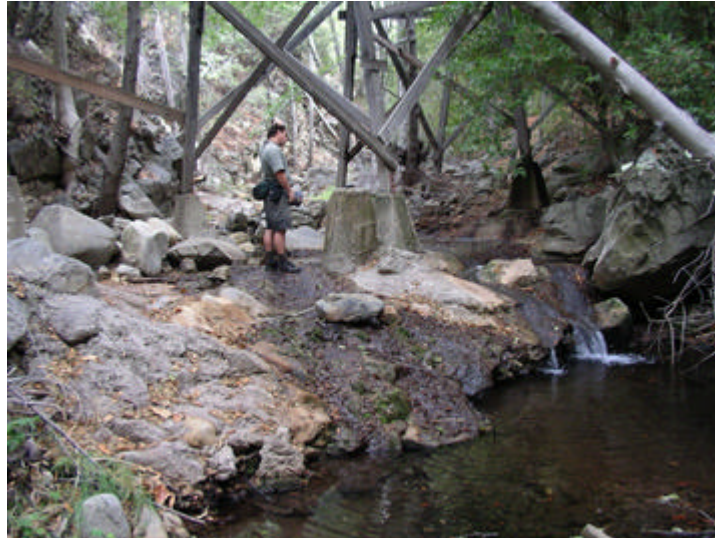
Barrier Status: Partial

Description: This concrete footing structure spans 33 feet across the stream channel. The footing anchors wood pilings that support the flume that carries water from the Alder Creek diversion dam (SY_AR_3) into Jameson Reservoir. The concrete structure extends 22 feet under the flume and is composed of large embedded boulders in concrete. The metal piling anchors are also embedded in the surface of the concrete. During the low flows encountered, a 12-inch drop occurs from the downstream end of the structure to the surface of the downstream pool. The downstream 8 feet of the structure drops a total height of 2 feet 6 inches. The maximum downstream pool depth measured 14 inches.

Diagnosis: During lower flows, upstream salmonid passage is impeded due to the moderate slope of the downstream end of the structure and shallow water conditions encountered. During moderate and higher flows, salmonids can jump/swim onto the concrete with a low degree of difficulty and utilize resting spots provided by the pilings and embedded boulders to swim upstream. Upstream passage during ideal flows can be accomplished with a moderate degree of difficulty.

Recommended Action: Continue to monitor the site to ensure adequate passage. Should the flume be altered in the future, the instream concrete and pilings could be removed and angled, upside-down V-shaped supports installed with anchors located outside the stream channel on the banks.

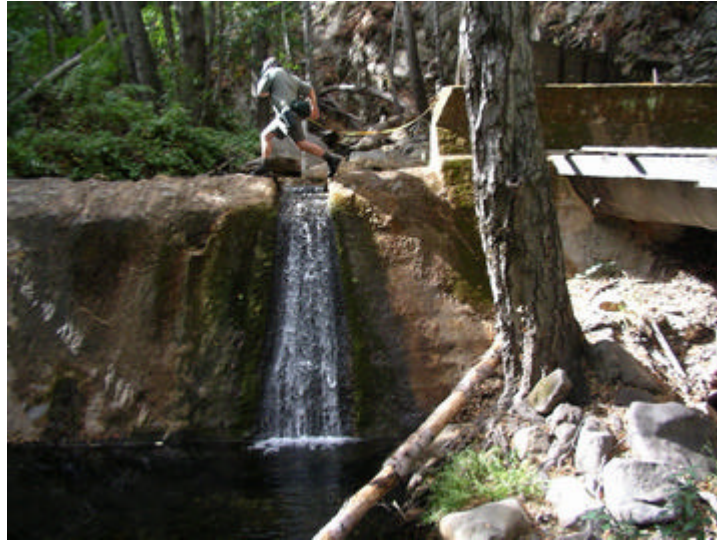
Barrier Status: Partial

Description: This concrete dam diverts surface flows into the flume that carries water to Jameson Reservoir. The dam measured 10 feet tall from the top to the surface of the downstream pool. A 2-foot wide by 10 inches deep notch occurs near the center of the dam. The dam extends 45 feet across the stream channel. Moderate downstream undercutting of the dam is occurring. The maximum depth of the downstream pool measured 3 feet 6 inches. The flume attaches to the river-left side of the dam and is partially screened. The screen measured 2 feet 8 inches tall by 14 feet long. The coarsely meshed screen is not properly sized to prevent even adult trout from being diverted into the flume. Oddly, there is a large unscreened section underneath the screen that allows fish and smaller debris to enter the flume freely. No stream flow was being diverted.

Diagnosis: Upstream passage at this site would be extremely difficult due to the jump height present, but during ideal flow conditions it appears that the downstream pool could backfill 3 to 4 feet and allow limited and difficult passage for larger trout and possibly. Smaller trout occur upstream and may be the offspring of transplants from below and/or larger spawners that successfully passed the structure. Downstream migrating salmonids can easily become entrapped in the flume and either make it to Jameson Reservoir or die in the flume as it dries out. The Jameson Reservoir Keeper informed us that he has spoken with people that have observed rainbow trout in the flume (pers. comm. Andaloro). Diversions impact downstream migratory connectivity and salmonid habitat.

Recommended Action: A small amount of habitat occurs upstream of the dam to the waterfall (SY_AR_4), but trout are present and the habitat is of high quality. The diversion should be installed with an adequately sized screen that prevents entrapment of downstream migrating salmonids. Upstream passage options should be discussed with the Montecito Water District, the National Forest, and others to determine the feasibility of various alternatives and long-term objectives. It may be possible to improve the facility for fish passage that would benefit all stakeholders. One option to consider would be the lowering of the dam by 2 to 3 feet and the creation of 1 or more downstream jump-pools using boulder weirs and/or concrete step pools.

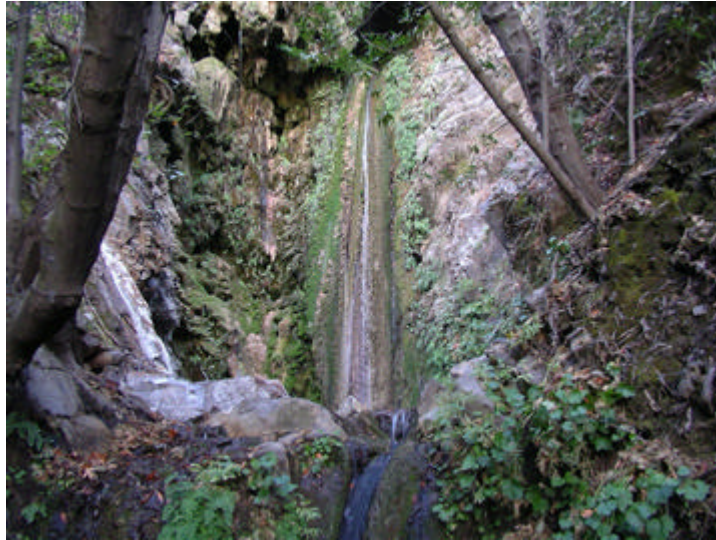
Barrier Status: Complete

Description: The total height of this bedrock waterfall measured approximately 30 feet from the top to the surface of the downstream pool. Masses of mineral deposits and algal growth produce impressive hanging formations on the waterfall. A spring was also observed dripping water out of the adjacent cliffs overhanging the falls. The downstream pool had a measured maximum depth of 5 feet.

Diagnosis: This feature is impassable due to the excessive height.

Recommended Action: No recommended action for this natural feature.

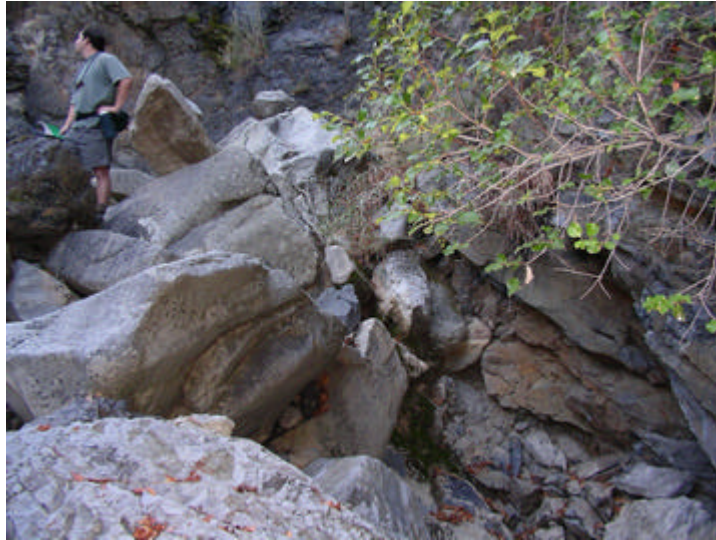
Barrier Status: Complete

Description: This bedrock and boulder waterfall measured 11 feet tall from the top to the downstream substrate. No pool occurred during the dry conditions encountered, but based on high water marks and debris, it appears that the downstream pool would not exceed 4 feet in depth. This entire area is composed of large boulders that may change the character of this reach following large flow events.

Diagnosis: In the current configuration, this structure represents the upstream limit to all salmonid migration due to the excessive jump height and lack of sufficient downstream jump depth. This dry tributary does not appear to have significant habitat benefits for salmonid rearing, but may provide some limited spawning habitat.

Recommended Action: No recommended action for this natural feature.

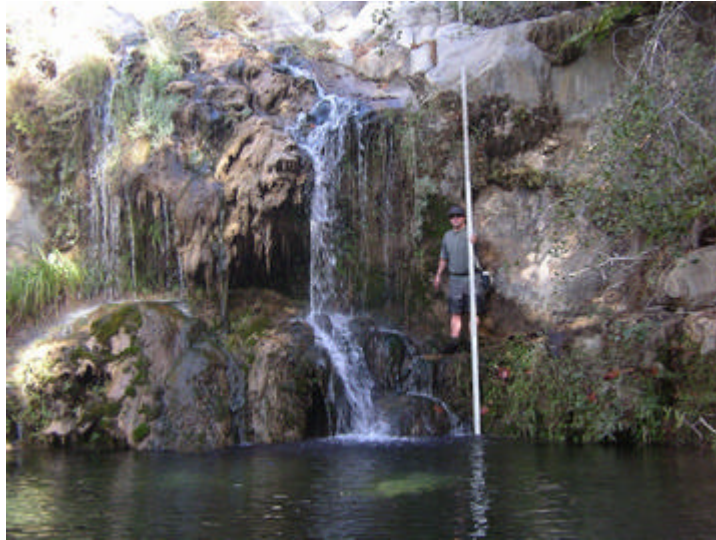
Barrier Status: Complete

Description: The total height of this bedrock waterfall measured 21 feet from the top to the surface of the downstream pool. The top 8 feet of the structure drops stream flows down a steep, two-part chute. Below the chute, water drops vertically 13 feet into the downstream pool. The large downstream pool had a measured maximum depth of 7 feet.

Diagnosis: This feature is impassable to all salmonids during all flows due to the excessive height. No trout were observed upstream of the falls to the next tributary confluence. Excellent salmonid habitat conditions occur downstream.

Recommended Action: No recommended action for this natural feature.

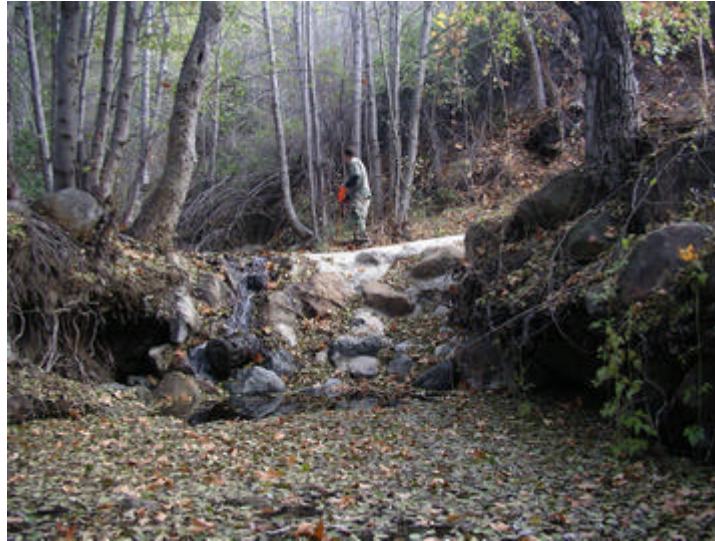
Barrier Status: Partial

Description: This road crossing measured 30 feet across the active stream channel and 15 feet wide. The crossing measured 14 feet wide and has a flat to mild slope with significant wear and irregular depressions with up to 4 inches of water depth. A steep, concrete and boulder apron extends for 10 feet downstream, dropping a height of 6 feet 1 inch to the surface of the downstream pool. The pool had a maximum measured depth of 3 feet during the encountered low flows. *Note-Steelhead Creek is the true perennial headwater stream of the upper Santa Ynez River judging by the flows and larger channel compared to the smaller, dry “mainstem” Santa Ynez River upstream from the confluence with Steelhead Creek. Steelhead Creek contains the best upper Santa Ynez River habitat (above Jameson Res. and excluding N.F. Juncal Creek) for salmonids and was likely the historic upstream spawning and rearing stream for the mainstem Santa Ynez River steelhead population prior to dam construction.*

Diagnosis: This structure significantly impedes upstream rainbow trout to excellent salmonid spawning and rearing habitat. All fish passage is prevented during low and moderate flows due to the shallow water depth spread out over the crossing's surface, excessive velocities on the apron, excessive jump height, and insufficient jump-depth encountered. During high flows, adequate water depth may develop in the downstream pool to allow a difficult jump onto the crossing surface and migration along the road margin. Excessive velocities over the concrete may impeded/prevent passage of smaller trout. While potentially passable during high stream flow conditions, this crossing

Recommended Action: Fish passage should be improved at this site to ensure effective upstream migration of spawning rainbow trout from Jameson Reservoir that need to access upstream perennial habitat. This rainbow population has been identified to contain the native southern steelhead genotype and is important to maintain for future recolonization efforts with the Santa Ynez River. Reducing the crossing to streambed level with a roughened surface or replacing it with a bridge would provide effective upstream migration and a bridge would improve vehicle access during higher flows. This narrow channel provides an ideal location to remove this crossing and replace it with a fairly short-span and less costly bridge.

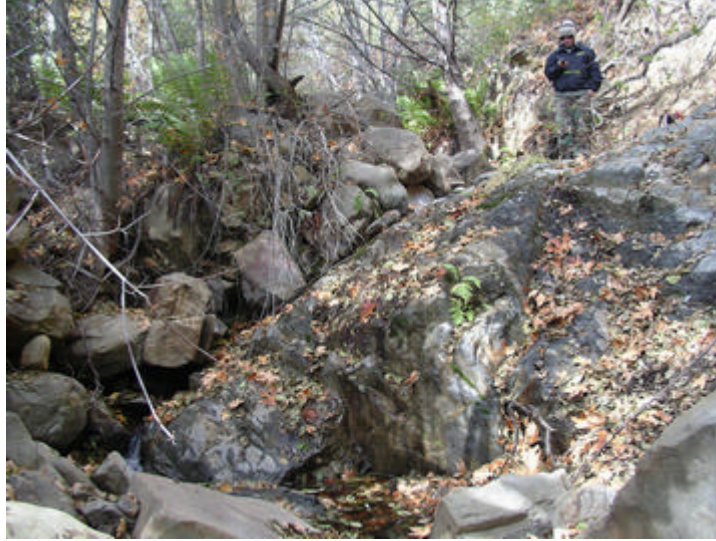
Barrier Status: Complete

Description: This bedrock chute measured 10 feet 4 inches tall and drops at a 45-degree angle to a tiny 6-inch deep pool downstream. A boulder cascade also occurs 300 feet downstream that drops 9 feet into a 4-foot deep pool.

Diagnosis: This bedrock chute prevents further upstream salmonids passage due to the excessive jump height, minimal downstream jump-pool, and excessive velocities produced during high stream flows. The boulder cascade 300 feet downstream also likely prevents upstream fish passage to the excessive jump height, but may be mobilized over time.

Recommended Action: This natural feature represents the end-of-the-line for salmonids migrating upstream on the mainstem of the Santa Ynez River and likely represents the historic upstream natural limit to steelhead migration on the Santa Ynez. Hopefully someday anadromous steelhead will be able to migrate upstream to this site once again!
