Barrier ID: SC_TT_21, SC_TT_22
Stream: Tepusquet Creek
Barrier Type: Culvert Crossings
Physical Location: Approximately 1.3 miles upstream of Colson Creek
GPS Location: N/A
Ownership/Interest: Unknown
Surveyor(s) and Date: Matt Stoecker and Jim Stoecker 12/16/02

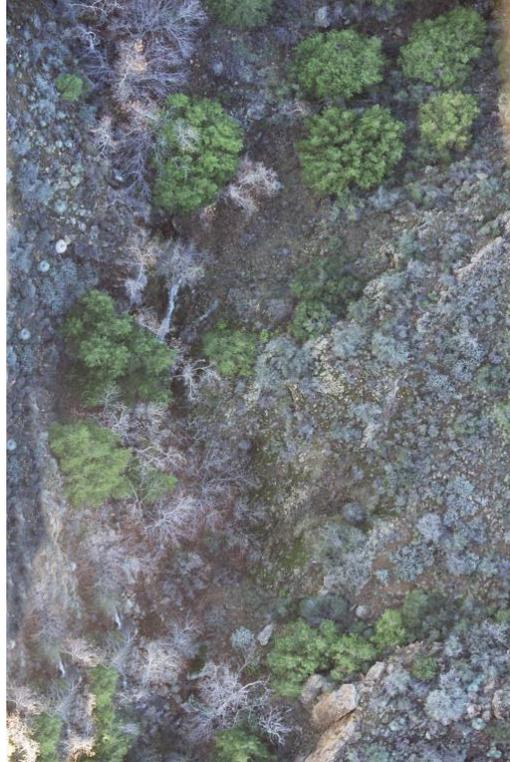
Bedrock waterfall

Description: Observations of this bedrock waterfall were made from the air and are limited in detail. This waterfall drops vertically more than 20 feet.

Condition: Stable bedrock feature.

Recommended Action: No recommended action for this natural feature.

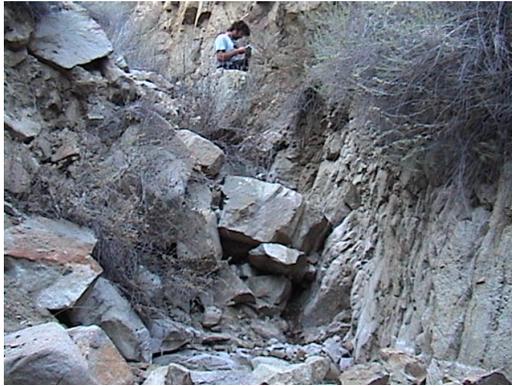
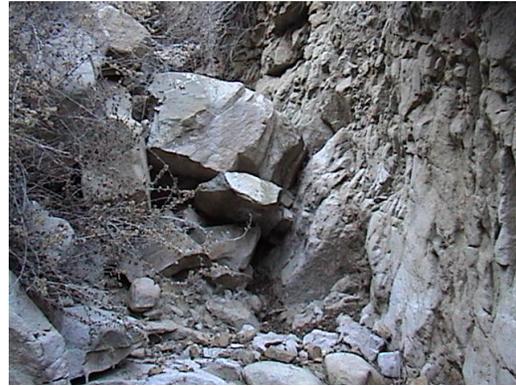
Upstream view of boulder/bedrock barrier

Description: This steep bedrock and boulder stream reach occurs in a confined canyon. Large boulders and exposed bedrock produce a nearly vertical drop with a height of 9 feet to the downstream substrate. Immediately downstream a large landslide would also likely prevent upstream migration, but this feature may flush out with high stream flows.

Recommended Action: No recommended action for this natural feature.

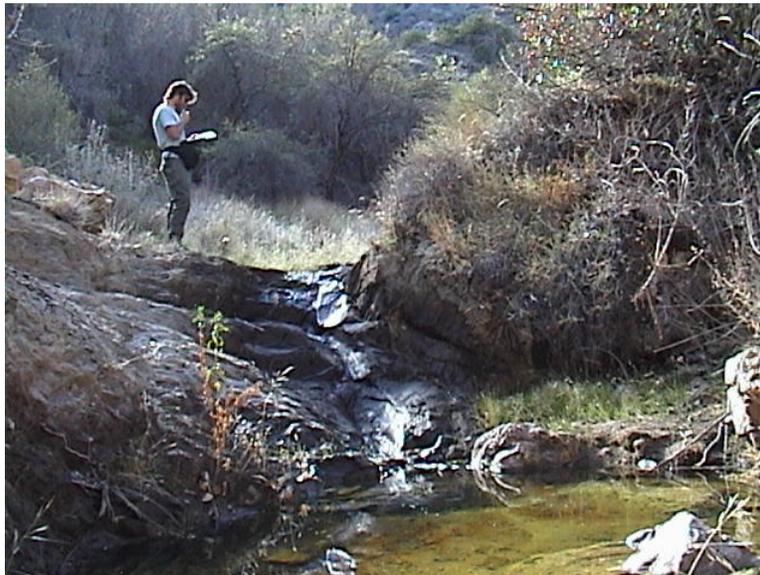
Bedrock chute looking upstream

Description: This steep bedrock chute measured 6 feet tall over a 12-foot horizontal distance. A small downstream pool occurs with a maximum depth of 12 inches. This tributary to Big Bend Creek is the second southern tributary upstream from the Sisquoc River identified on the 7.5 minute USGS topo map. The next southern tributary downstream was dry at the confluence with Big Bend Creek and does not appear to provide significant salmonid habitat.

Recommended Action: No recommended action for this natural feature.

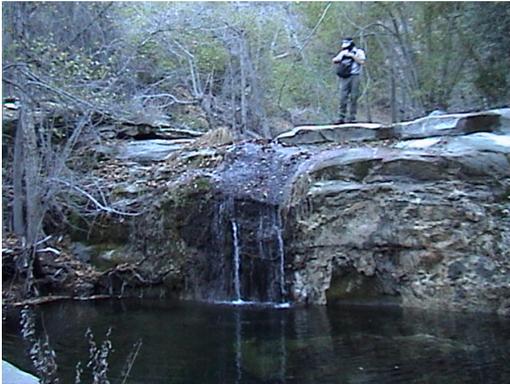
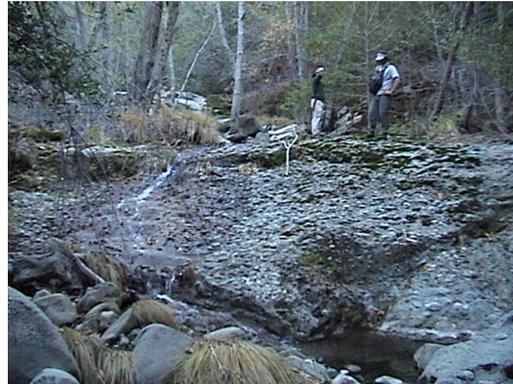
Bedrock Waterfall

Bedrock Chute

Description: Two natural features are described here. A steep bedrock chute occurs approximately 100 feet downstream from a bedrock waterfall. This bedrock waterfall drops water vertically 9 feet to the surface of the large downstream pool, which had a maximum measured depth of 7 feet. The chute measured 22 feet long with a vertical rise of 7 feet. A small 6 inch deep pool exists downstream of this chute.

Recommended Action: No recommended action for these natural features.

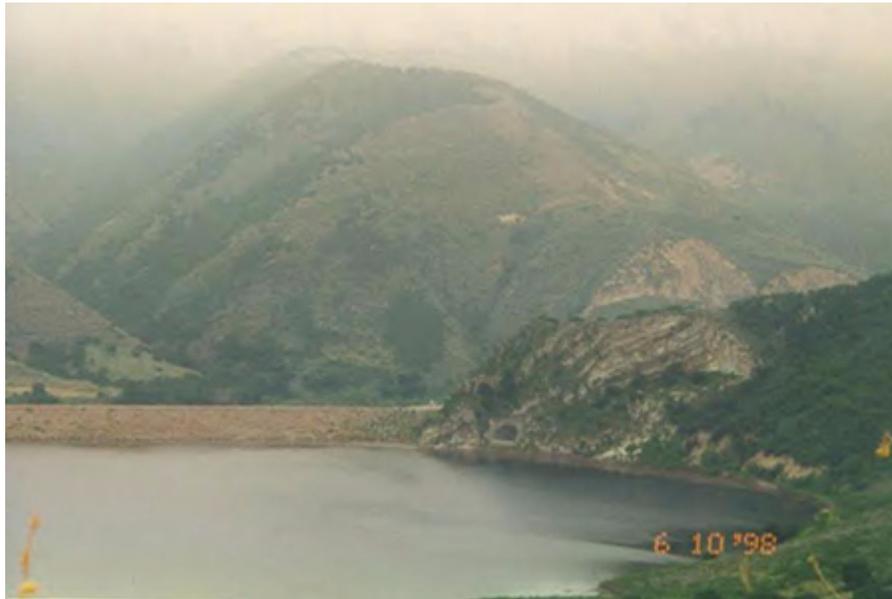
Twitchell Dam and Reservoir following a big El Nino year.

Diagnosis: Twitchell Dam and the manipulated water releases associated with it constitute the most limiting migration barrier to the now endangered steelhead of the Santa Maria River watershed. This dam physically blocks steelhead from accessing over half of the watershed upstream of the dam, where numerous rainbow trout bearing streams such as Huasna River, Kelly Canyon Creek, Deal Creek, Alamo Creek, Bear Trap Creek, and Reyes Creek occur (Donna Toth, LPNF files). In addition, the manipulated downstream water releases have exacerbated the

In a section at the end of his 1945 report, “Recommendations for Protection of the Fishery Resources for the Santa Ynez and Santa Maria River”, Shapovalov makes several recommendations that should accompany any dam building on the Cuyama and Sisquoc Rivers, including the following:

- “During the winter season sufficient water be released from both Vaquero (now Twitchell) and Round Corral reservoirs to permit steelhead to ascend from the ocean past Round Corral Dam (up the Sisquoc River).”
- “...Releases of water for ground percolationmaintain proper conditions in the streams (for steelhead).”

The existing operations at Twitchell Dam do not reflect either of these recommendations. As a result, the second largest steelhead fishery in Santa Barbara County, and one of the largest in the southern California ESU, has been nearly wiped out. The current approved water control
